MSC-00171

APOLLO 11 MISSION REPORT

MANNED SPACECRAFT CENTER  
HOUSTON, TEXAS  
NOVEMBER 1969

Mission Evaluation Team

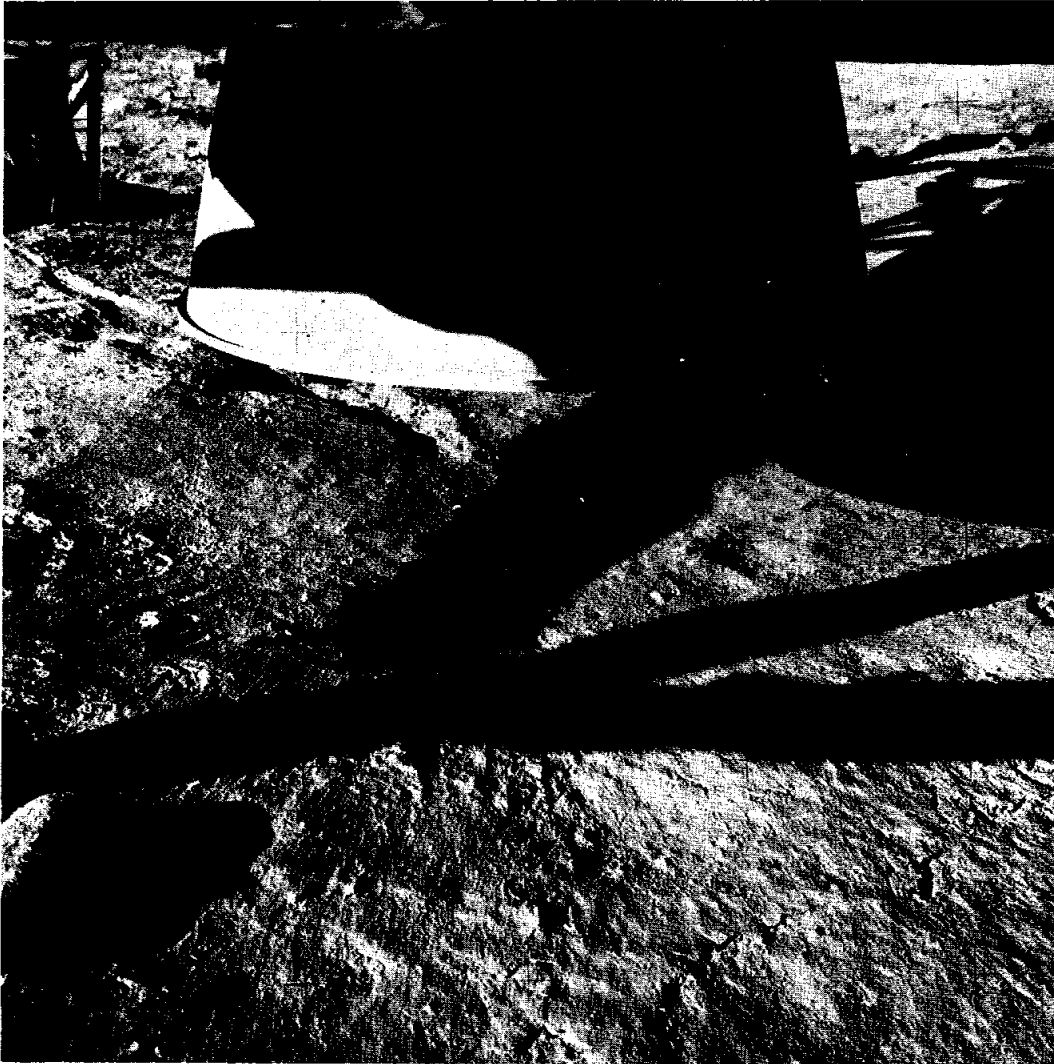
Figure 11-14.- Lunar surface under descent stage engine .

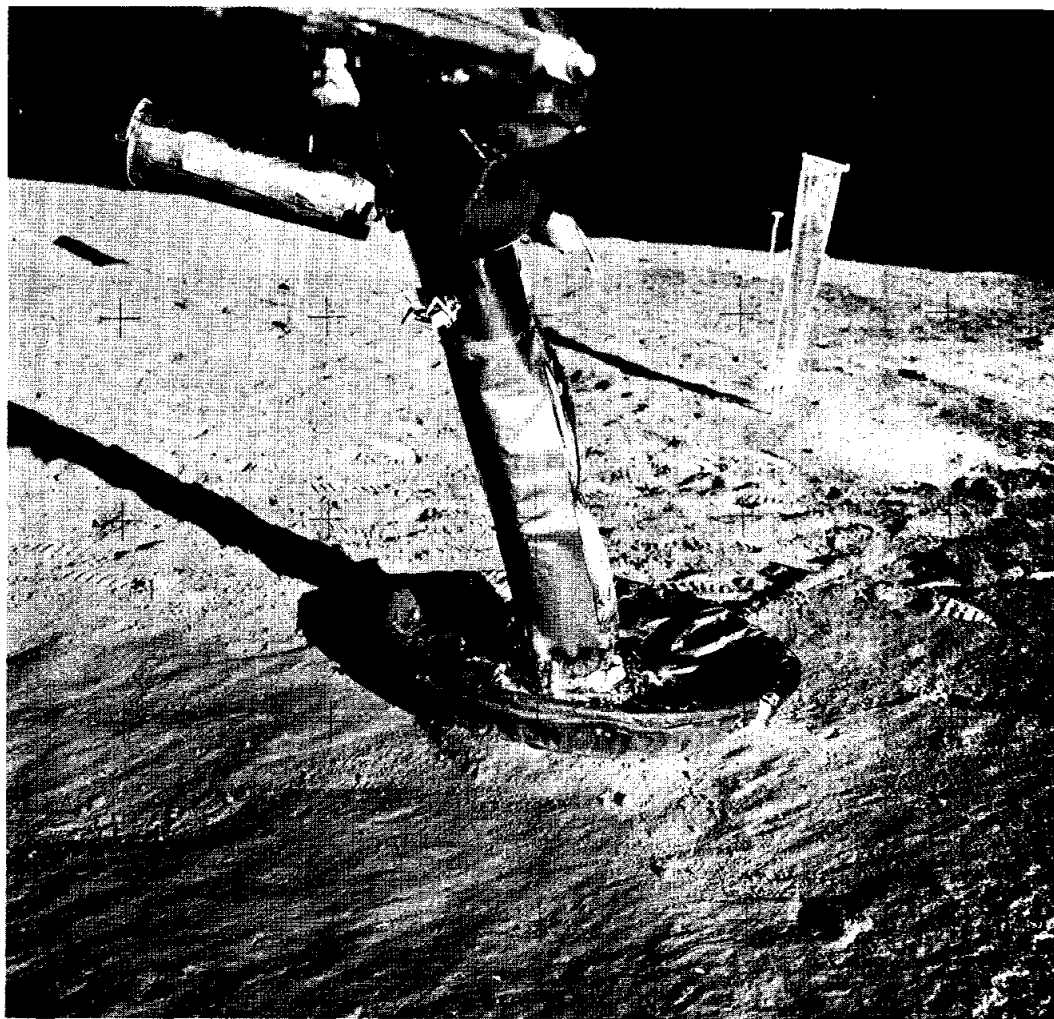
Figure 11-15.- Interaction of plus Y footpad and contact probe with lunar surface.

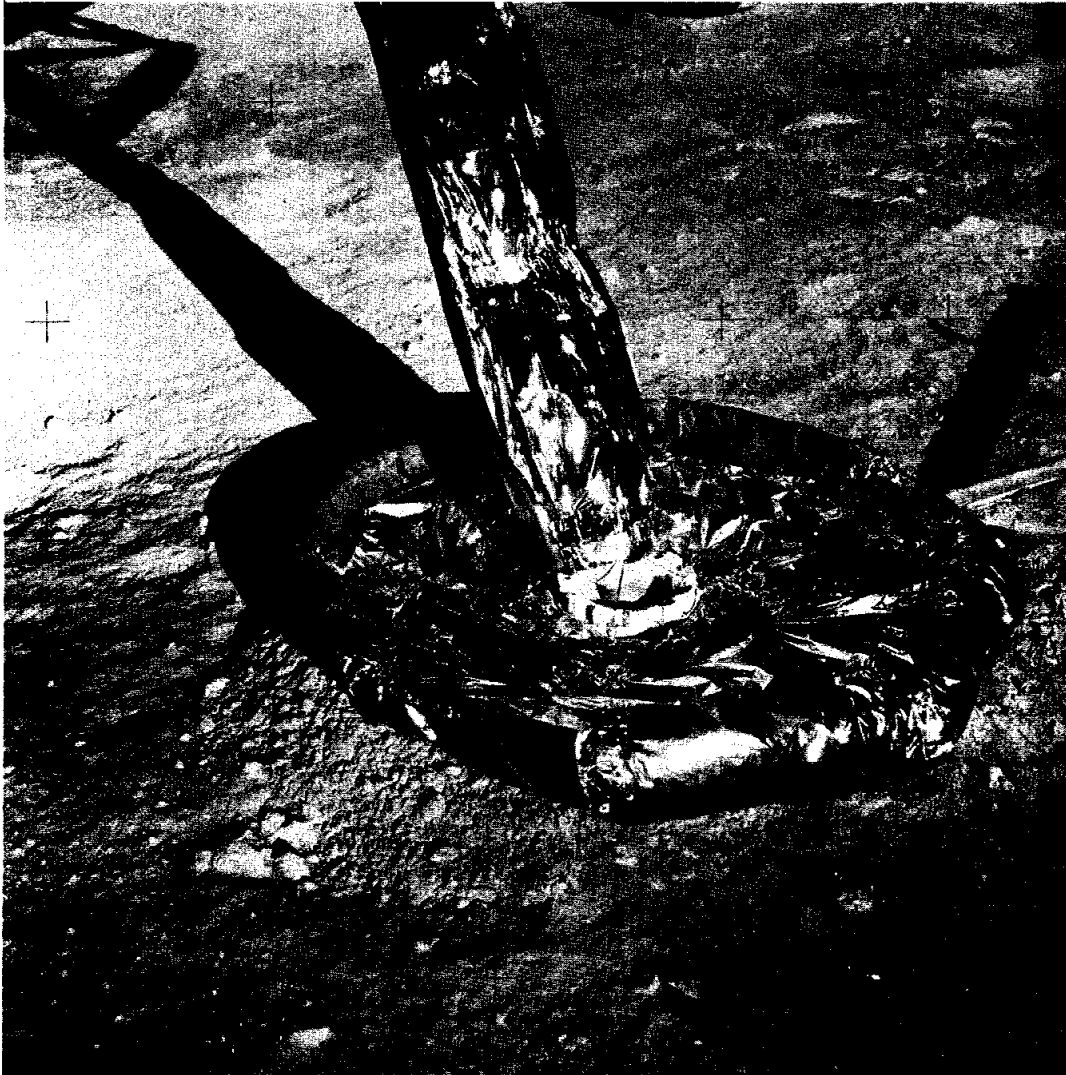
Figure 11-16.- Interaction of the minus Z footpad with lunar surface.

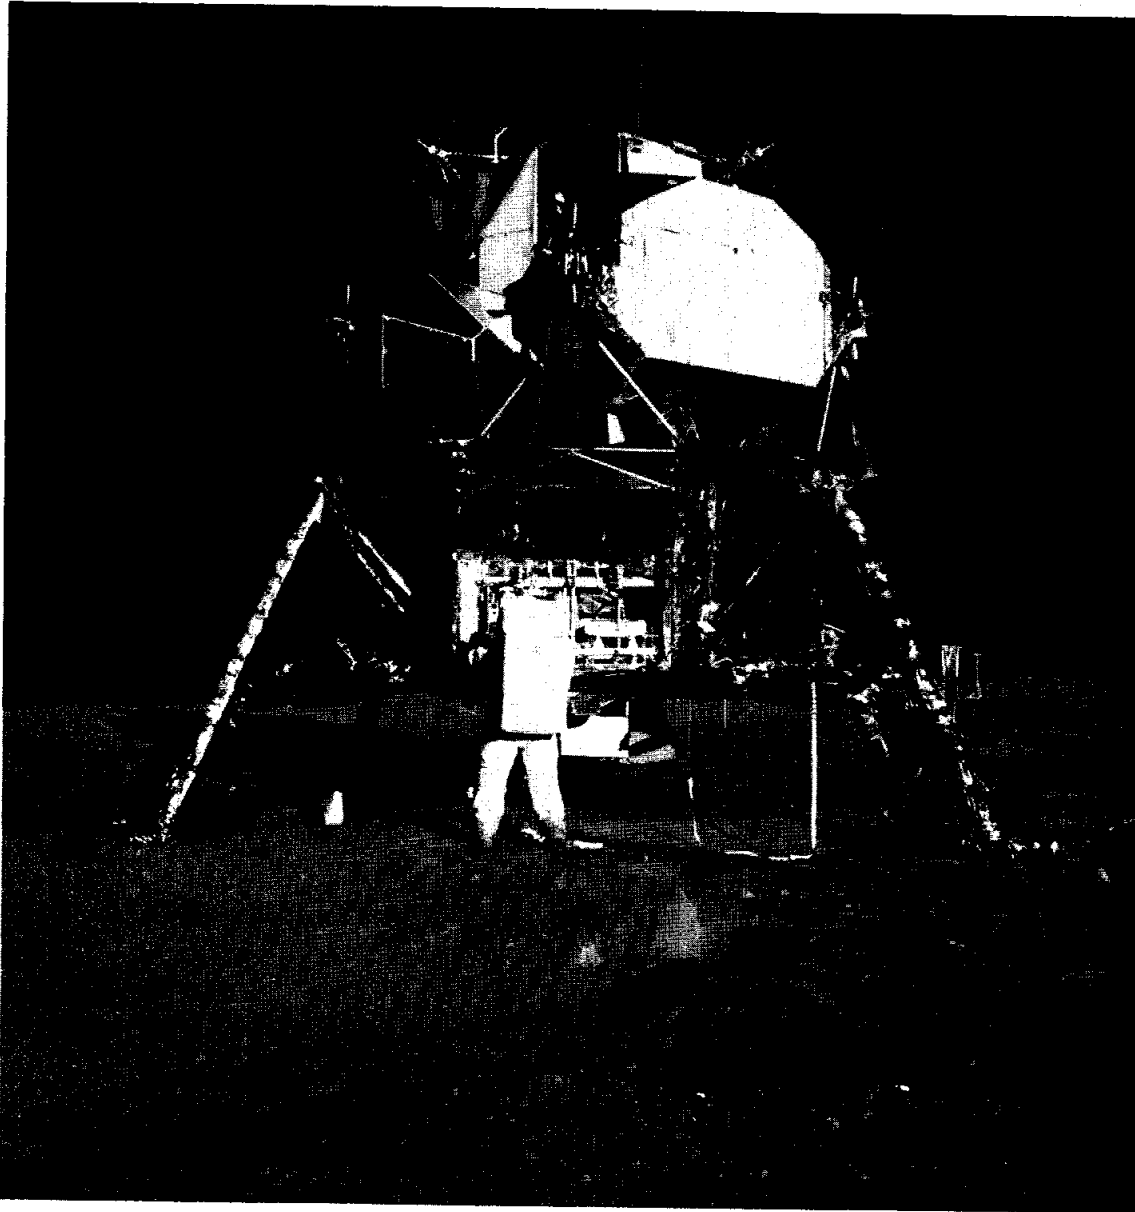
Figure 11-18.- Soil disturbance in the minus Y foot pad area.

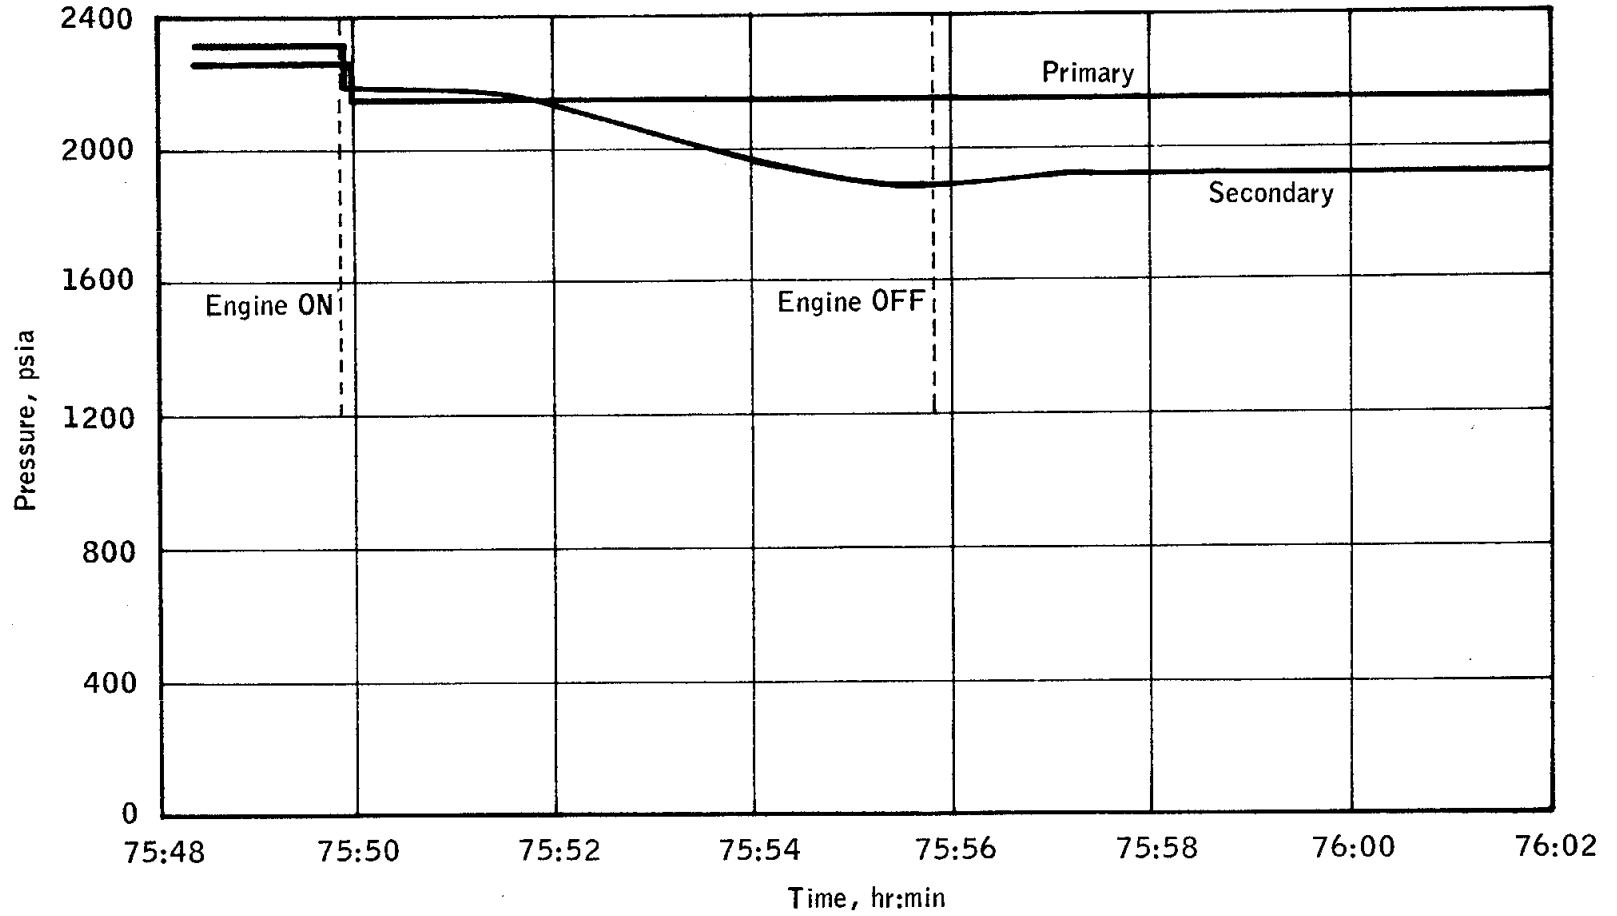
Figure 16-1.- Nitrogen pressure during initial lunar orbit insertion firing.

An abnormal decay in the secondary (system B) nitrogen pressure was observed during the lunar orbit insertion service propulsion firing, indicating a leak in the system which operates the engine upper bipropellant valve bank. No further leakage was indicated during the remainder of the mission. This anomaly is discussed in greater detail in section 16.1.1.

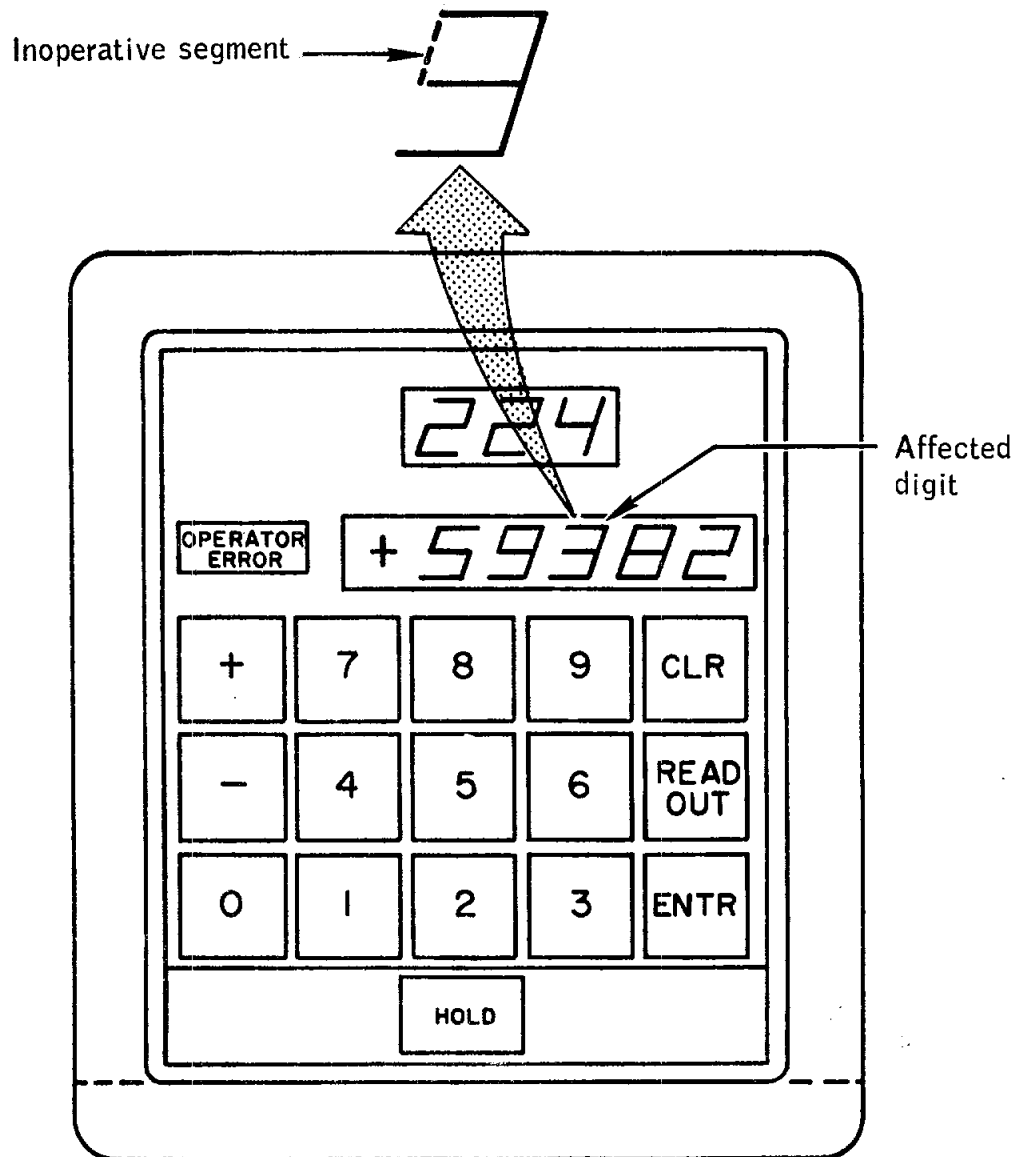
Figure 16-15.- Inoperative segment in one digit of data entry and display assembly.
