## CHAPTER 4

### REVIEW AND ANALYSIS OF APOLLO 13 ACCIDENT

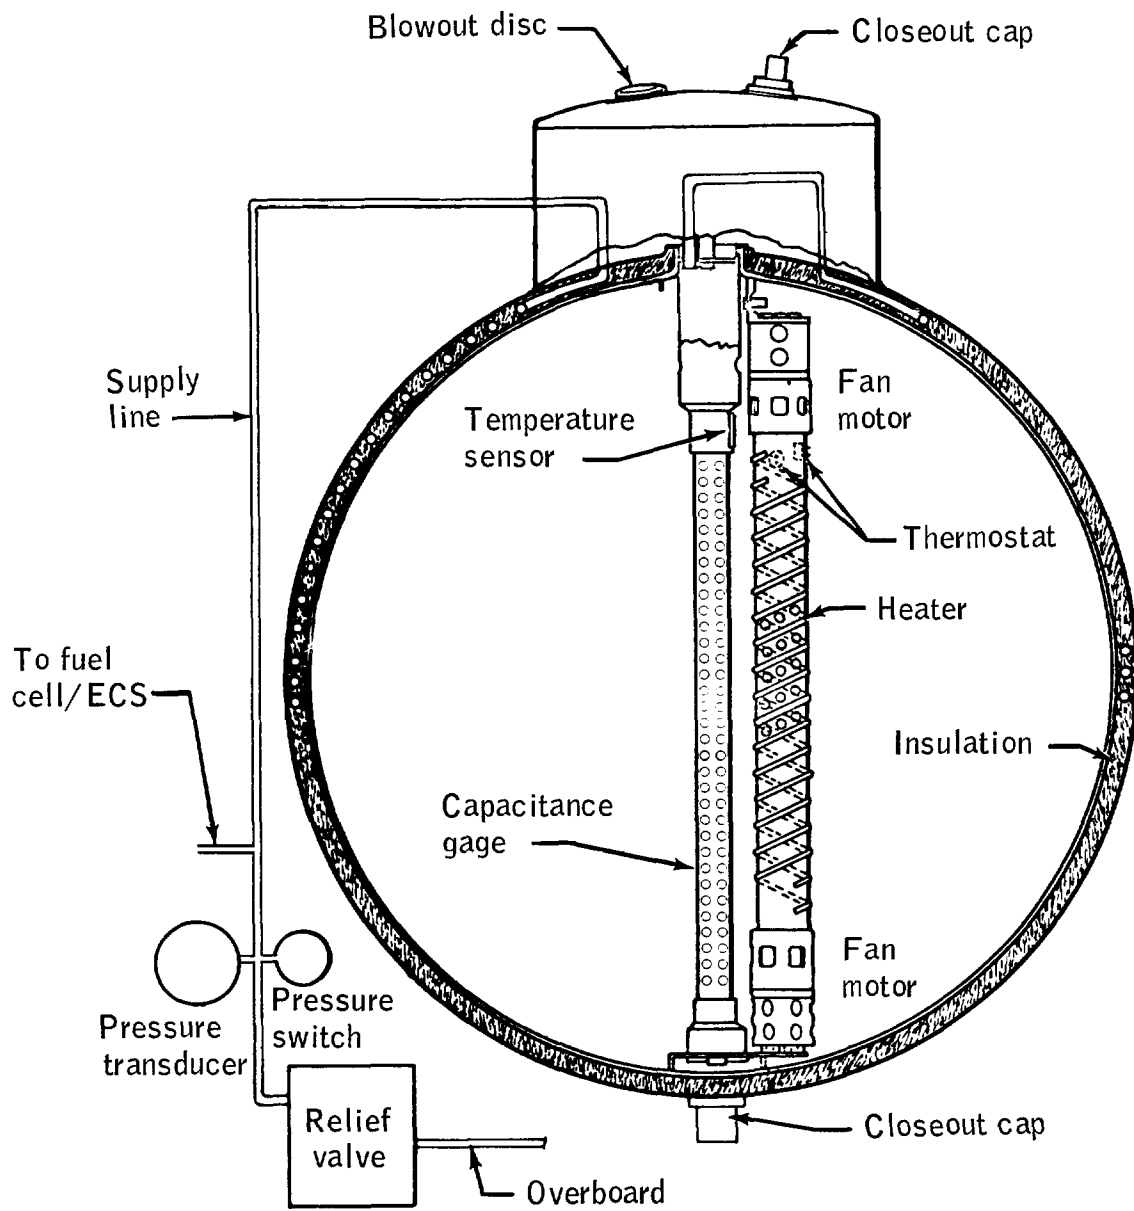
As the simplified drawing in figure 4-1 indicates, each oxygen tank has an outer shell and an inner shell, arranged to provide a vacuum space to reduce heat leak, and a dome enclosing paths into the tank for transmission of fluids and electrical power and signals. The space between the shells and the space in the dome are filled with insulating materials. Mounted in the tank are two tubular assemblies. One, called the heater tube, contains two thermostatically protected heater coils and two small fans driven by 1800 rpm motors to stir the tank contents. The other, called the quantity probe, consists of an upper section which supports a cylindrical capacitance gage used to measure electrically the quantity of fluid in the tank. The inner cylinder of this probe serves both as a fill and drain tube and as one plate of the capacitance gage. In addition, a temperature sensor is mounted on the outside of the quantity probe near the head. Wiring for the gage, the temperature sensor, the fan motors, and the heaters passes through the head of the quantity probe to a conduit in the dome. From there the wiring runs to a connector which ties it electrically to the appropriate external circuits in the CSM. The routing of wiring and lines from the tank through the dome is shown in figure 4-2.

Figure 4-1.- Oxygen tank no. 2 internal components.

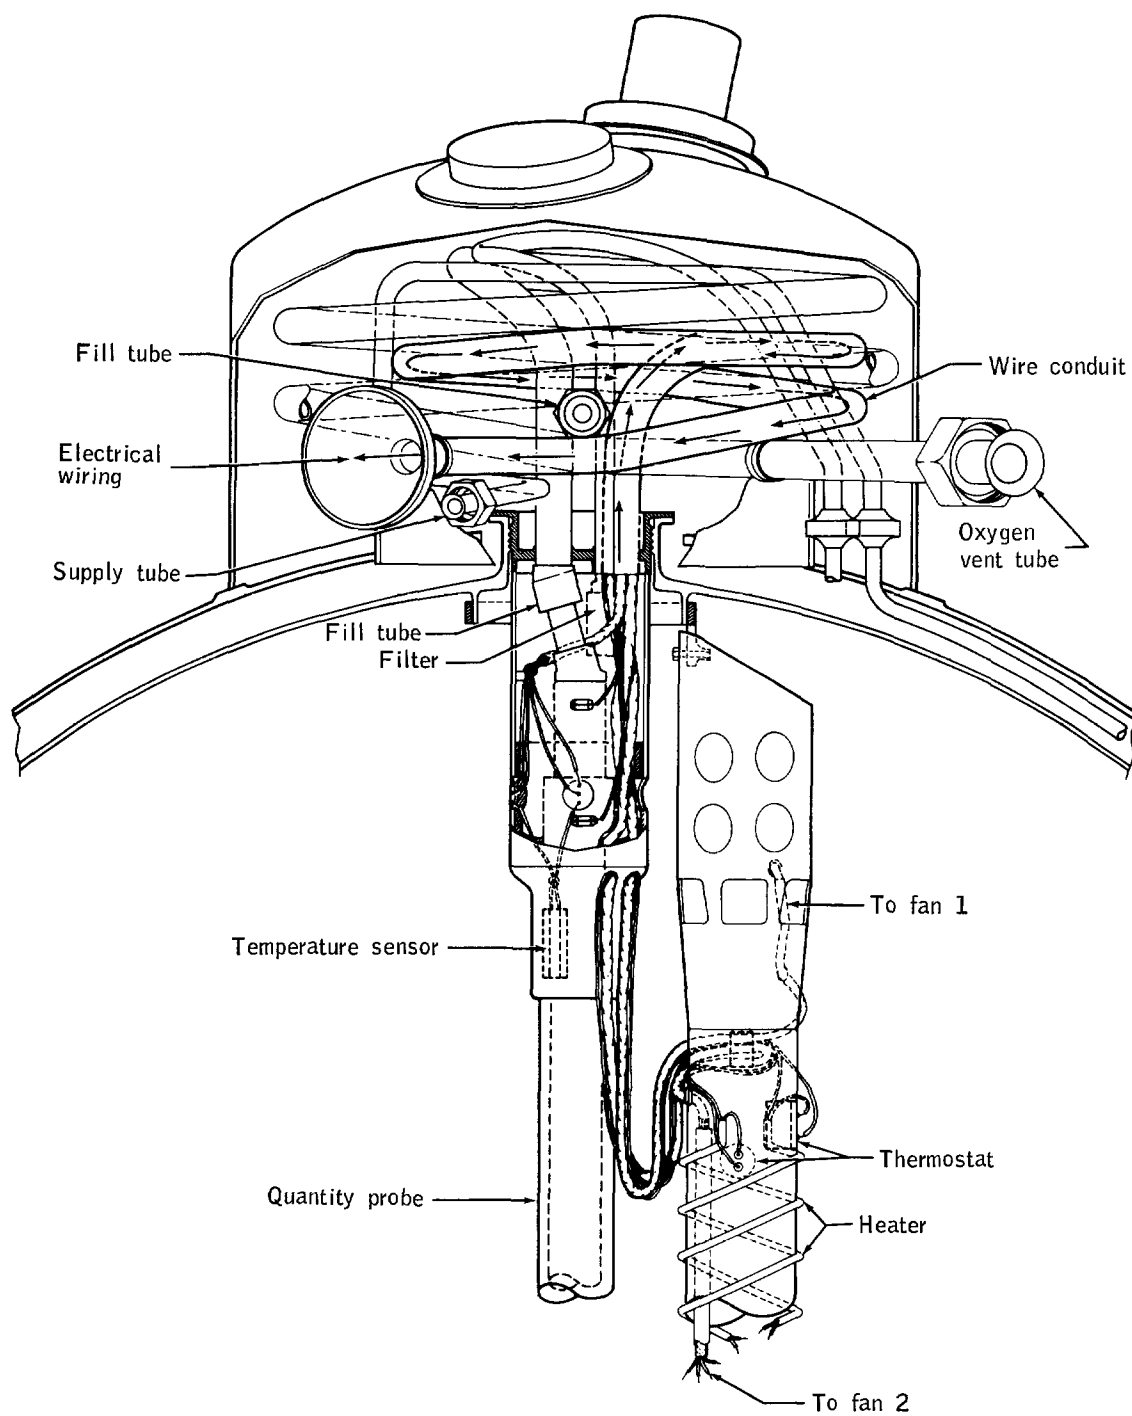
As shown in figure 4-2, the fill line from the exterior of the SM enters the oxygen tank and connects to the inner cylinder of the capacitance gage through a coupling of two Teflon adapters or sleeves and a short length of Inconel tubing. The dimensions and tolerances selected are such that if "worst case" variations in an actual system were to occur, the coupling might not reach from the fill line to the gage cylinder (fig. 4-3). Thus, the variations might be such that a very loose fit would result.

Figure 4-2.- Oxygen tank wiring and lines.

As noted earlier in this chapter, and shown in figure 4-2, each heater is protected with a thermostatic switch, mounted on the heater tube, which is intended to open the heater circuit when it senses a temperature of 80° F. In tests conducted at MSC since the accident, however, it was found that the switches failed to open when the heaters were powered from a 65 V dc supply similar to the power used at KSC during the detanking sequence. Subsequent investigations have shown that the thermostatic switches used, while rated as satisfactory for the 28 V dc spacecraft power supply, could not open properly at 65 V dc. Qualification and test procedures for the heater assemblies and switches do not at any time test the capability of the switches to open while under full current conditions. A review of the voltage recordings made during the detanking at KSC indicates that, in fact, the switches did not open when the temperature indication from within the tank rose past 80° F. Further tests have shown that the temperatures on the heater tube may have reached as much as 1000° F during the detanking. This temperature will cause serious damage to adjacent Teflon insulation, and such damage almost certainly occurred.

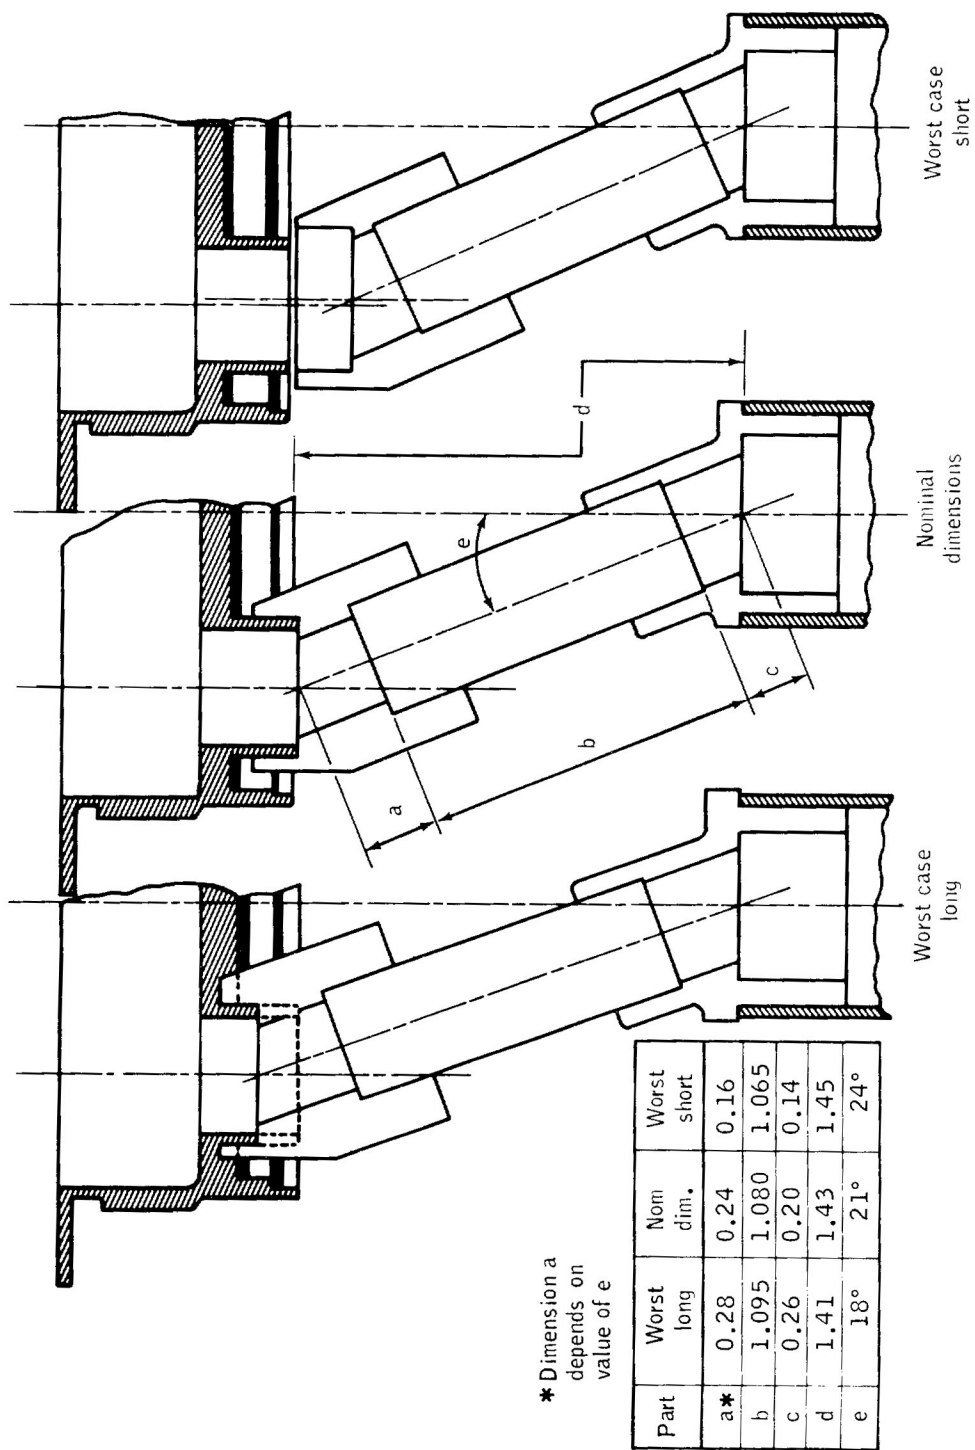
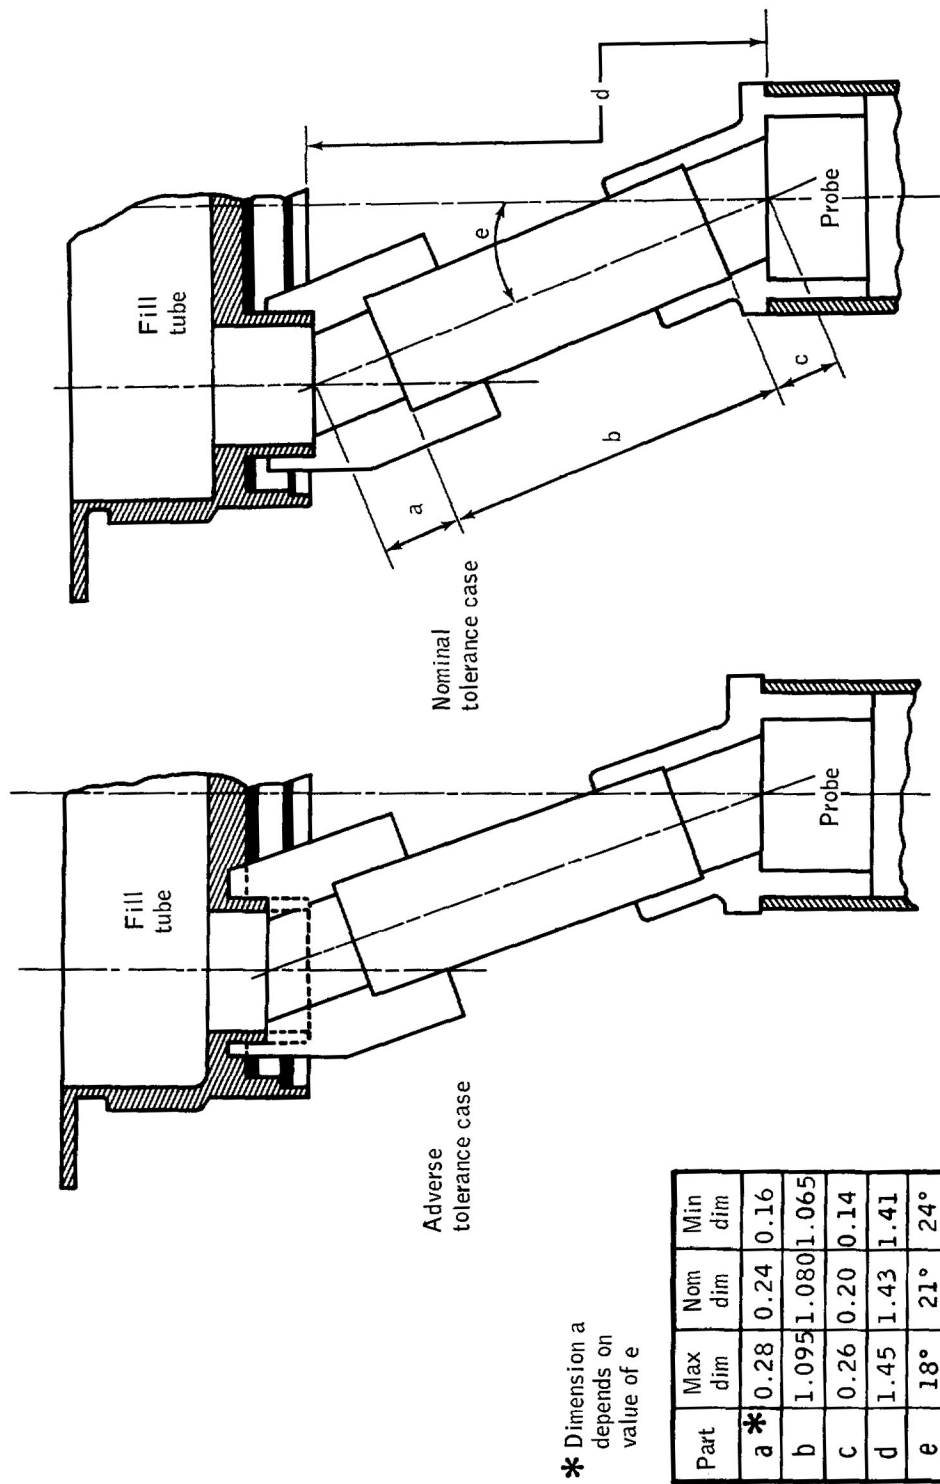
Figure 4-3.- Nominal and adverse tolerance cases.

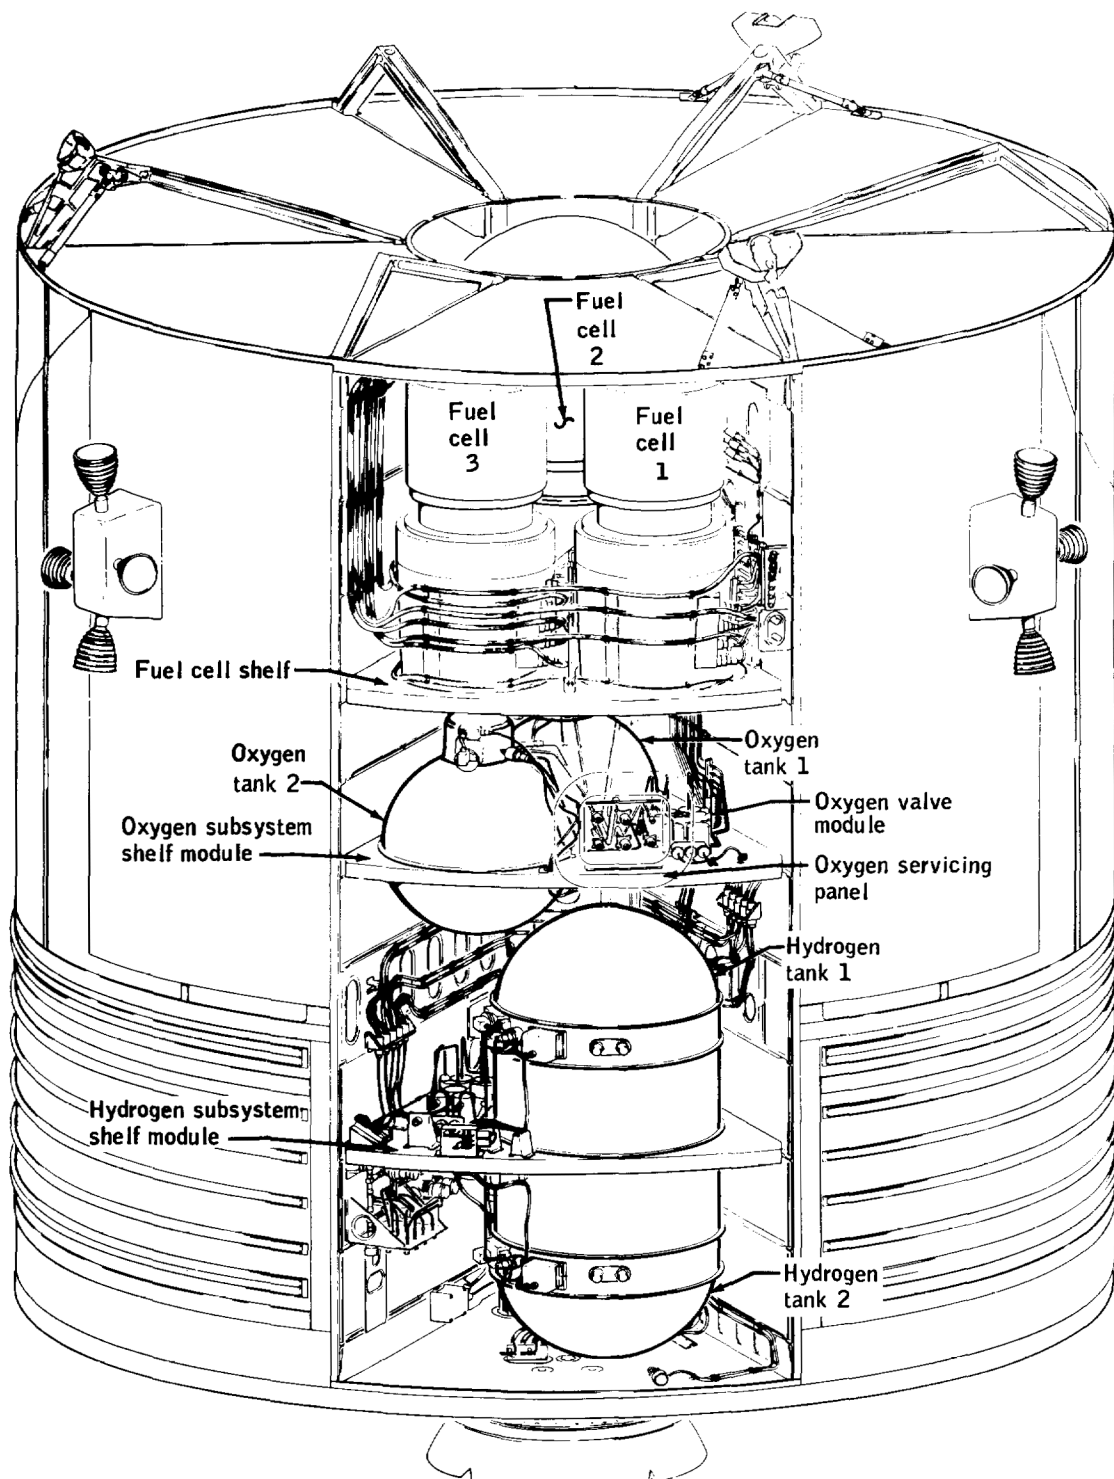
Two oxygen tanks are mounted on a shelf in bay 4 of the SM, as shown in figure 4-4. Figures 4-5 through 4-8 are photographs of portions

Figure 4-4.- Arrangement of fuel cells and cryogenic systems in bay 4.

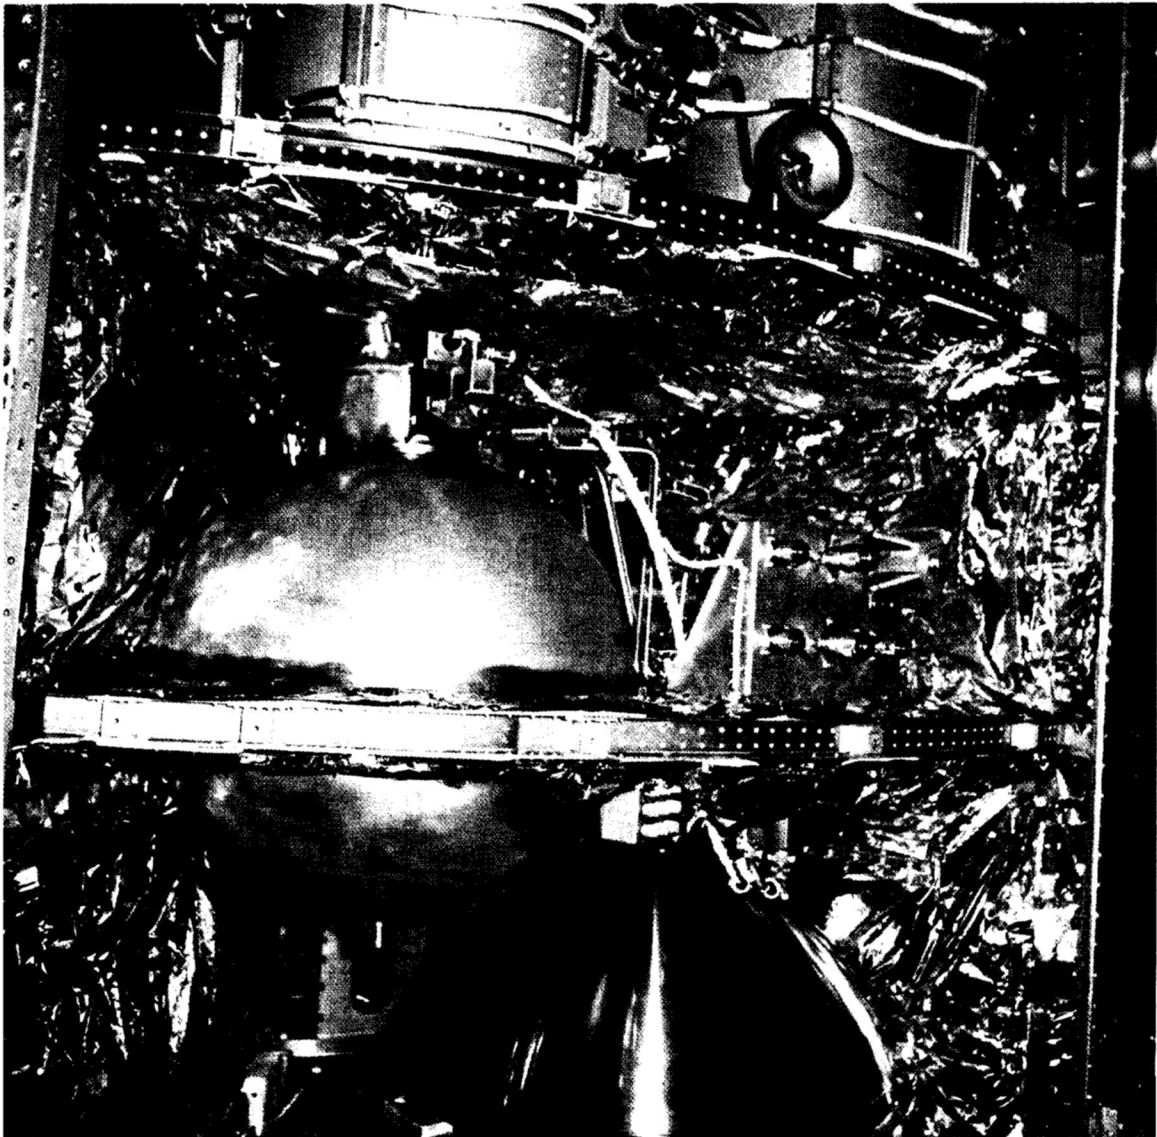
Figure 4-6.- Oxygen tank shelf.

of the Apollo 13 service module (SM 109) at the North American Rockwell plant prior to shipment to KSC. Figure 4-5 shows the fuel cell shelf, with fuel cell 1 on the right, fuel cell 3 on the left, and fuel cell 2 behind cells 1 and 3. The top of oxygen tank no. 2 can be seen at the lower left. Figure 4-6 shows the oxygen tank shelf, with oxygen tank no. 2 at left center. Figure 4-7 shows the hydrogen tank shelf with hydrogen tank no. 1 on top and hydrogen tank no. 2 below. The bottom of the oxygen shelf shows some of the oxygen system instrumentation and wiring, largely covered by insulation. Figure 4-8 is a photograph of the bay 4 panel, which was missing from the service module after the accident.

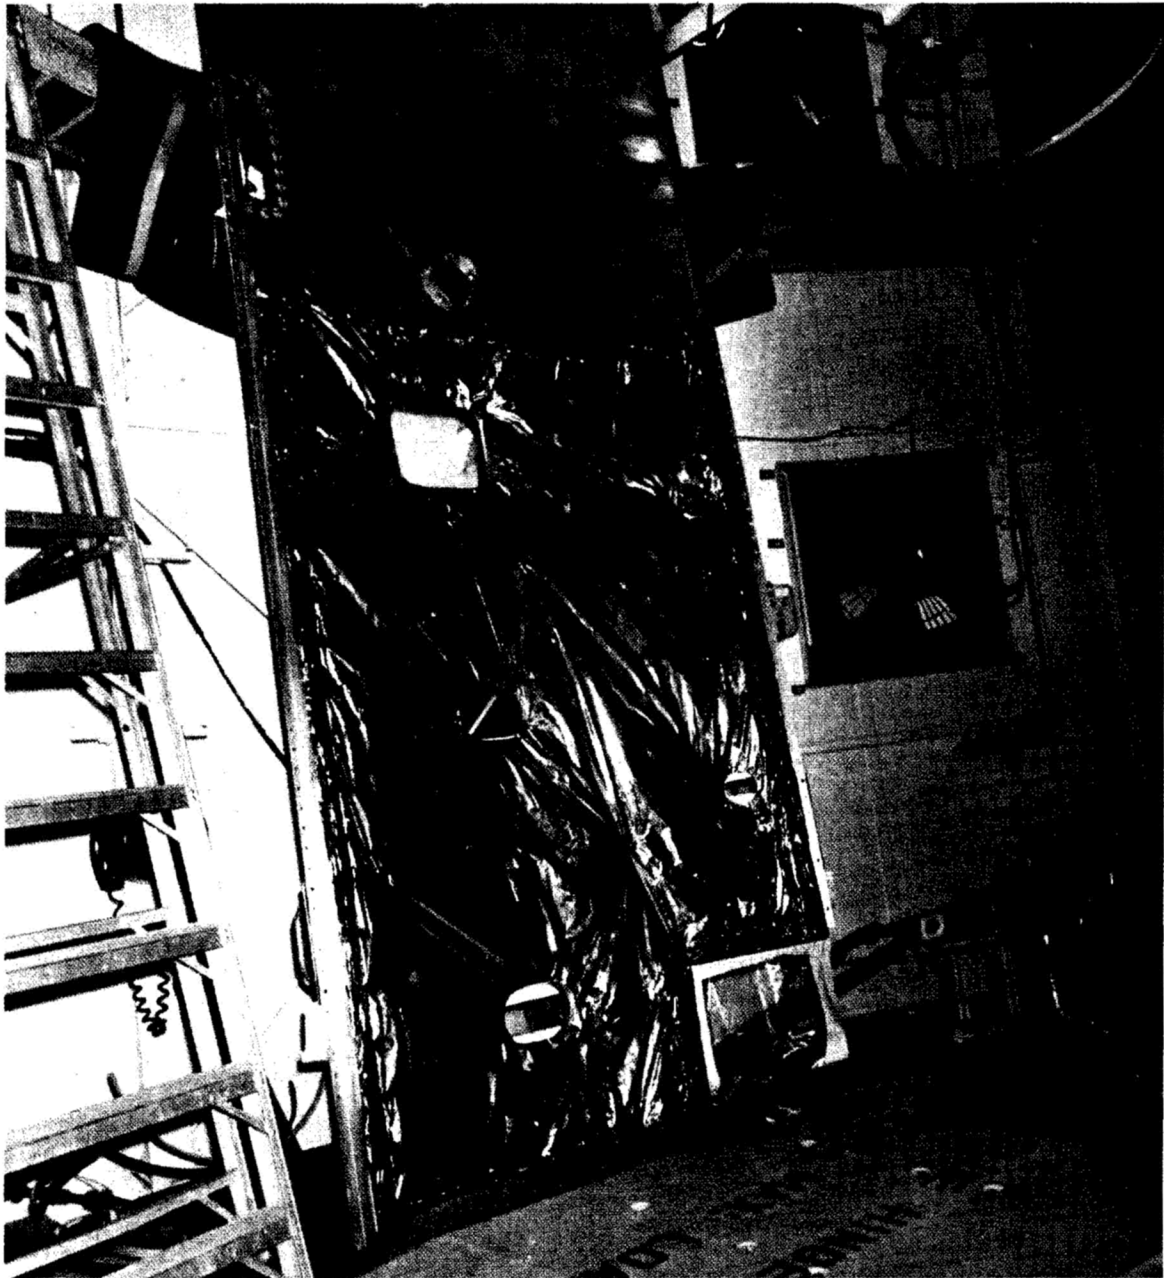
4-8.-  
Figure ~~XXX~~ Inside view of panel covering bay 4.

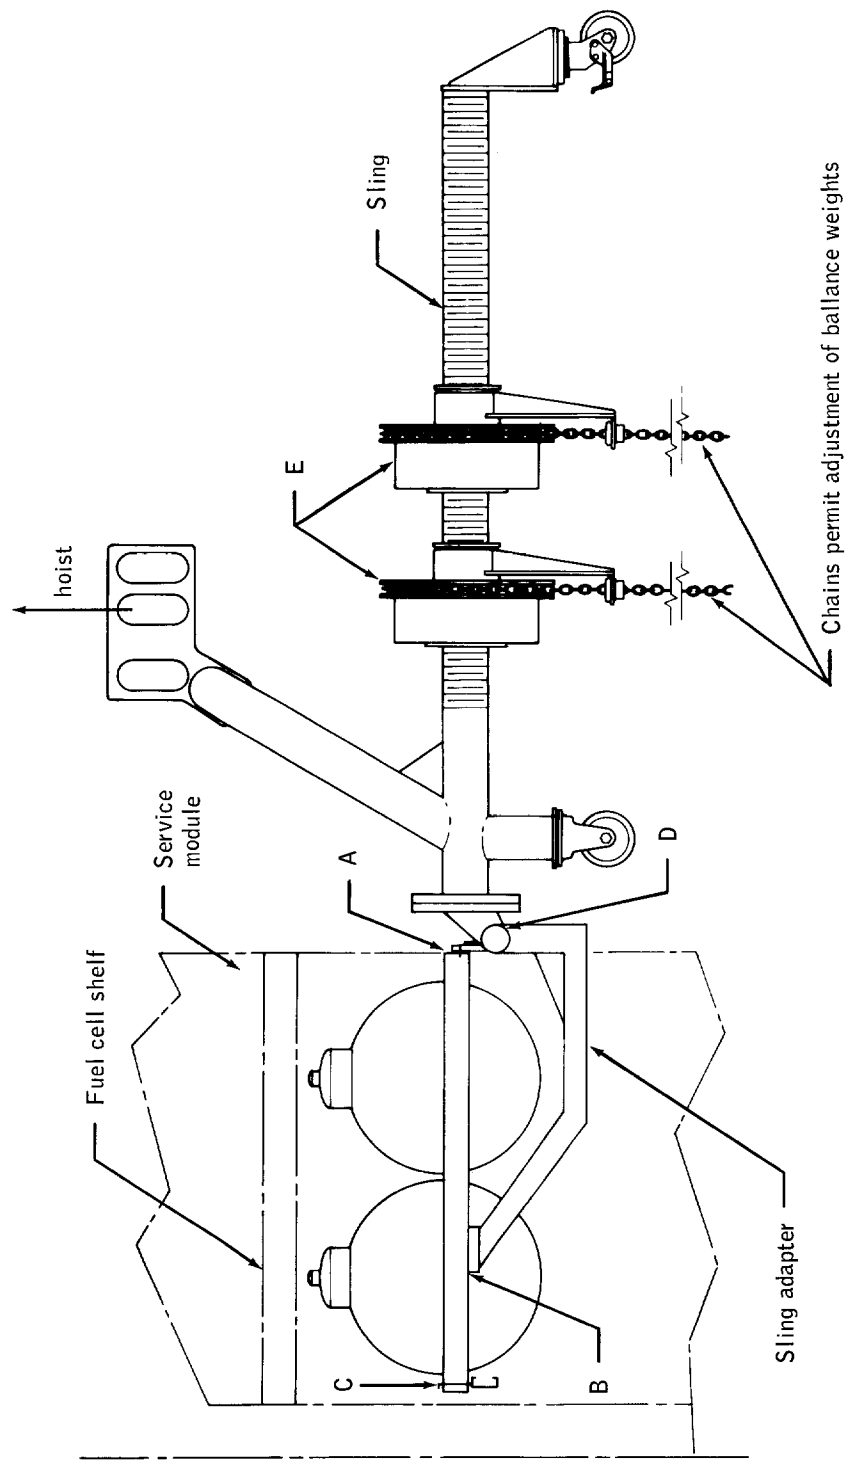
The oxygen shelf was removed in the manner shown in figure 4-9. After various lines and wires were disconnected and bolts which hold the shelf in the SM were removed, a fixture suspended from a crane was placed under the shelf and used to lift the shelf and extract it from bay 4. One shelf bolt was mistakenly left in place during the initial attempt to remove the shelf; and as a consequence, after the front of the shelf was raised about 2 inches, the fixture broke, allowing the shelf to drop back into place. Photographs of the underside of the fuel cell shelf in SM 106 indicate that the closeout cap on the dome of oxygen tank no. 2 may have struck the underside of that shelf during this incident. At the time, however, it was believed that the oxygen shelf had simply dropped back into place and an analysis was performed to calculate the forces resulting from a drop of 2 inches. It now seems likely that the shelf was first accelerated upward and then dropped.

The remaining bolt was then removed, the incident recorded, and the oxygen shelf was removed without further difficulty. Following removal, the oxygen shelf was retested to check shelf integrity, including proof-pressure tests, leak tests, and functional tests of pressure transducers and switches, thermal switches, and vac-ion pumps. No cryogenic testing was conducted. Visual inspection revealed no problem. These tests would have disclosed external leakage or serious internal malfunctions of most types, but would not disclose fill line leakage within oxygen tank no. 2. Further calculations and tests conducted during this investigation, however, have indicated that the forces experienced by the shelf were probably close to those originally

Figure 4-9.- Hoist and sling arrangement - oxygen shelf.

calculated assuming a 2-inch drop only. The probability of tank damage from this incident, therefore, is now considered to be rather low, although it is possible that a loosely fitting fill tube could have been displaced by the event.

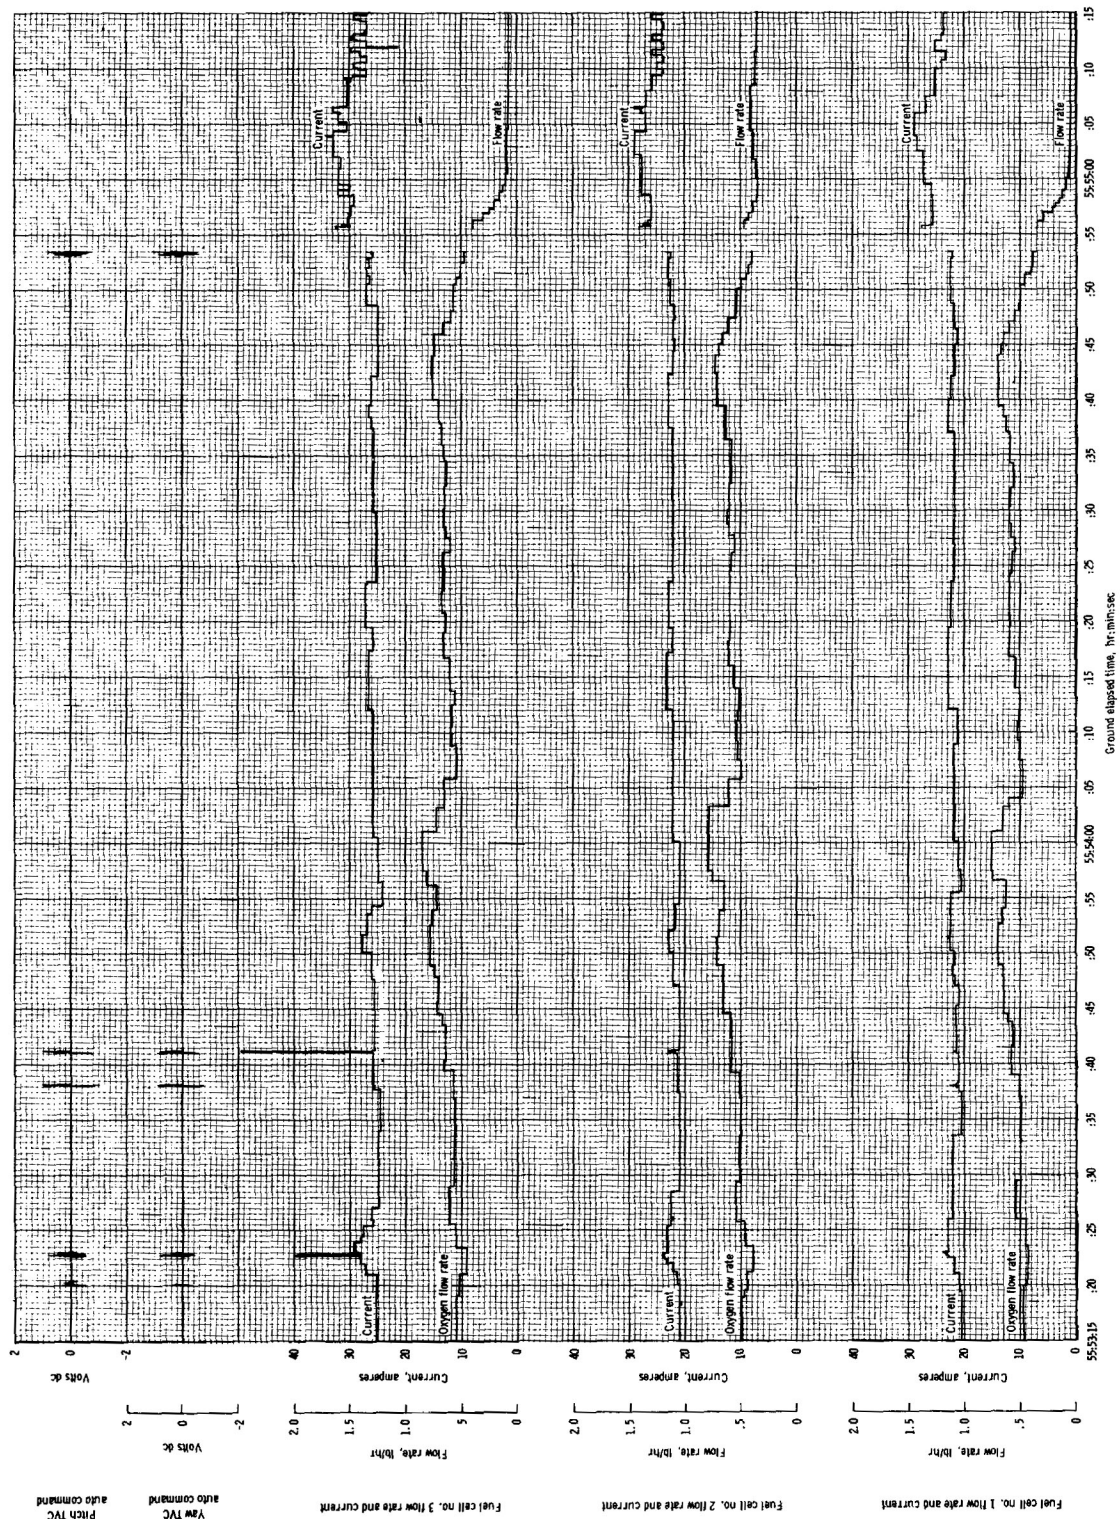
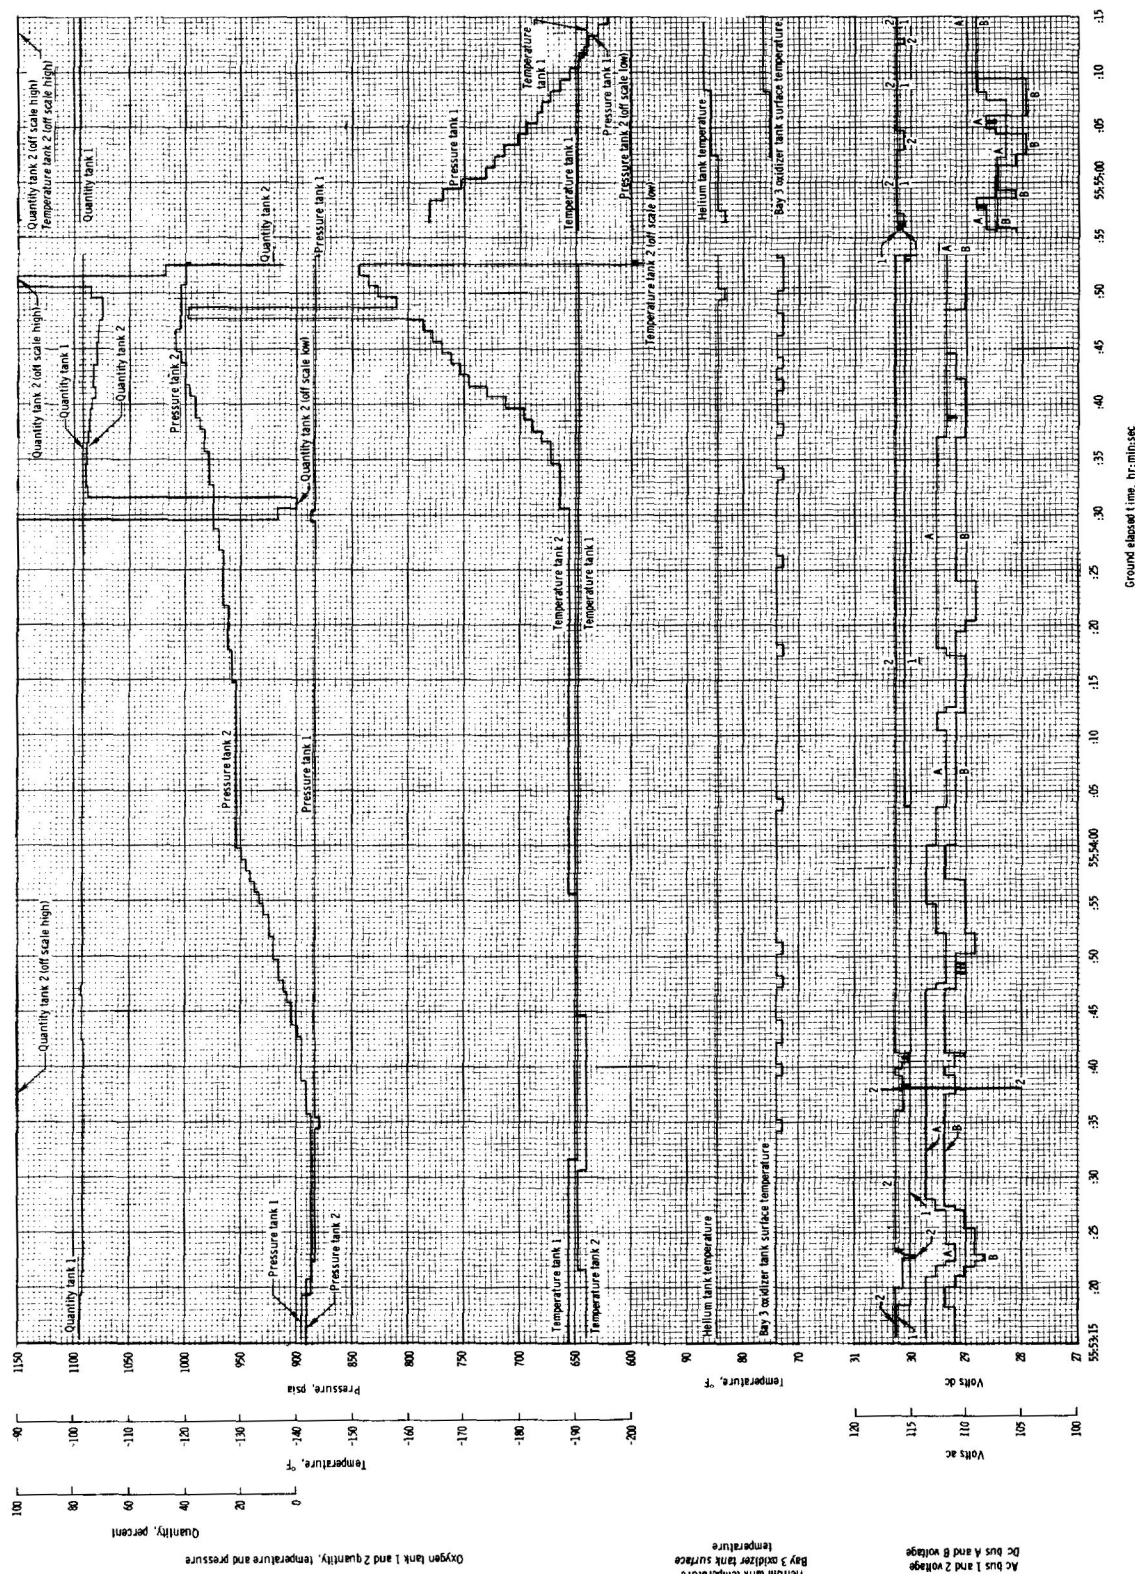
The various telemetered parameters of primary interest are shown in figure 4-10 and listed in table 4-11.

Figure 4-10.- Telemetry record.

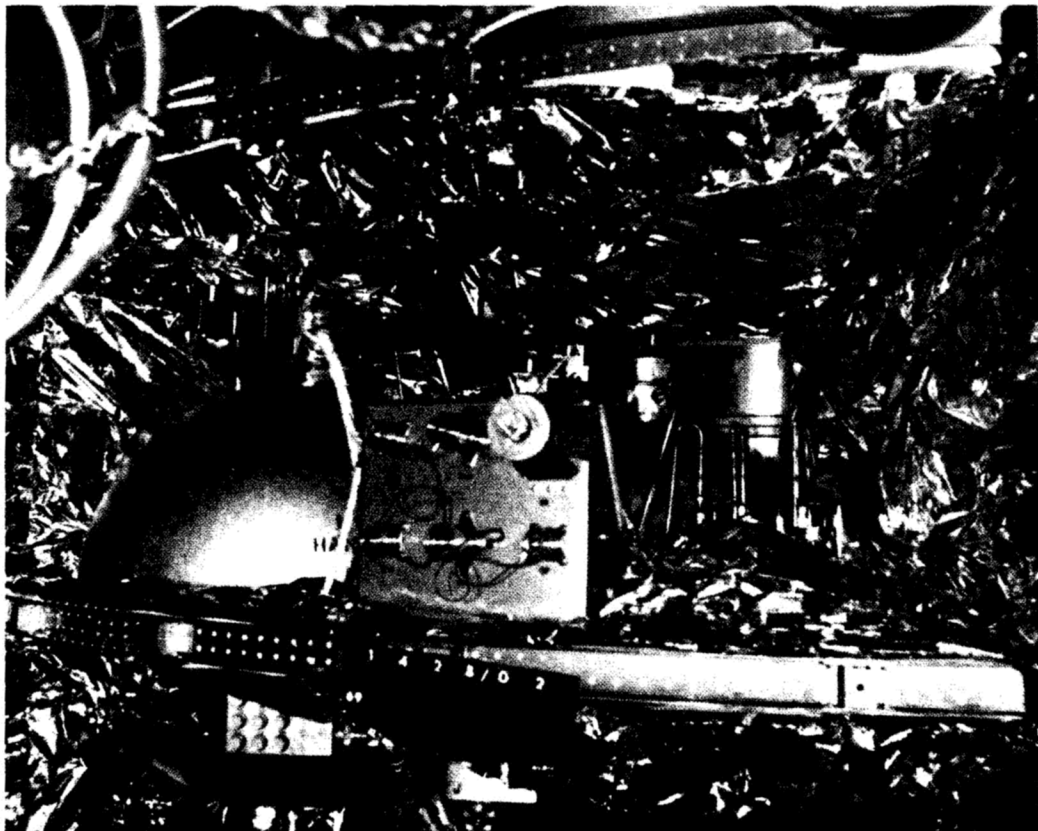
Release of the oxygen then began to pressurize the oxygen shelf space of bay 4. If the hole formed in the pressure vessel were large enough and formed rapidly enough, the escaping oxygen alone would be adequate to blow off the bay 4 panel. However, it is also quite possible that the escape of oxygen was accompanied by combustion of Mylar and Kapton (used extensively as thermal insulation in the oxygen shelf compartment, figure 4-11, and in the tank dome) which would augment the

4-11.-  
Figure ~~XX-XXX~~ Closeup view of oxygen tank shelf.

pressure caused by the oxygen itself. The slight temperature increases recorded at various SM locations indicate that combustion external to the tank probably took place. Further testing may shed additional light on the exact mechanism of panel ejection. The ejected panel then struck the high-gain antenna, disrupting communications from the spacecraft for the 1.8 seconds.

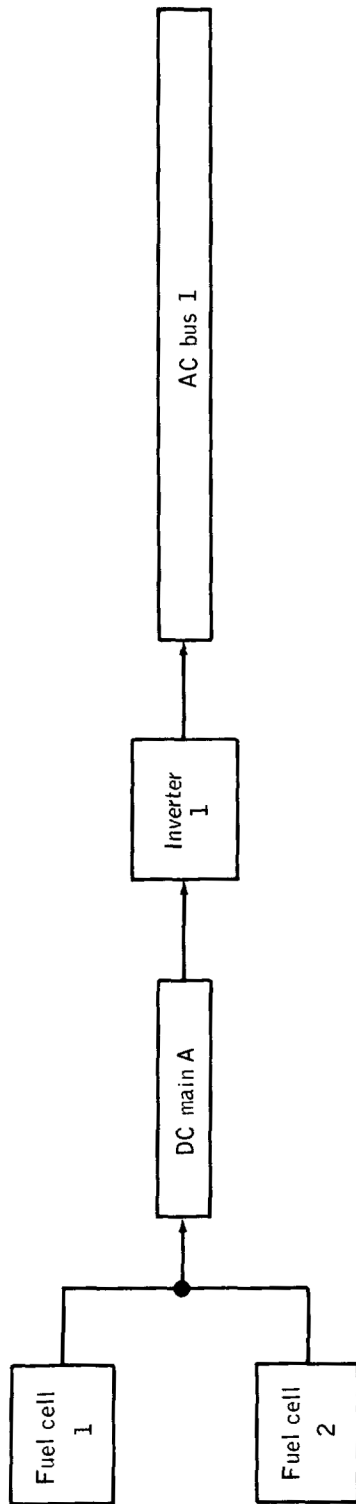
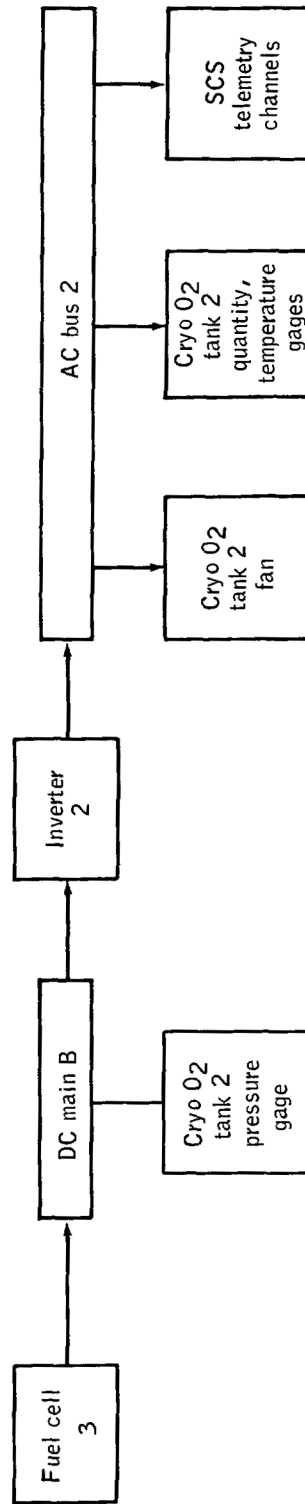
The failure of oxygen tank no. 2 and consequent removal of the bay 4 panel produced a shock which closed valves in the oxygen supply lines to fuel cells 1 and 3. These fuel cells ceased to provide power in about 3 minutes, when the supply of oxygen between the closed valves and the cells was depleted. Fuel cell 2 continued to power ac bus 1 through dc main bus A, but the failure of fuel cell 3 left dc main bus B and ac bus 2 unpowered (see fig. 4-12). The oxygen tank no. 2 temperature and quantity gages were connected to ac bus 2 at the time of the accident. Thus, these parameters could not be read once fuel cell 3 failed at 55:57:44 until power was applied to ac bus 2 from main bus A.

Figure 4-12.- Electrical configuration at 55:54:53 g.e.t.

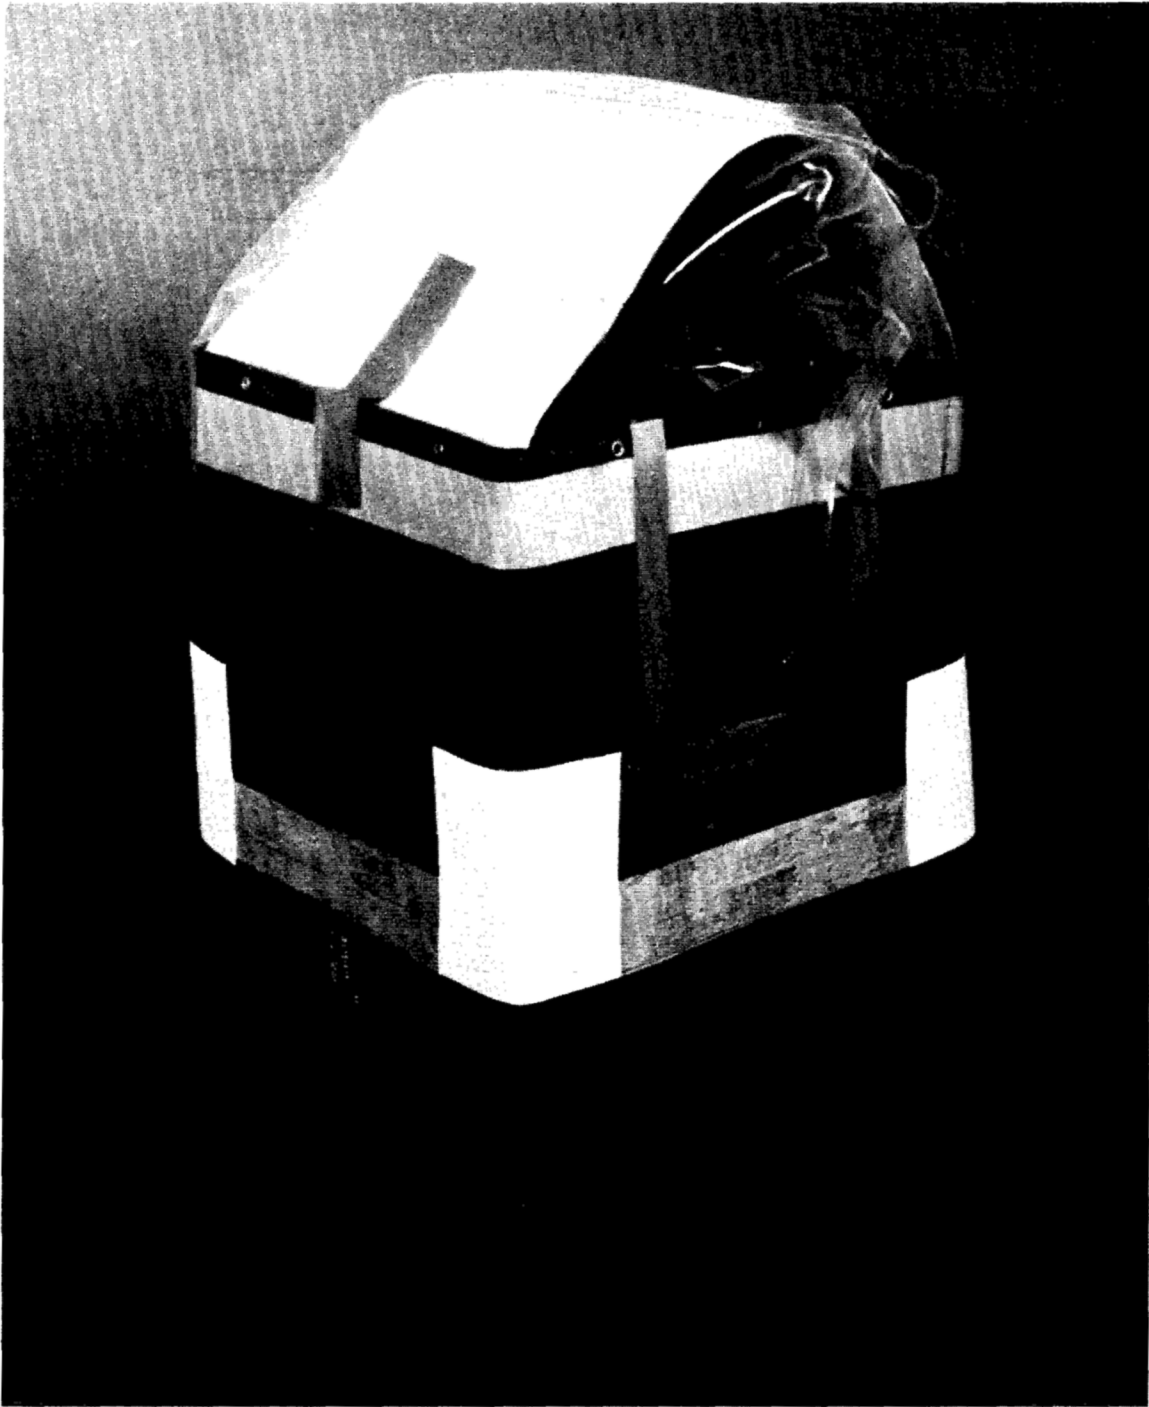
Figure 4-16.- Lithium hydroxide canister modification.
