# **REPORT OF APOLLO 13 REVIEW BOARD**

**APPENDIX B - REPORT OF MISSION  
EVENTS PANEL**

**APPENDIX B**  
**REPORT OF MISSION EVENTS PANEL**

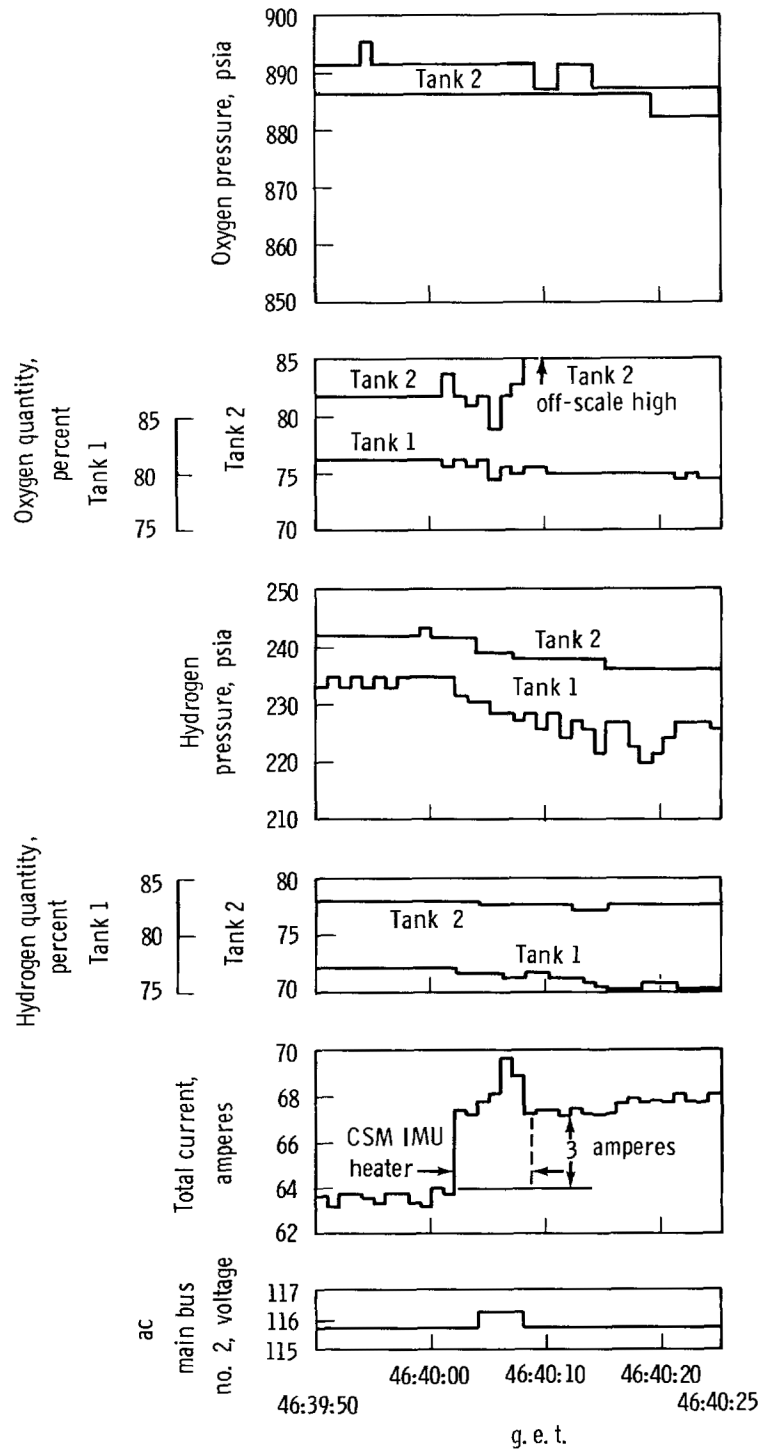
Figure B4-12.- Fan cycle at 46:40.

At 47:40:08 the oxygen quantity changed from approximately 82 percent to 100 percent, or full-scale high. This change in reading or quantity system malfunction occurred just after or at the time the oxygen tank no. 2 fans were turned on. Because of the way the system recovered at the time of the accident, the data indicate that the probe or its associated wiring shorted. Since the instrumentation system was in low bit rate, it is possible to determine exactly when the oxygen

tank no. 1 and no. 2 fans were turned on. The electrical data indicate that the oxygen tank no. 1 and no. 2 fans were turned on between the times of 47:40:05 and 47:40:08. A plot of cryogenic pressures, quantities, total CSM current, and ac main bus 2 is shown in figure B<sup>4</sup>-12. Therefore, the oxygen tank no. 1 and no. 2 fans were turned on in a period of time between 3 seconds prior to the probe malfunction and the time that the probe malfunctioned.

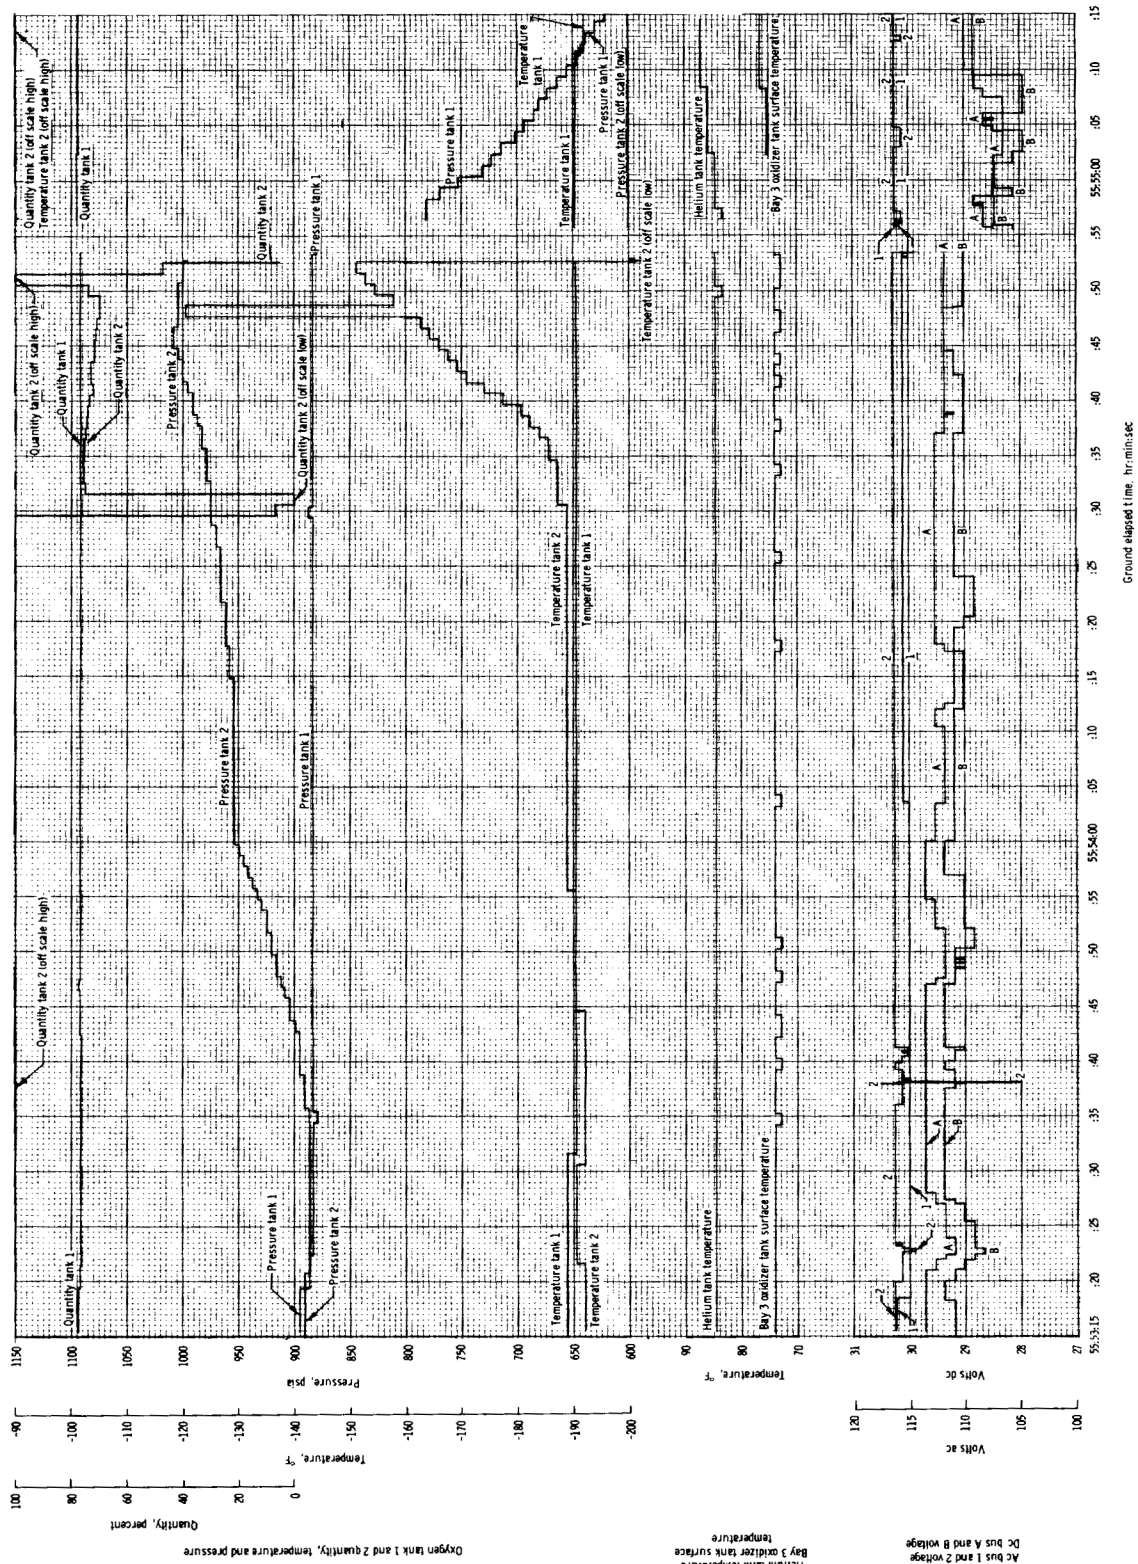
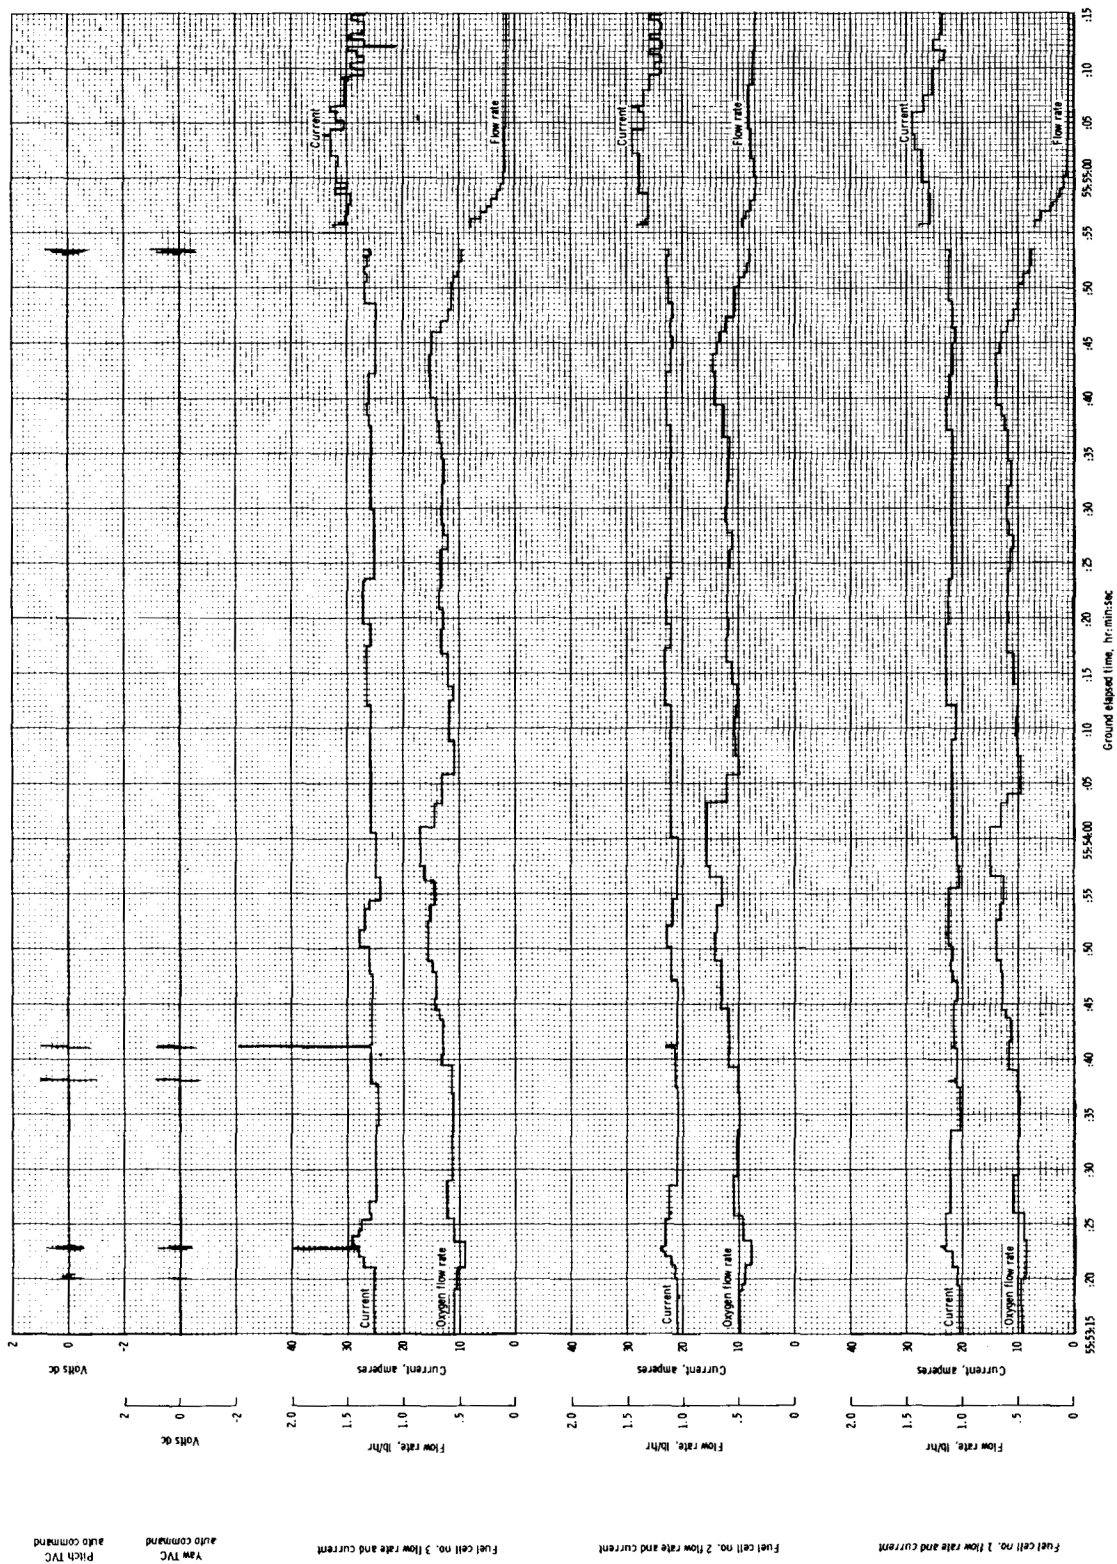
Figure B5-3(a).-- Telemetered parameters during anomaly.

At 55:53:20 the crew turned on the cryogenic oxygen tank no. 2 fans. An increase in fuel cell current of 1-1/2 amperes, a drop in ac bus 2

voltage of 0.6 volt, and a glitch in the stabilization control system telemetry indicated that the fans had been electrically energized. These events are shown in figures B5-4 and B5-5. However, it is not certain that the fans began rotating at this time, since the tank no. 2 pressure showed a minimum observable drop and the fan motor stall current does not significantly differ from the running current. The quantity gage in tank no. 2 was already in a failed condition, and the fuel cell flowmeters were already being affected by the fan operation in tank no. 1. so that neither of these instruments could positively verify rotation of the fans in tank no. 2. During the next 20 seconds a series of electrical anomalies occurred which cannot be explained as a result of known loads in the spacecraft. These anomalies are shown in figure B5-4. The first, at 55:53:23 was an 11-amp positive spike in the output current of fuel cell 3. Several events were associated with this spike:

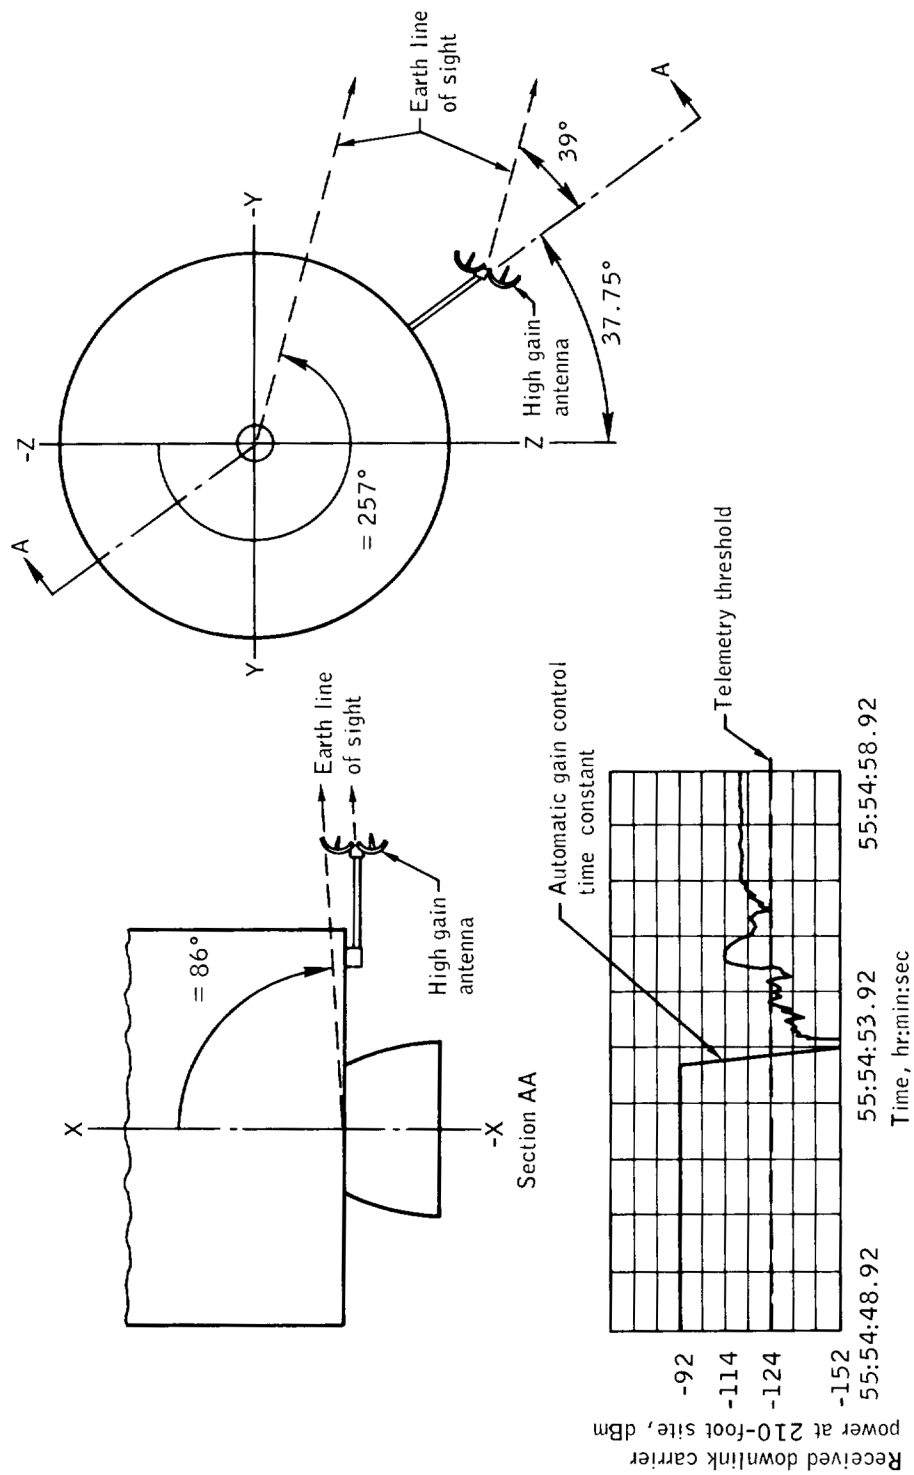
Figure B5-6.- Received S-band downlink power.

At the time of the accident the spacecraft telemetry signal was being received on both a 210-ft-diameter and an 85-ft-diameter antenna at the Deep Space Instrumentation Facility in Goldstone, California. The carrier level on the Goldstone 85-ft antenna was -100 dBm. At 55:54:53 the signal strength dropped abruptly below -160 dBm, the lower limit of the signal strength recorder, and began an erratic increase. Figure B5-6 is a plot of the carrier strength received at the 85-ft antenna, corrected by 8 dB to show the carrier strength received at the 210-ft antenna. The 210-ft antenna was not equipped with a signal strength recorder.

Telemetry data recovered completely 1.8 seconds after the loss of carrier power. Sporadic telemetry data are available within the 1.8-second period.

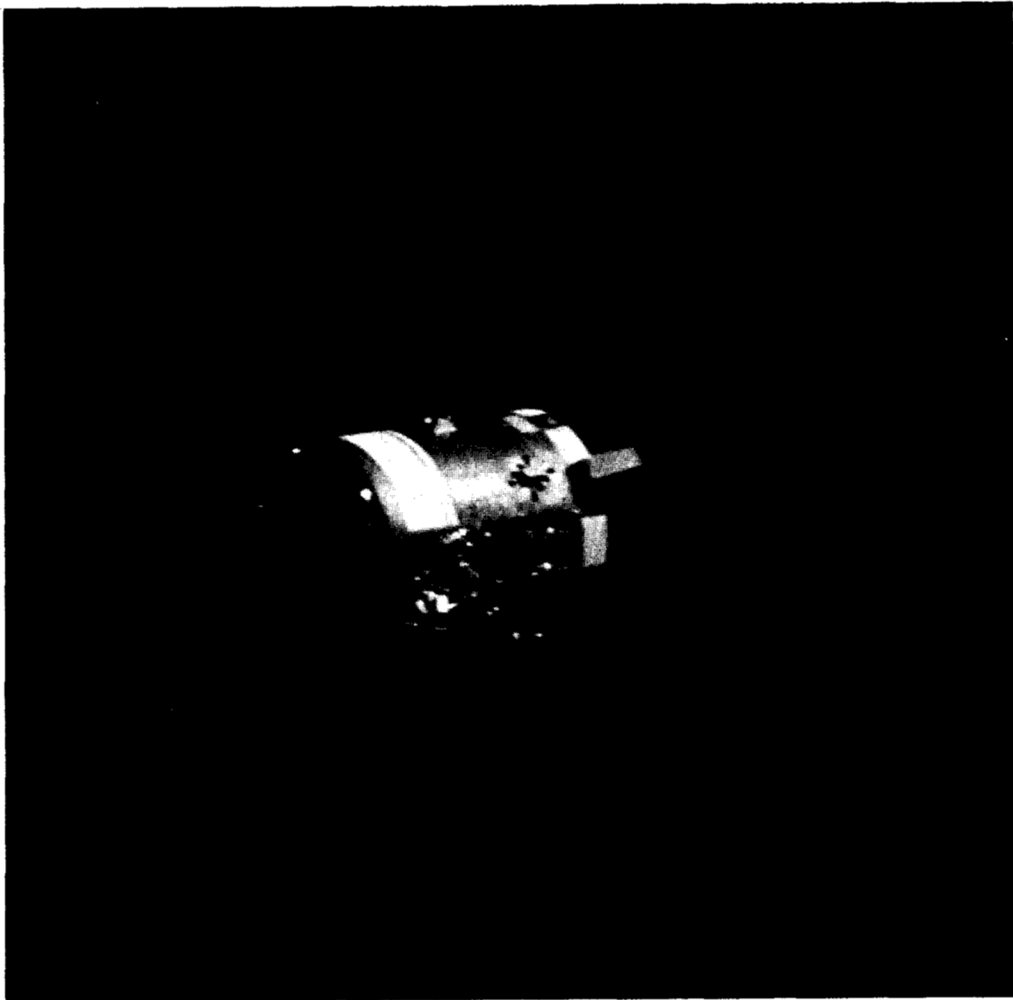
Figure B5-9.- Photograph of service module taken by crew.

Photographs later taken by the crew show the panel covering bay 4, the bay containing the cryogenic oxygen tanks, cryogenic hydrogen tanks, and fuel cells, to be missing. One of these photographs is reproduced in figure B5-9 and a photograph prior to launch is shown in figure B5-10. The high-gain antenna located adjacent to bay 4 shows a misalignment of one of the four dishes. The photographs also show that the axes of fuel cells 1 and 3 have shifted 7 degrees in such a way that the tops of the fuel cells point outward. It is not possible to determine conclusively from the photographs whether or not cryogenic oxygen tank no. 2 is present, partially missing, or totally missing. It is probable that the loud bang heard by the crew was caused by the separation of the panel from the spacecraft approximately at the time of telemetry loss.

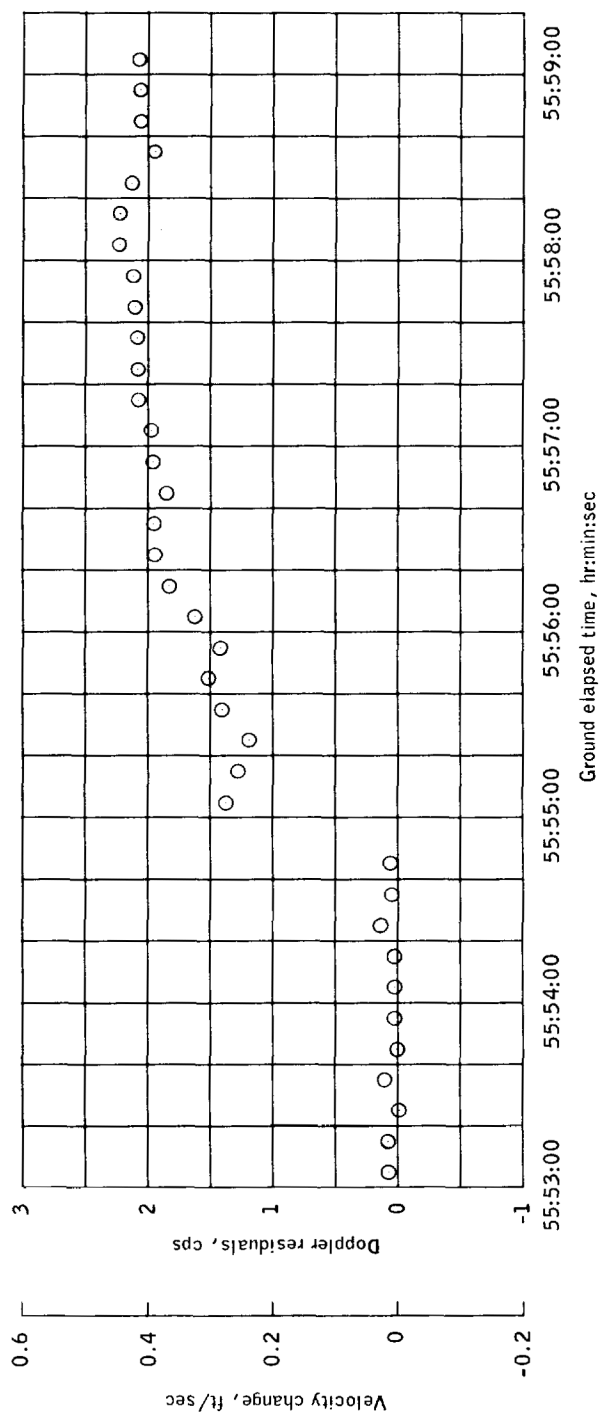
Figure B5-12.- Velocity increment at 55:54:53.

Between 55:54:45 and 55:55:05 doppler measurements indicated a radial velocity increment of 0.26 fps. This is shown in figure B5-12. Following this abrupt change in velocity at approximately the time of telemetry loss, additional velocity changes were observed, as shown in figure B5-13. These velocity increments were caused in part by venting from the spacecraft and in part by firings of reaction control system jets.
