APPENDIX C
REPORT OF MANUFACTURING
AND TEST PANEL

TASK ASSIGNMENT AND IMPLEMENTATION

PART C-4

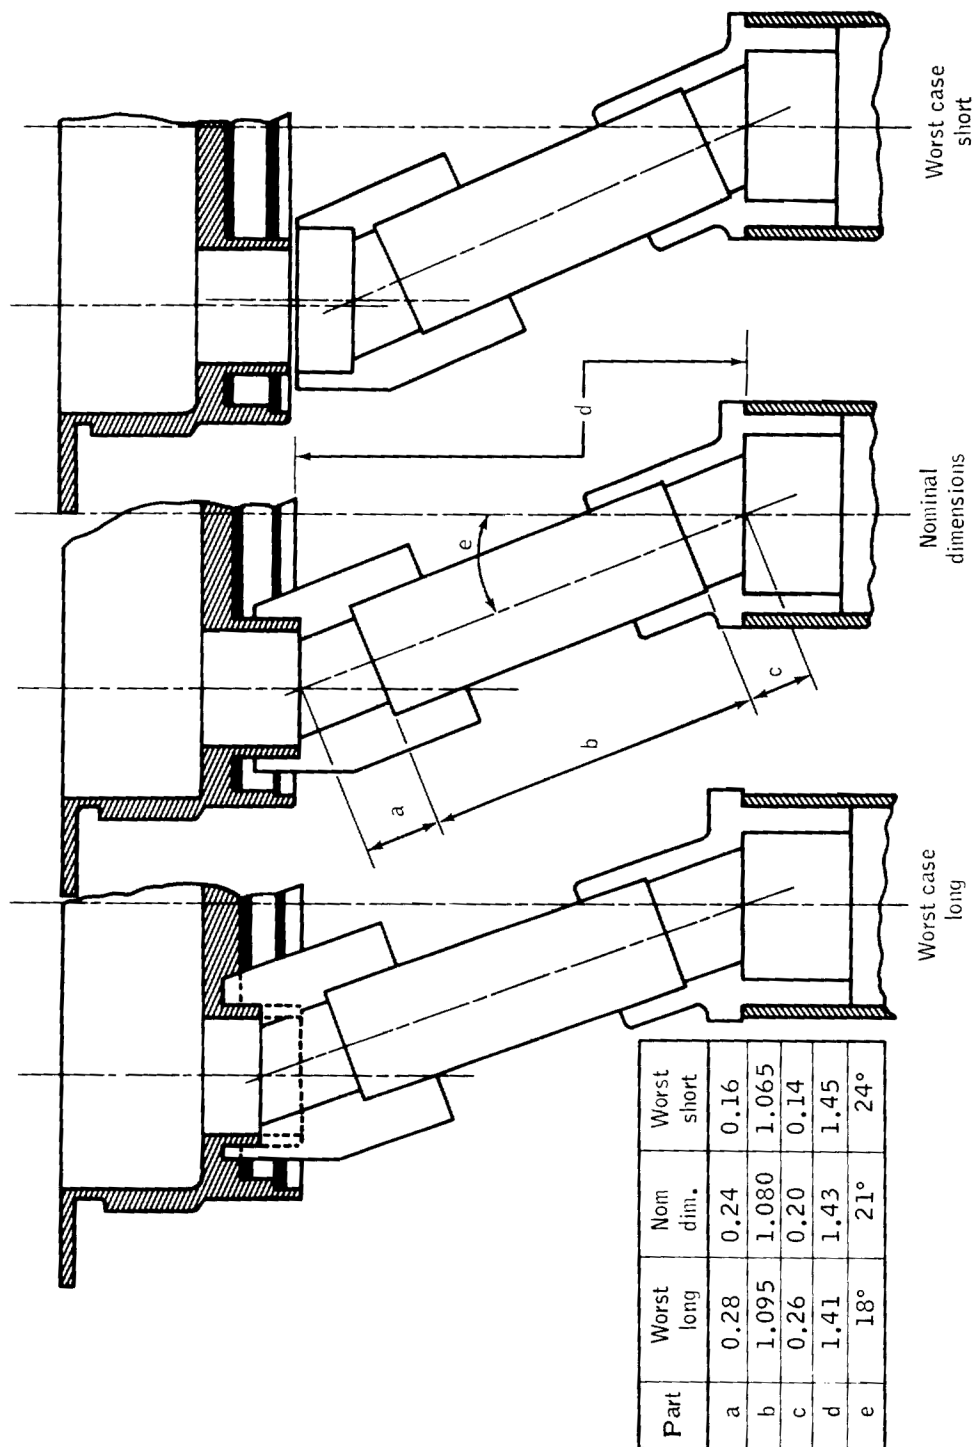
Figure C4-49.- Extreme and nominal tolerance cases for fill tube connection parts.

In addition to the tolerance condition that can exist for the fill tube connecting parts, the center tube of the quantity probe could move downward due to Teflon cold flow. The center tube is supported in the axial position by two Teflon bushings installed in the center tube and a semi-tubular rivet. Prolonged heating, such as the vacuum pumpdown cycles (three cycles for this tank assembly resulting in a total of 1532 hours at 190 to 220° F), could result in the thin walls of the center tube slowly cutting into the Teflon bushings.

Table C4-II shows the range of diametral clearances that can exist at ambient conditions (73° F) and at a typical detanking condition (-278° F, which corresponds to the saturation temperature of liquid oxygen at 40 psia). The fit between the Teflon bushing and the tank adapter fitting can result in a maximum 0.003-inch interference. The only other clearance that results in an interference fit occurs if the minimum size holes are provided where the Teflon bushings slide on the 3/8-inch Inconel tube. Tests at liquid nitrogen temperature (-320° F) indicate that the Teflon is not overstressed and does not crack when subjected to interference fits of this type.

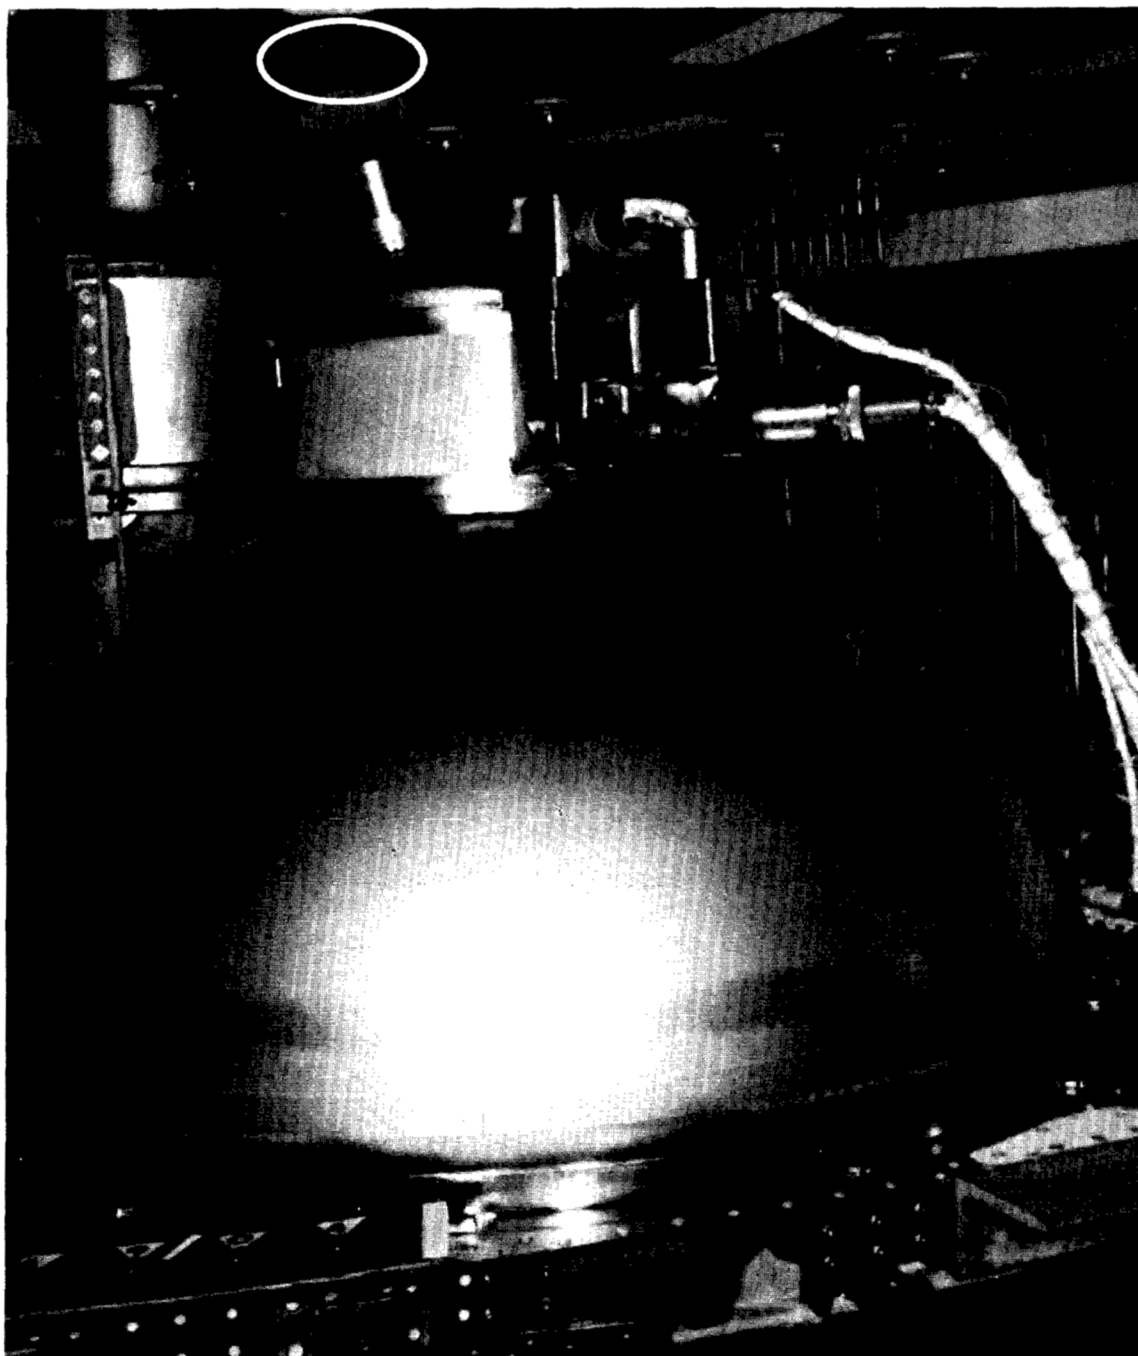
The oxygen shelf moved and came to rest on the supporting beams through what was at the time described as a "2-inch drop". Observation of adjacent portions of SM 106 identified minor damage, including a dent in the underside of the fuel cell shelf above.

Figure C4-54.- Replacement oxygen shelf installed in Service Module 106. Note repairs to fuel cell shelf over oxygen tank no. 2.

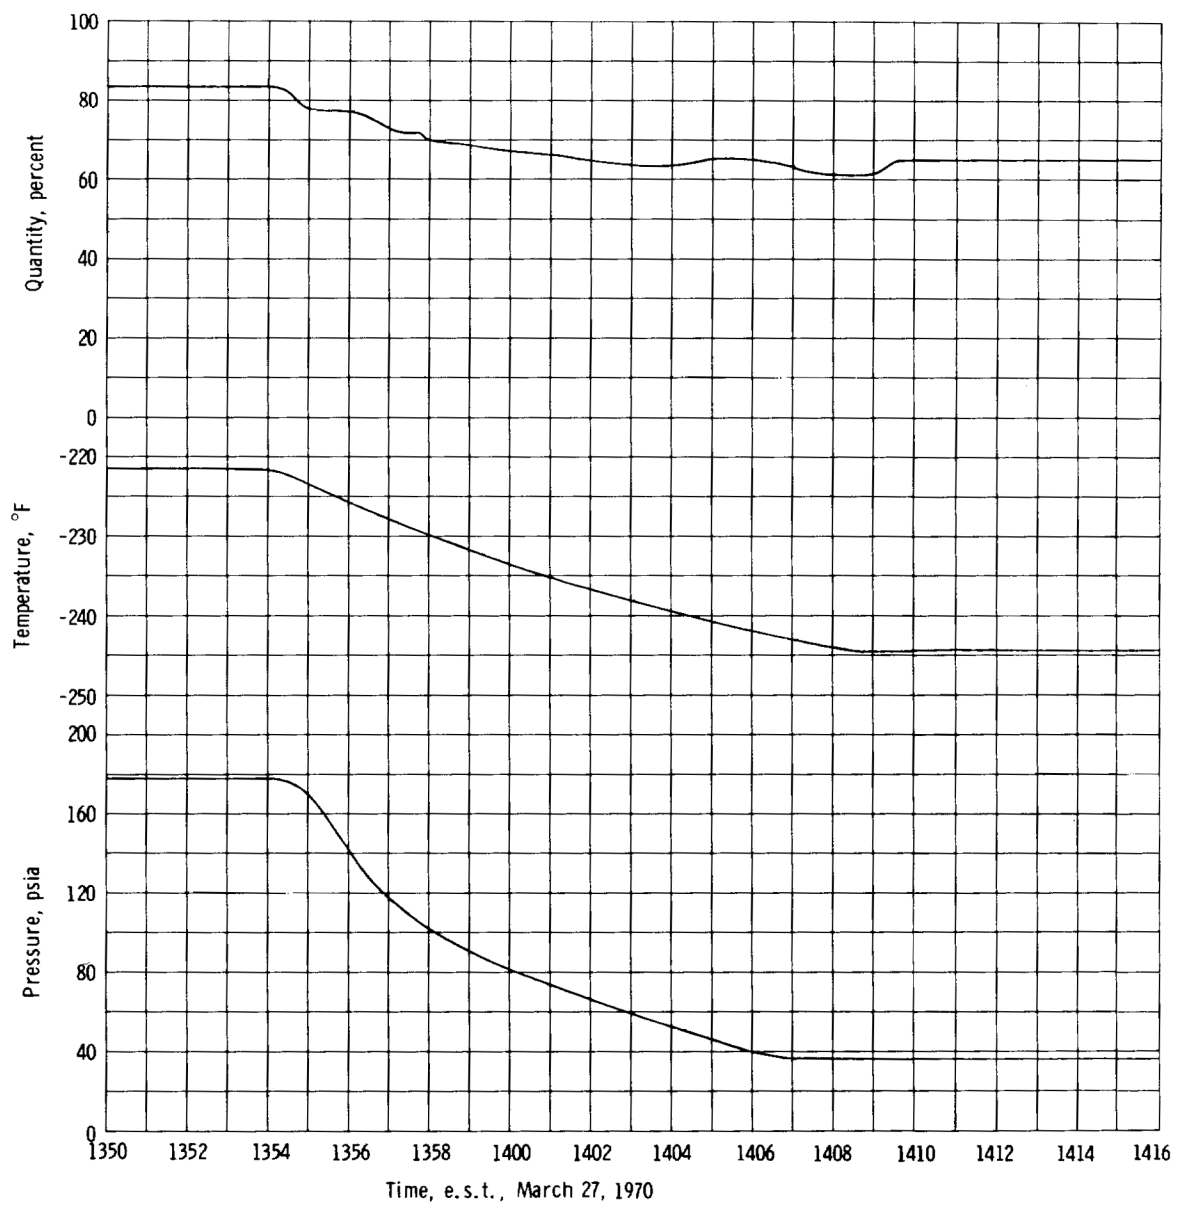
Figure C4-58.- Oxygen tank 2 detanking characteristics (pressure decay through the fill line - CDDT).

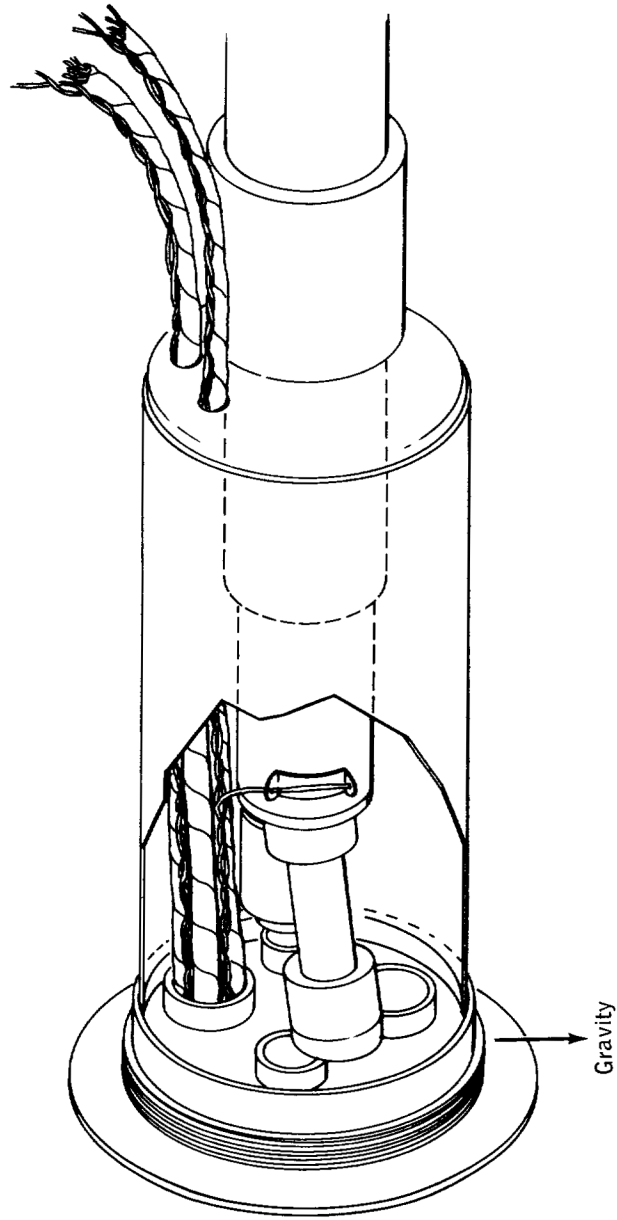
It appears pertinent to this review to note that during SM transportation the fill tube segments within the upper portion of the oxygen tank no. 2 quantity probe assembly lay with the tank-exit end of the fill tube segments about 20 degrees above the horizontal, if they were still in place after previous handling and the "shelf drop." Neither the wires nor the feed line filter were below it to restrict rotation of the fill tube about the central tube of the quantity probe (fig. C4-64).

Figure C4-64.- Isometric sketch of quantity probe head as oriented during SM transportation.

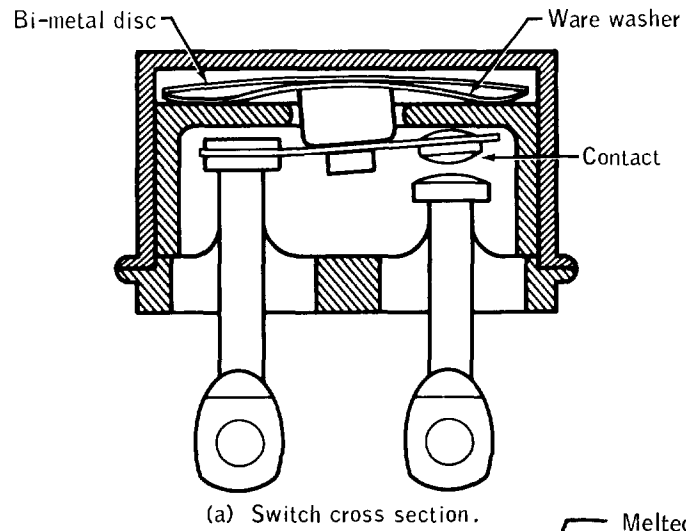
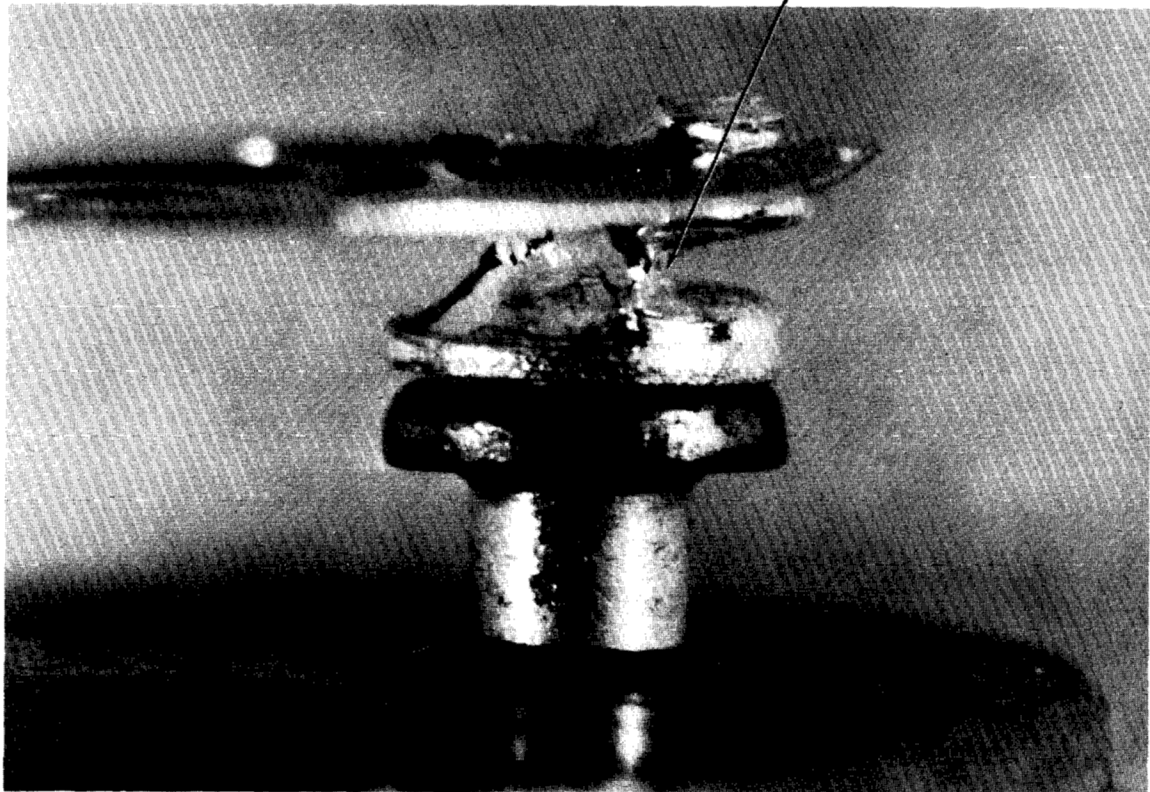
Tests were conducted at the Manned Spacecraft Center to evaluate the effects of the sustained heater operation during the special detanking operation at KSC on March 27, 1970. These tests demonstrated that the thermostats would weld closed when they attempted to interrupt the 5.9 amps, 65 volts dc GSE power (a condition for which they were neither designed nor qualified) resulting in their failing to limit the temperature inside the tank. The tests also showed that with the heaters on continuously and as the cryogenic liquid boiled away, temperatures in the 700° to 1000° F range would exist on portions of the heater tube in contact with the motor wires. These temperatures severely damaged the Teflon insulation even in the nitrogen atmosphere of these tests. Small-scale tests subjecting Teflon insulated wires to 700° to 1000° F temperature oxygen atmosphere indicated even more severe damage to the Teflon insulation.

Figure C4-67.- Thermostat configuration and welded contacts.

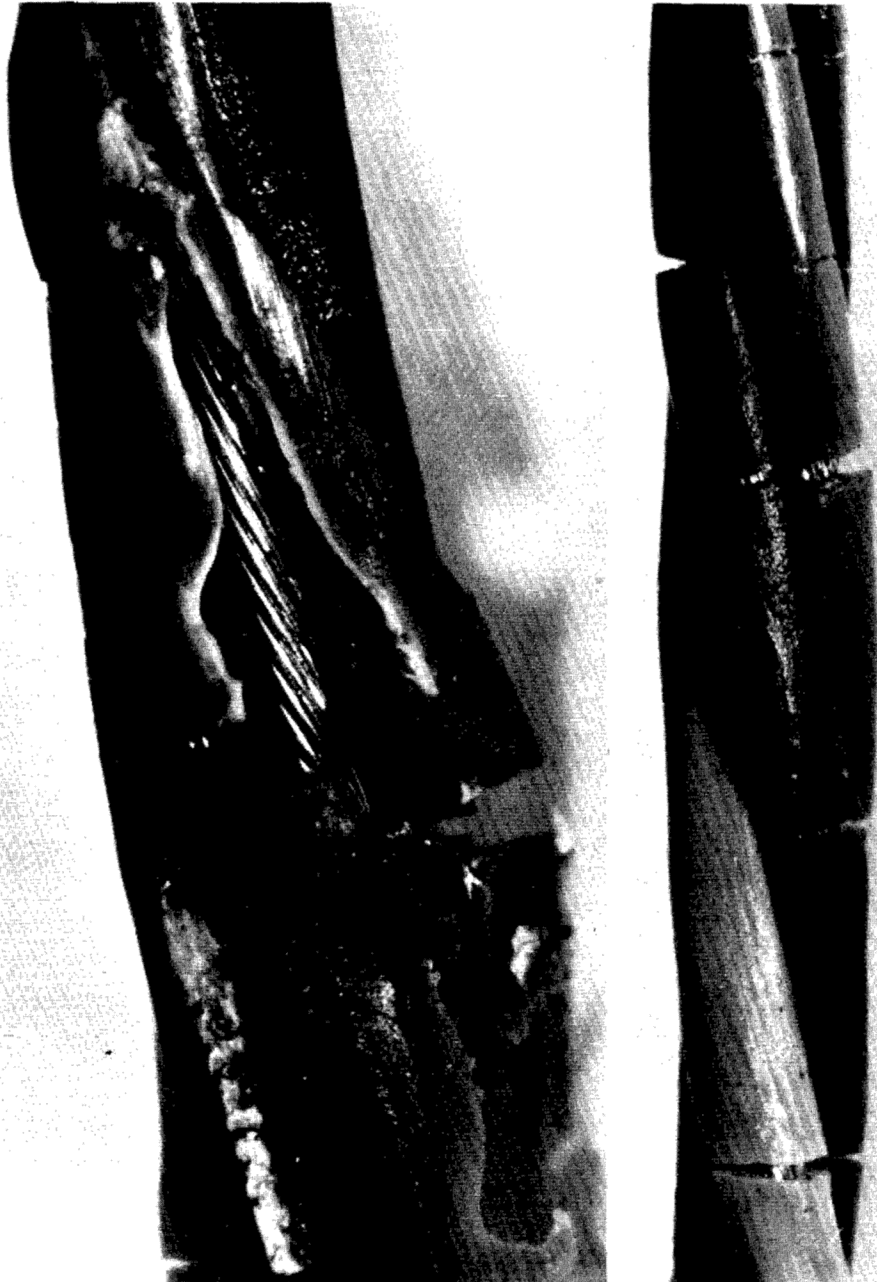
Therefore it is reasonable to conclude that the special detanking procedures employed on tank 0008 at KSC prior to launch of Apollo 13 severely damaged the insulation of the motor wiring inside the tank.

Figure C4-68.- Wire damage from heater tube assembly temperature test.
