**APPENDIX D**  
**REPORT OF DESIGN PANEL**

The Design Panel was assigned the task of reviewing the design of the systems involved in the Apollo 13 accident, including their qualification history. The service history of the specific components flown on Apollo 13 was also to be examined from a design point of view to ascertain whether any abnormal usage experienced might have had a detrimental effect on the functional integrity of the components. The Panel was also charged with review of other spacecraft systems of similar design or function to ascertain whether they contained potential hazards. Finally, the Panel was to analyze, as required by the Board, proposed failure mechanisms to the extent necessary to support the theory of failure.

Early in the proceedings of the Board, it became evident that the failure was centered in the cryogenic oxygen subsystem of the electrical power system of the spacecraft, and, more specifically, in the no. 2 cryogenic oxygen tank. For this reason, detailed examinations of the Panel were limited to this subsystem. Interfacing systems were examined only to the extent required to understand the function of the oxygen system and/or to relate data fr

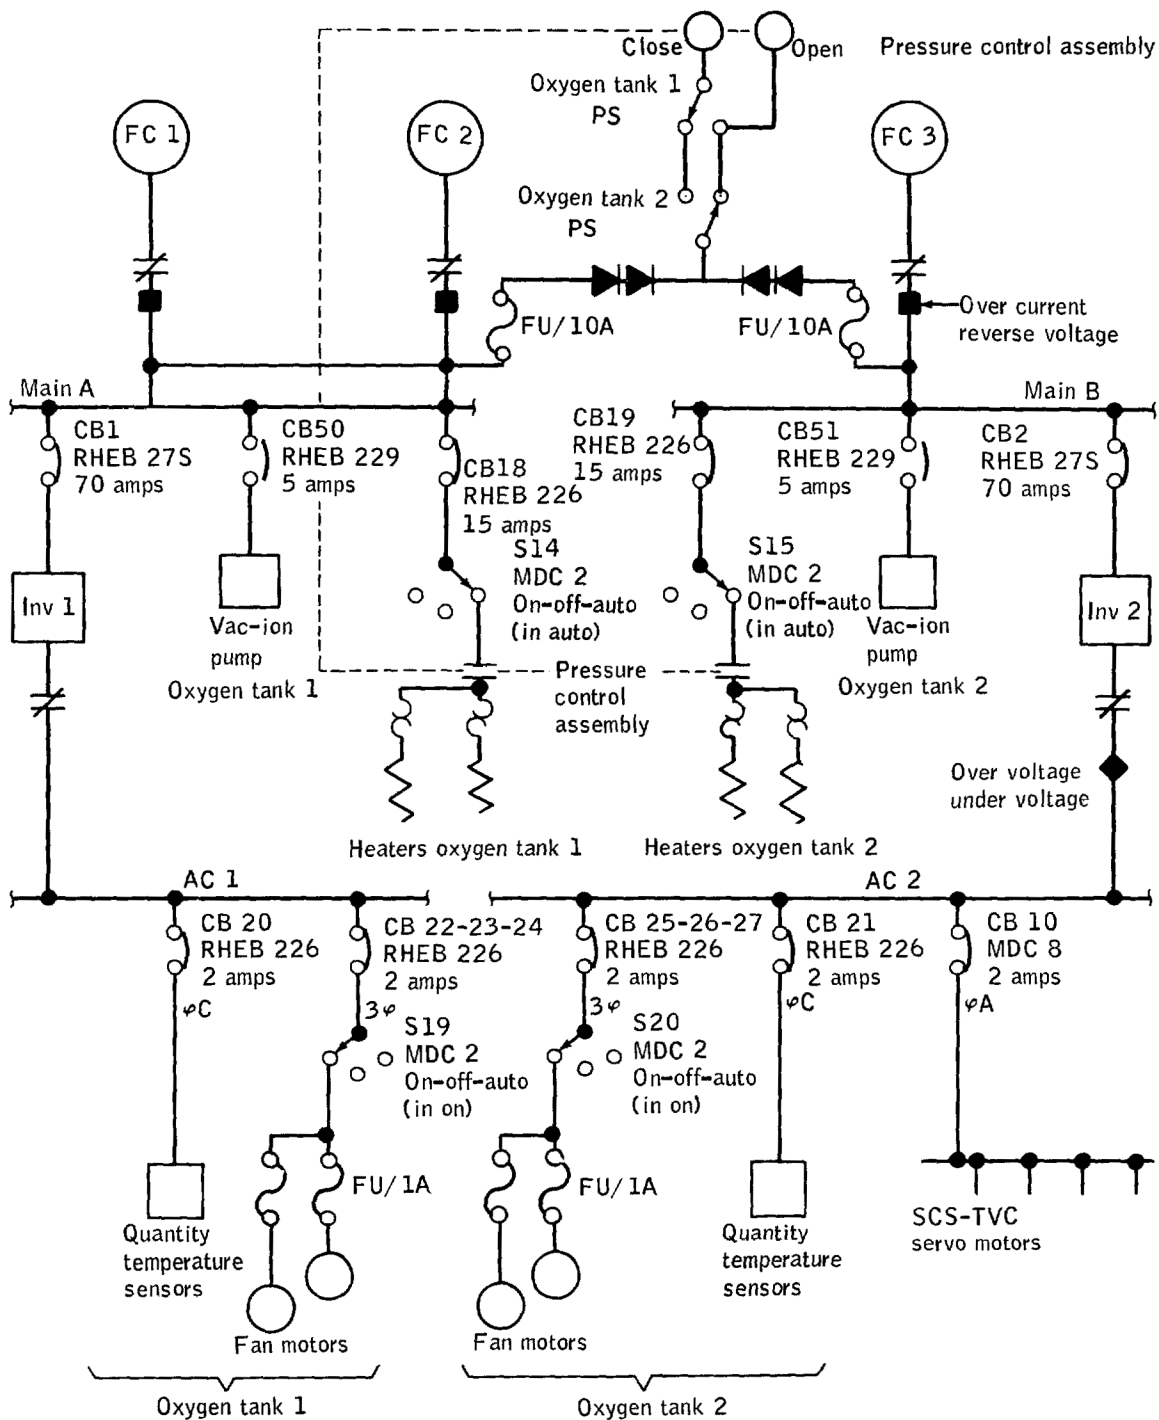
Figure D3-5.- Electrical schematic of relevant portions of electrical power system at 55:53:21.

The electrical power system, in general, provides multiple power busses with switching options for selecting an operating configuration. At 55:53:21, the electrical system was configured in accordance with reference 1, as shown in figure D3-5, with fuel cells 1 and 2 connected to main bus A and fuel cell 3 connected to main bus B. Inverter 1 was connected to main bus A and powering ac bus 1. Inverter 2 was connected to main bus B and powering ac bus 2. Inverter 3 was not connected. Battery busses A and B were not connected to main bus A or B. The switches controlling heater operation for both oxygen tanks were in the "automatic" position, controlling heater operation through the pressure control assembly. Pressures in the oxygen tanks were at levels which did not demand operation of the heaters. Temperature and quantity sensors on oxygen tank no. 2 were energized from ac bus 2. The quantity gage

had remained off-scale high from 46:40:06, indicating a probable short circuit either on the leads or the probe assembly. Operation of the fan motors in the oxygen tanks was accomplished throughout the mission using manual control in lieu of the automatic operation afforded by the logic of the pressure control assembly. A routine operation of the fans was requested by the ground at 55:52:58 and acknowledged by the crew at 55:53:06. Energizing of the fans in oxygen tank no. 1 is confirmed by a drop in voltage of ac bus 1 and an increase in total fuel cell current at 55:53:18. Energizing of the fans in oxygen tank no. 2 is confirmed by a drop in voltage of ac bus 2 and an increase in total fuel cell current at 55:53:20. Data substantiating operation and operation times are presented in Appendix B.

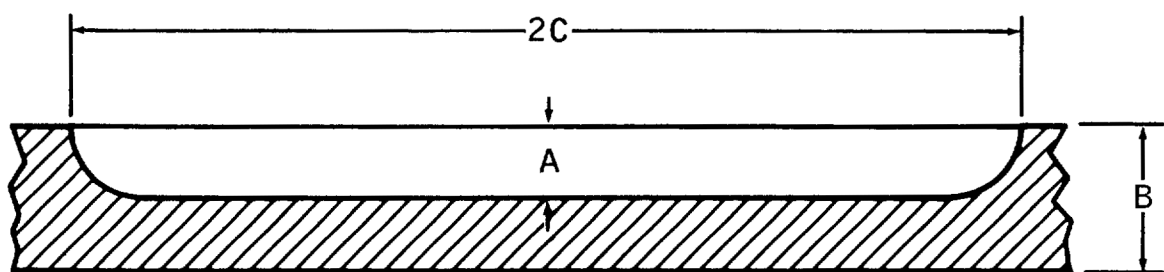
Figure D3-9.- Ligament model for ductile fracture of pressure vessel.

Area of lack of fusion produces  
an effective crack of depth  $A$   
& length  $2C$  in tank wall of  
thickness  $B$ .  $2C \gg A$

equatorial weld. It is postulated that the ligament will fail when its stress reaches the tensile strength of the material. Calculations show that the ligament stress  $\sigma_l$  is related to the average wall stress

where  $F_{tu}$  is the ultimate tensile strength. Failure will occur by tearing of the ligament accompanied by rapid decompression of the tank. It should be appreciated that this is a rather crude model of ductile fracture, and will probably overestimate the failure stresses in a spherical vessel. However, it should be useful in assessing the effectiveness of the proof tests in light of subsequent service, because of the very large margins between proof and operating pressures.

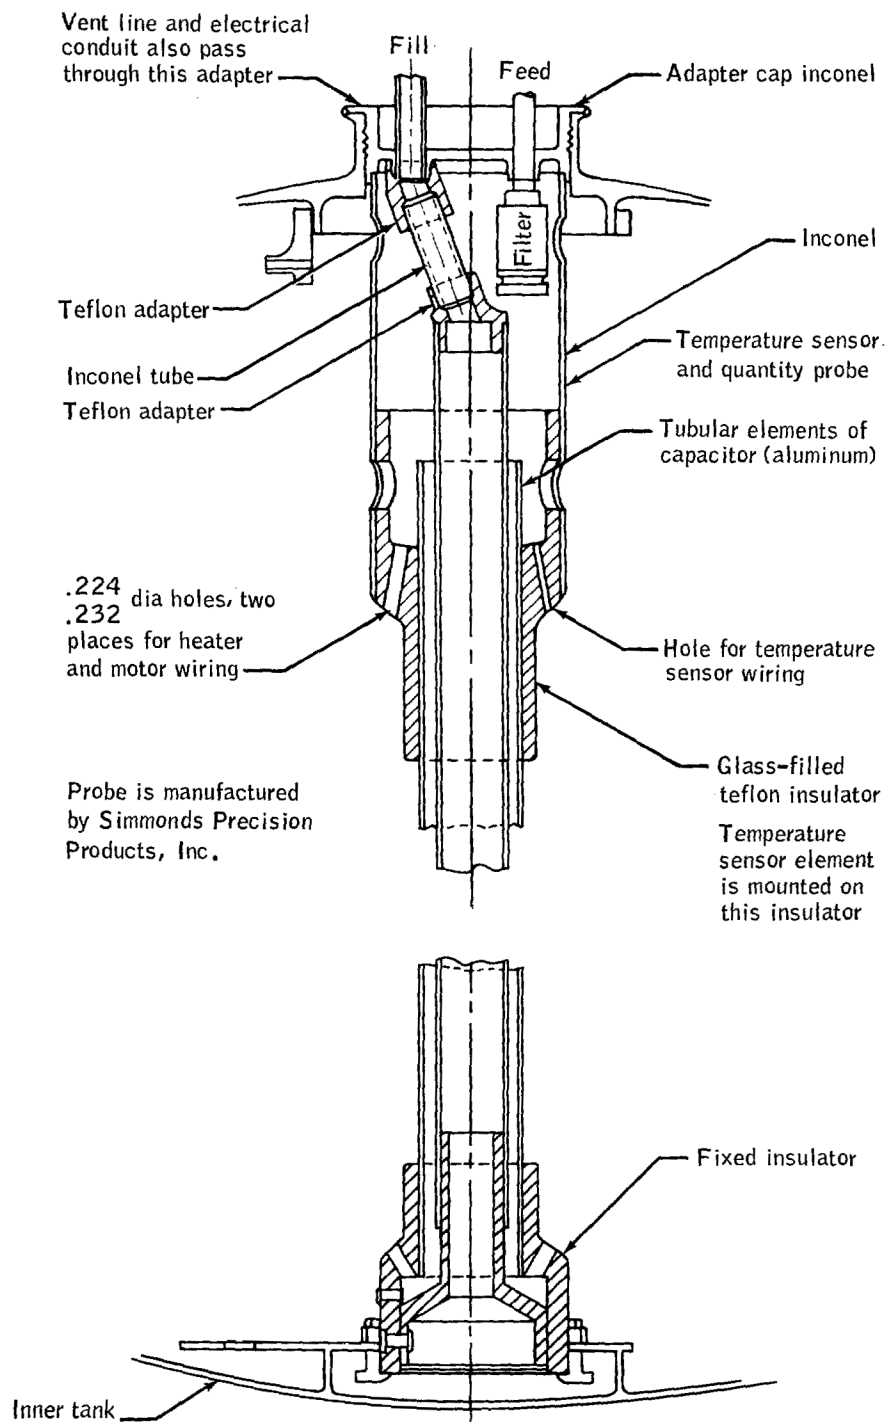
Figure D3-12.- Quantity gage.

The quantity gage capacitor (fig. D3-12) consists of two concentric aluminum tubes which are adequately mounted and supported. The inner tube of the capacitor constitutes the extension of the fill line. The outer tube is perforated to insure access of the oxygen to the space between the capacitor plates. The relative position of the two plates is maintained by insulating Teflon separators. Shorting of the capacitor at the plates within the tank requires bridging of the gap between the tubes by a conductive material. Shorting could also be induced by the contact of bare lead wires resulting from insulation damage. The power input to the quantity gage is regulated and limited by the high impedance source of the signal conditioner. The spark that could be

generated is at the 7- to 10-millijoule level. The evidence provided by the data can be construed to indicate that the effects of the probe failure during flight were limited to data loss.

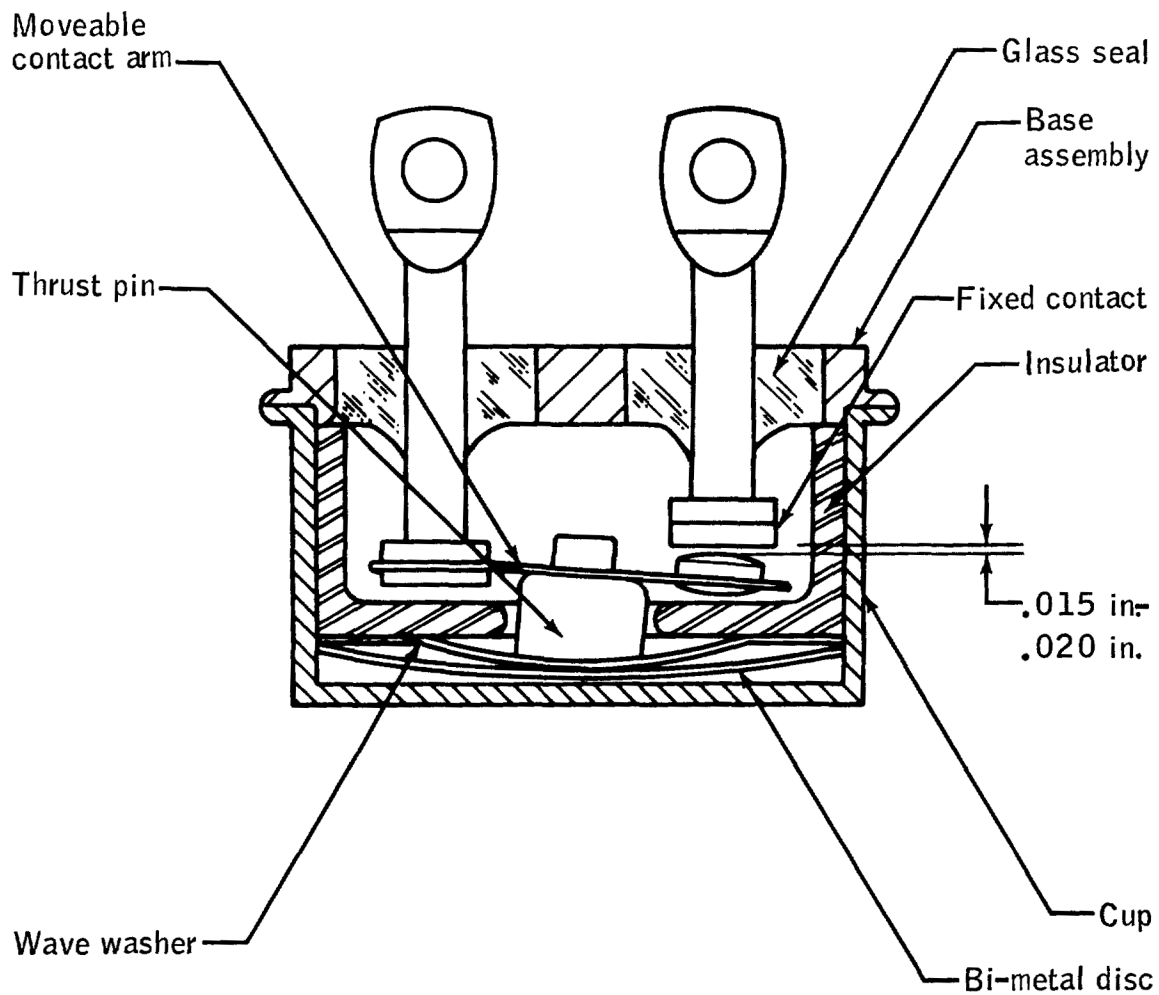
Figure D3-14.- Cross section of thermostat.

Qualification testing of the thermostats was accomplished as part of the overall testing of the assembled oxygen tanks. These tests included vibration, acceleration, and mission simulation. Operation of the heater circuit at Beech during the oxygen tank qualification program and for all normal acceptance testing is accomplished using 65 V ac for initial pressurization. Since this is done only when the tank is filled with liquid oxygen, it is highly unlikely that temperatures would be raised to levels that would cause operation of the thermostats. One instance of a single thermostat operating to open a heater was experienced in the First Mission Subsystem Qualification Test (ref. 27). At this time, heaters were being energized from a 28 V dc bus.

All qualification and acceptance tests identified were primarily concerned with the repeatability of the thermostat actuation at the specified temperatures. No qualification or acceptance tests have been identified which would verify the ability of the thermostats to open the heater circuit when energized at 65 V dc.

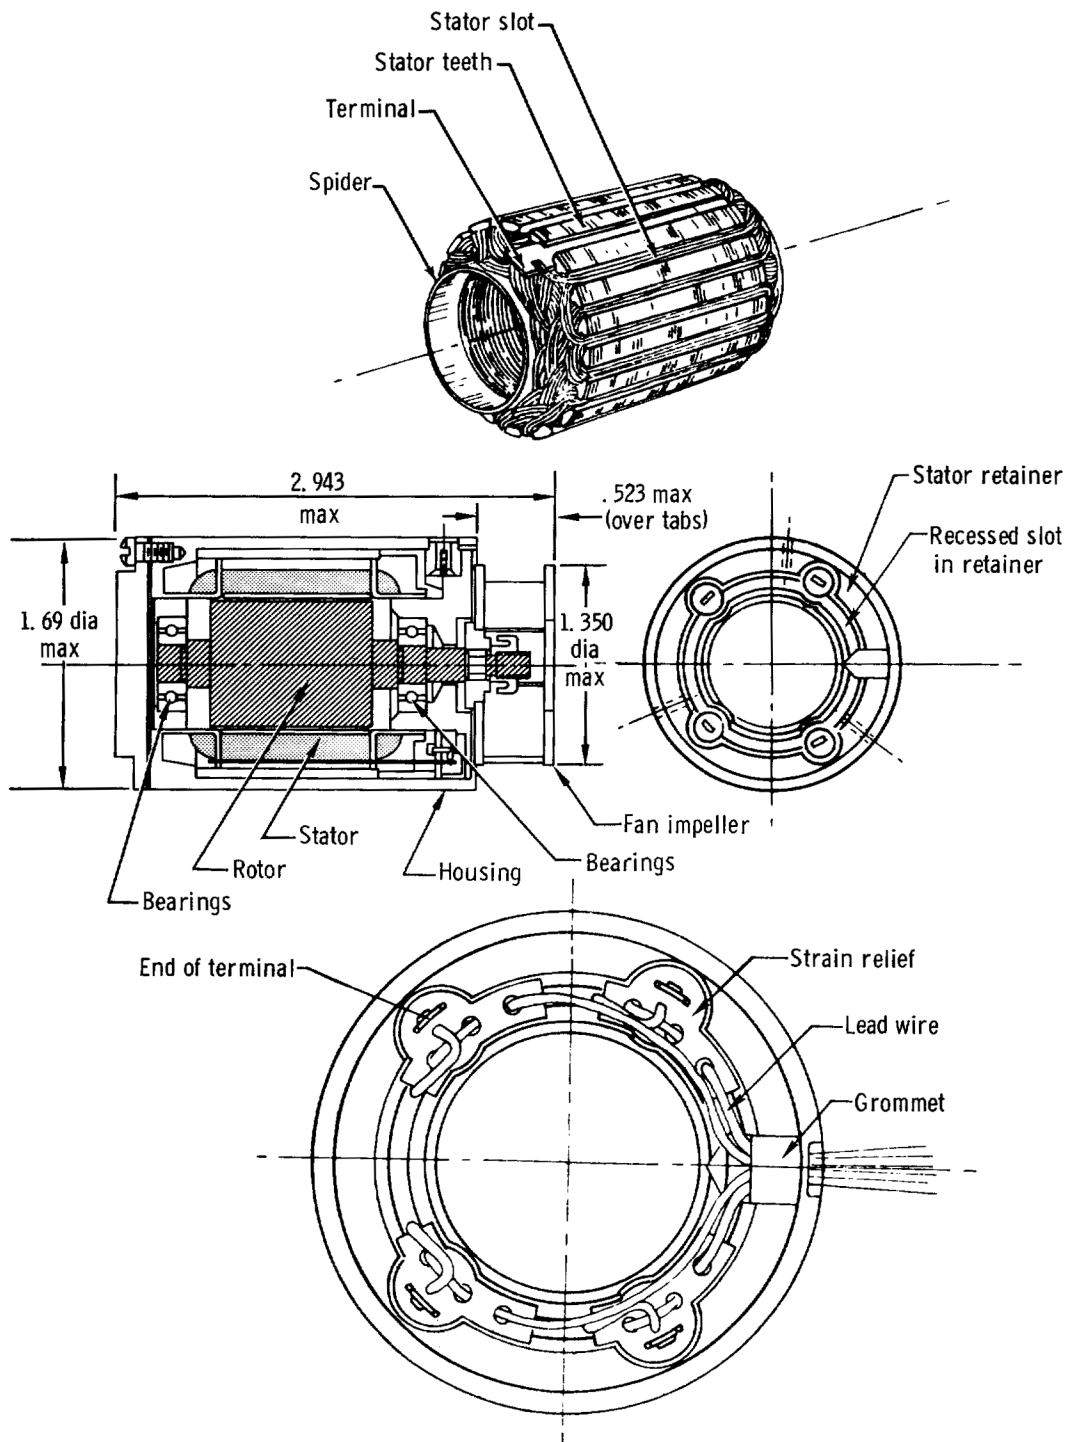
Figure D3-15.- Oxygen fan motor.

The two oxygen fan motors (fig. D3-15) are three-phase, four-wire, 200/115-volt, 400-hertz, miniature, open induction motors, driving centrifugal flow impellers. The minimum speed of the motors is 1800 revolutions per minute at a torque output of 0.9 ounce-inches. The motors are mounted at each end of the motor-heater support tube by a cantilevered attachment joined to the motor back plate. The motor clearance within the support tube wall is a nominal 0.01 inch. The stator windings and bearings of the motors are exposed to oxygen.

The stator windings are fabricated with number 36 American Wire Gage (AWG) wire, using a Teflon-coated ceramic insulation. The ceramic insulation is brittle and subject to breakage if proper tension is not used in fabricating windings or if sharp bends are made at the winding

end turns. Acceptance testing of the wire is conducted on the first 100 feet of each reel. The wire is considered acceptable if no more than 10 breaks in insulation are exhibited in the sample when pulled through mercury at 25 feet per minute. The rejection rate for stator winding faults for motors processed early in the production run was substantial. Improved yield was achieved only by rigid adherence to the winding tension process control used in fabricating the windings, proper assembly techniques, and frequent in-process dielectric testing. Phase-to-phase short circuits or shorted turns within a single phase are more likely than phase-to-ground faults. A limited amount of insulation is provided between windings and ground. Phase-to-phase insulation is limited to the end turns. Considerable improvement was accomplished in the acceptance rate of motors built after the fabrication control techniques were developed (Appendix C). No problem was exhibited in the testing of the two motors finally installed for flight in oxygen tank S/N XTA0008.

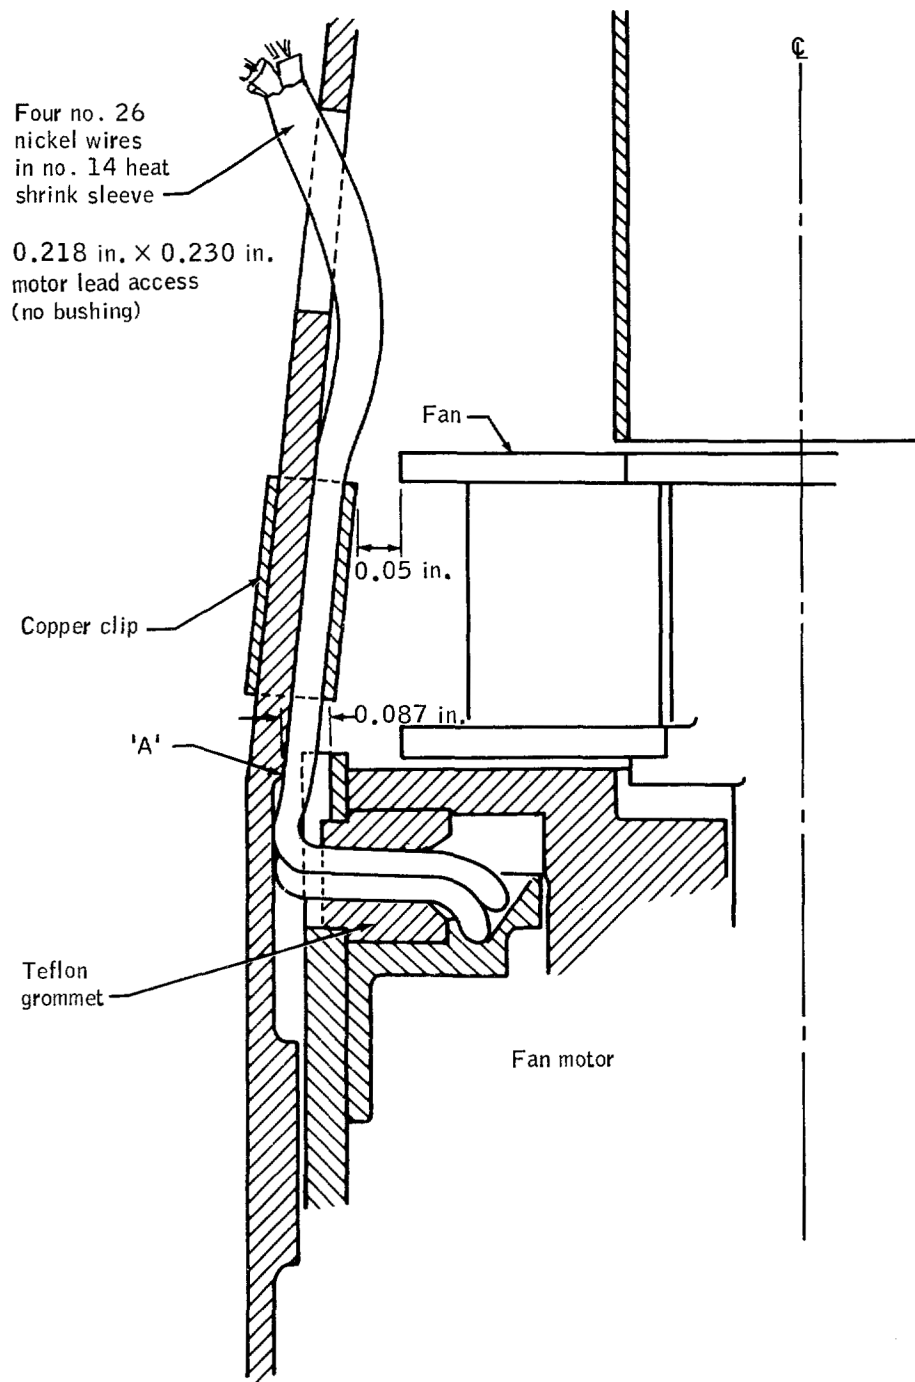
Figure D3-17.- Typical wire routing for fan motor (four times full size).

During assembly of the tank, three bundles of six wires each are sequentially pulled through the conduit. The first bundle, consisting of the two quantity gage wires and the four temperature sensor wires, is pulled through the conduit along with the pull wires for the other bundles. The second and third bundles each consist of one set of motor leads encased in 0.012-inch shrink-fit tubing and one set of heater leads. The pull wires have a break-strength of 65 pounds. Since the third bundle of wire must be forcefully pulled through the conduit, damage to wires in this bundle or the others may result which may not be detectable without physical inspection. Physical inspection cannot be accomplished with this design.

The calculated break strength of a number 26 AWG nickel wire is 11 pounds and elongation of 28 percent can be experienced before break. If the number 26 AWG wires do not share the load associated with pulling the bundle through the conduit, damage to the wire(s) will result before the pull wire breaks. Stretching of the wire results in local neck-down of both the conductor and insulation. In subsequent operation of the circuit, the locally smaller gage conductor can produce local hot spots and progressive deterioration of the insulation.

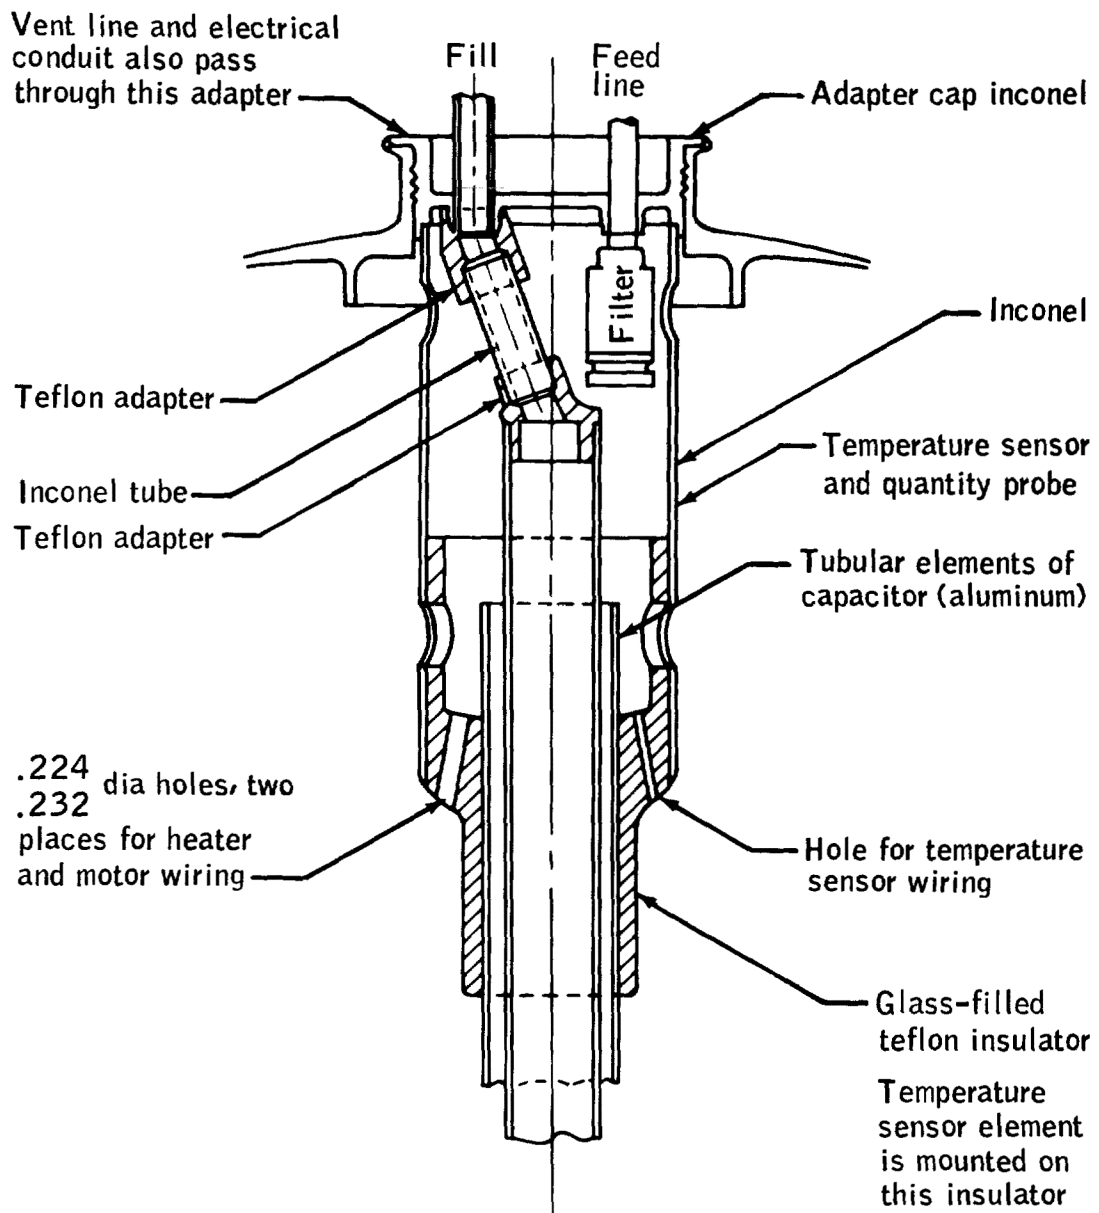
Figure D3-18.- Arrangement of head end of tank.

The head ends of the tank and the temperature sensor and quantity probe are shown in figure D3-18. One of the more significant features of the design is the arrangement of the connections in the fill line which routes the cryogenic fluid to the bottom of the tank, via the inner element of the quantity gage capacitor, and which permit the fluid to flow from the bottom of the tank during ground detanking. The manufacturing drawings of the elements of this connection, two Teflon adapters and an Inconel tube, allow a tolerance stack which is excessive. One combined worst case results in a connection which cannot reach from the fill tube connection in the tank head to the center element of the quantity gage capacitor. The other results in a connection length which prevents assembly of the probe to the adapter in the head of the tank. These are shown in figure D3-19. The tolerances on concentricity between the inner element of the capacitor and the outer shell of the probe are not known and are omitted from this figure. Inclusion would show an even worse situation than shown.

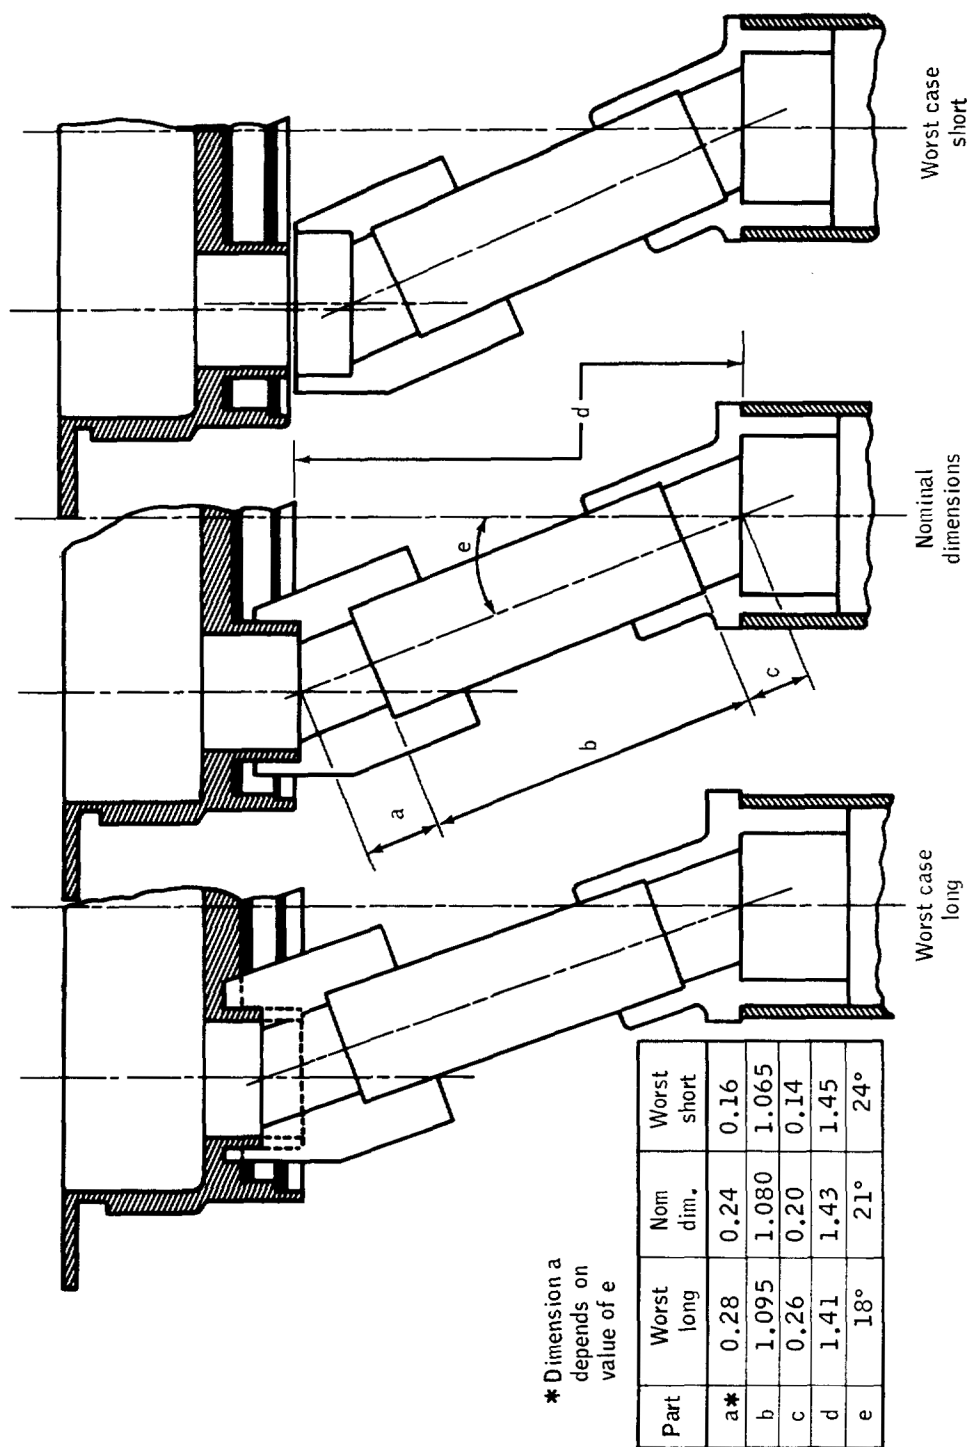
Figure D3-19.- Possible variations in fill line connection.

The experience with the oxygen tank no. 2 in Apollo 13 (apparently normal detanking at Beech, but normal detanking not possible at KSC) suggests that the components used in the fill line connection were close to a worst-case short situation. Tests conducted recently at Beech show that near normal detanking is possible when considerable leakage is present at the joints in the connection, and that a substantial displacement of the top Teflon adapter relative to the fill line in the tank adapter cap is necessary to reproduce the KSC situation.

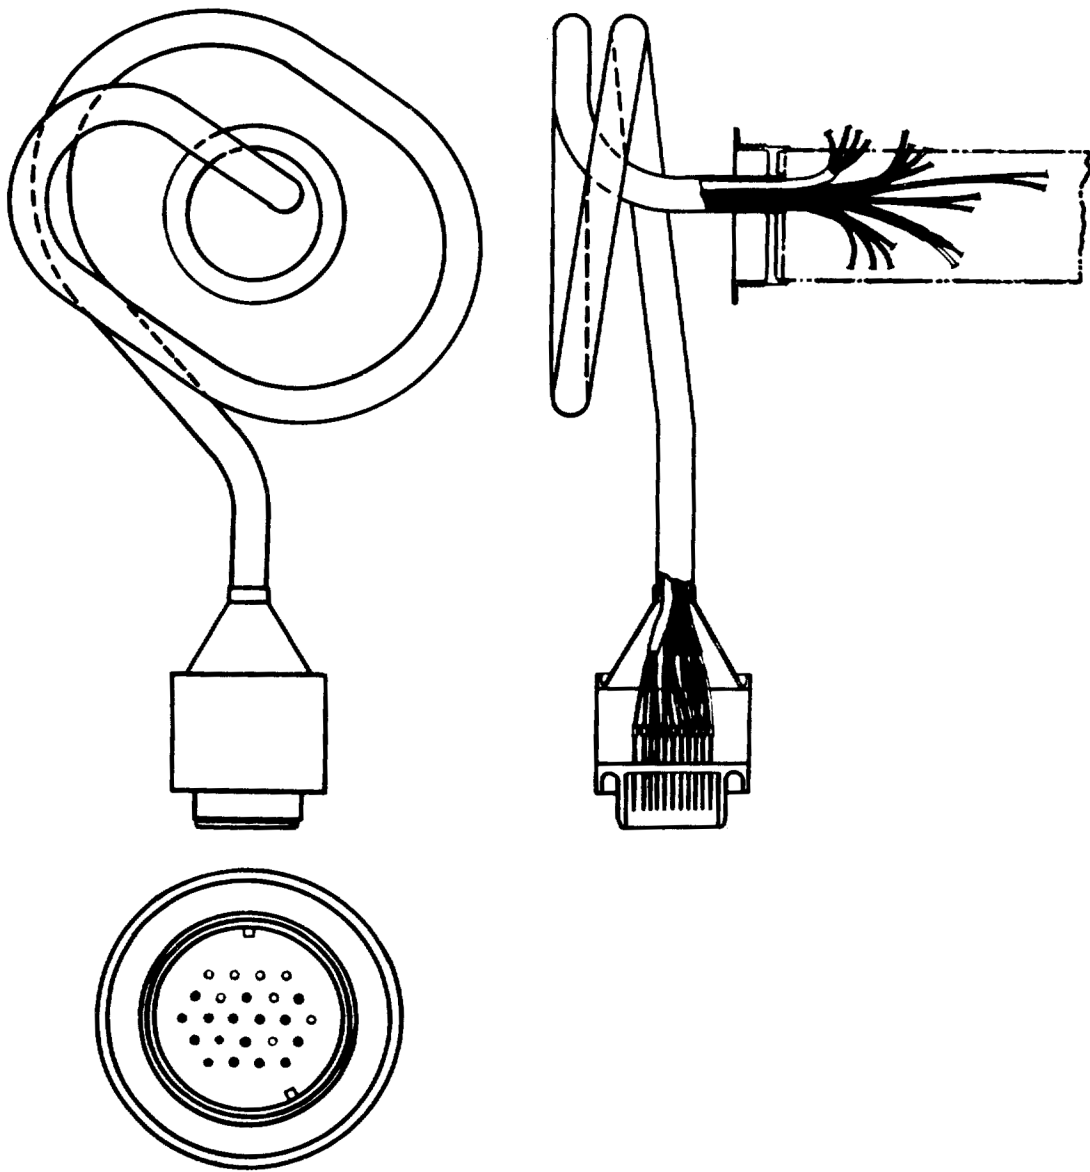
Figure D3-23.- Arrangement of electrical conduit.

A total of 18 wires pass through the electrical conduit, eight AWG no. 26's, four AWG no. 22's, and six AWG no. 20's. The conduit is shown in figure D3-23. At the start of the investigation some members of the Panel felt that the unorthodox detanking procedure used at KSC could have resulted in unacceptably high temperatures in this electrical conduit due to resistive heating of the heater wires. This possibility is discussed in a later section.

The design of this portion of the tank results in a configuration in which it is not possible to perform visual inspection of wiring after assembly. In consequence, the possibility of damage, in many cases undetectable by normal quality assurance procedures, is significant.
