# **REPORT OF APOLLO 13 REVIEW BOARD**

**APPENDIX F - SPECIAL TESTS AND ANALYSES**

**APPENDIX F**  
**SPECIAL TESTS AND ANALYSES**

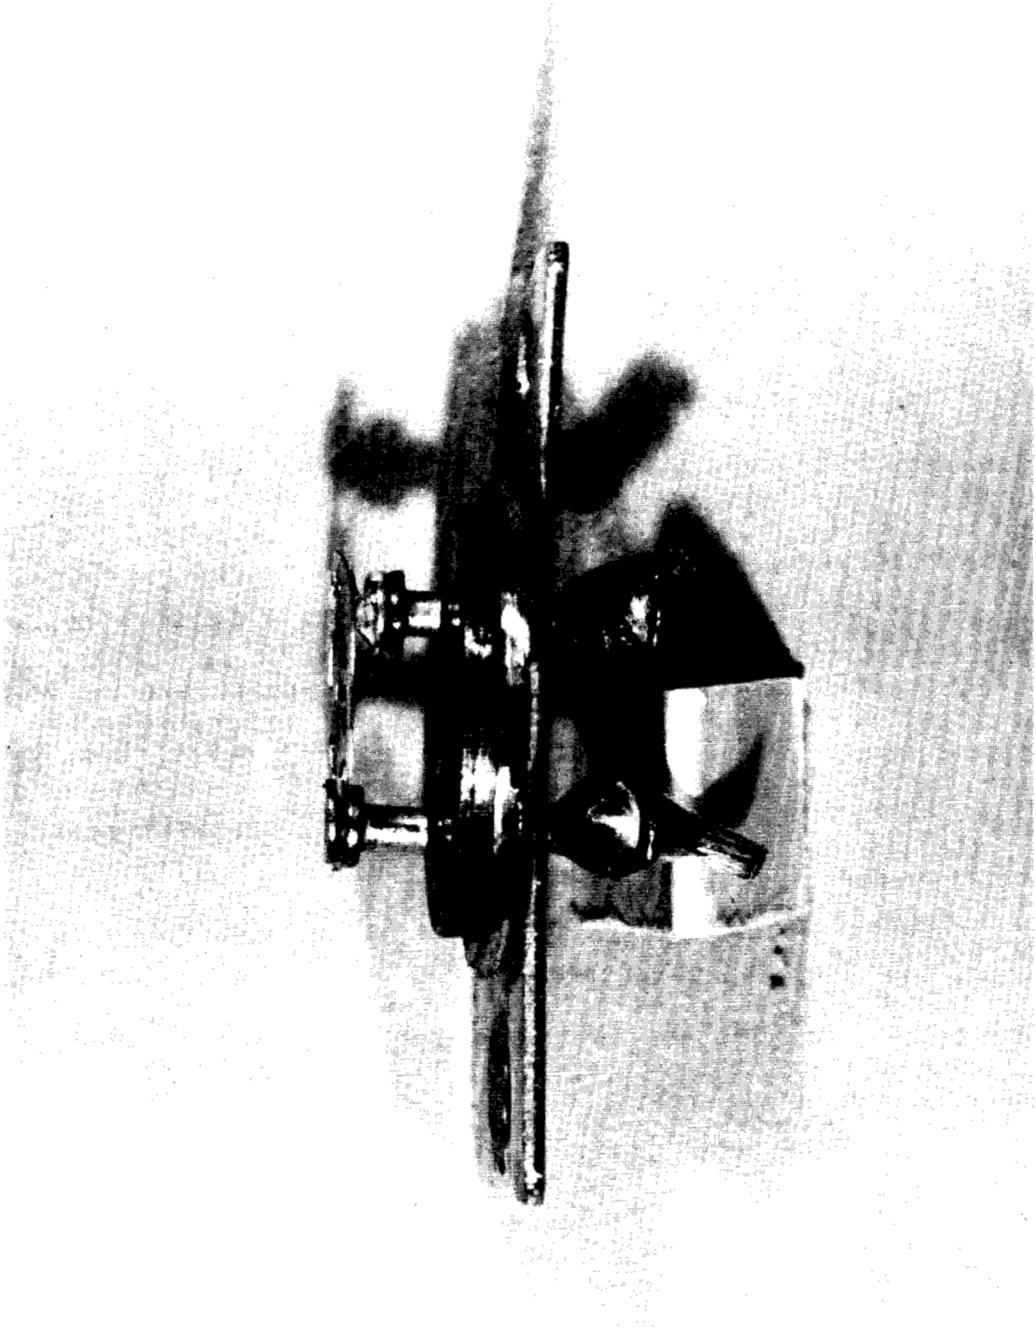
Batteries were used as a power source to test the switches. They were initially supplied with 31 V dc at currents up to 3.5 amperes. No contact degradation was observed under these conditions. When the voltage was raised to 65 V dc, some increase in contact resistance (up to about 3 ohms from a few milliohms) was noted at 1.25 amperes, although the switch continued to operate. The current was then increased to 1.5 amperes at 65 V dc; and when the switch attempted to open, it fused closed. The body of the switch was removed and the condition of the contact can be seen in figure F3.1-1.

Thermostatic switches similar to those in oxygen tank no. 2 will fuse closed when they attempt to open with a 65 V dc potential and currents in excess of 1.5 ampere.

Figure F3.1-1.- Fused thermal switch control.

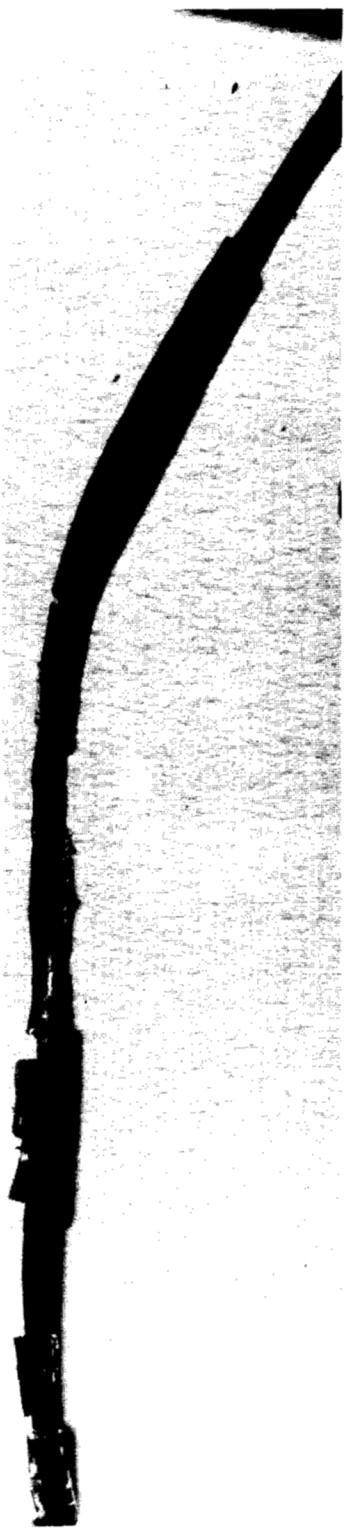
The tests reveal that severe damage could have resulted to the wire insulation during the abnormal detanking procedure. In several places along the leads, bare wire was exposed which could have led to the short circuits that initiated the accident.

Figure F3.2-1.- Damaged Teflon insulation.

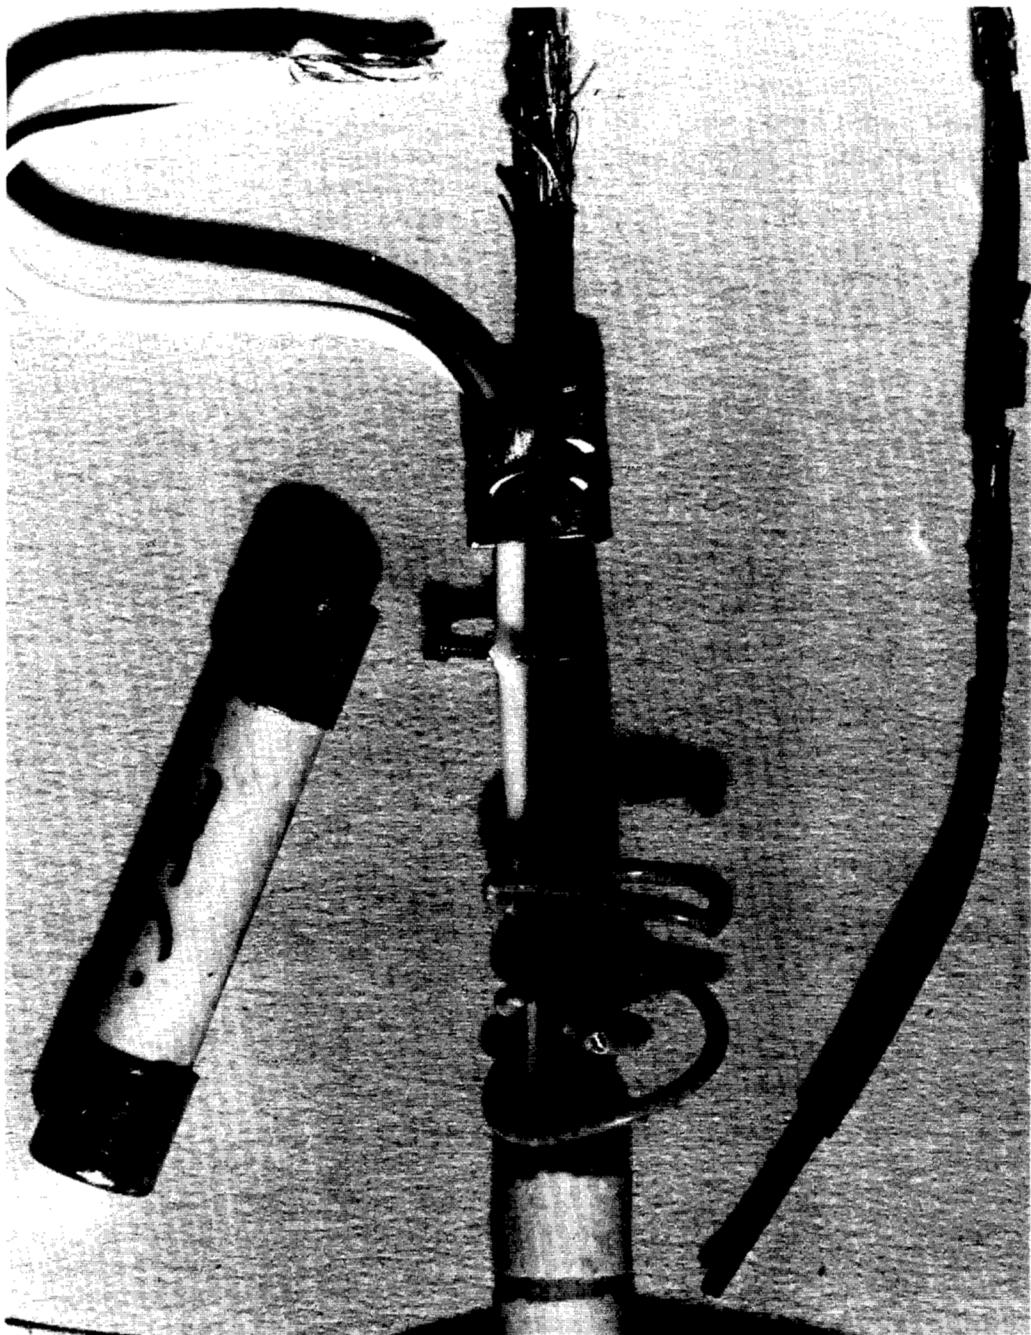
Sample sections of Teflon-insulated conductors obtained from Beech Aircraft Corporation through MSC were baked in oxygen for 5 hours at 572° F, held overnight at room temperature in oxygen, and baked further for 2 hours at 842° F. The Teflon lost its pliability, cracked, and flaked off as shown in figure F3.4-1.

Figure F3.4-1.- Heat degraded wire and test harness replica.

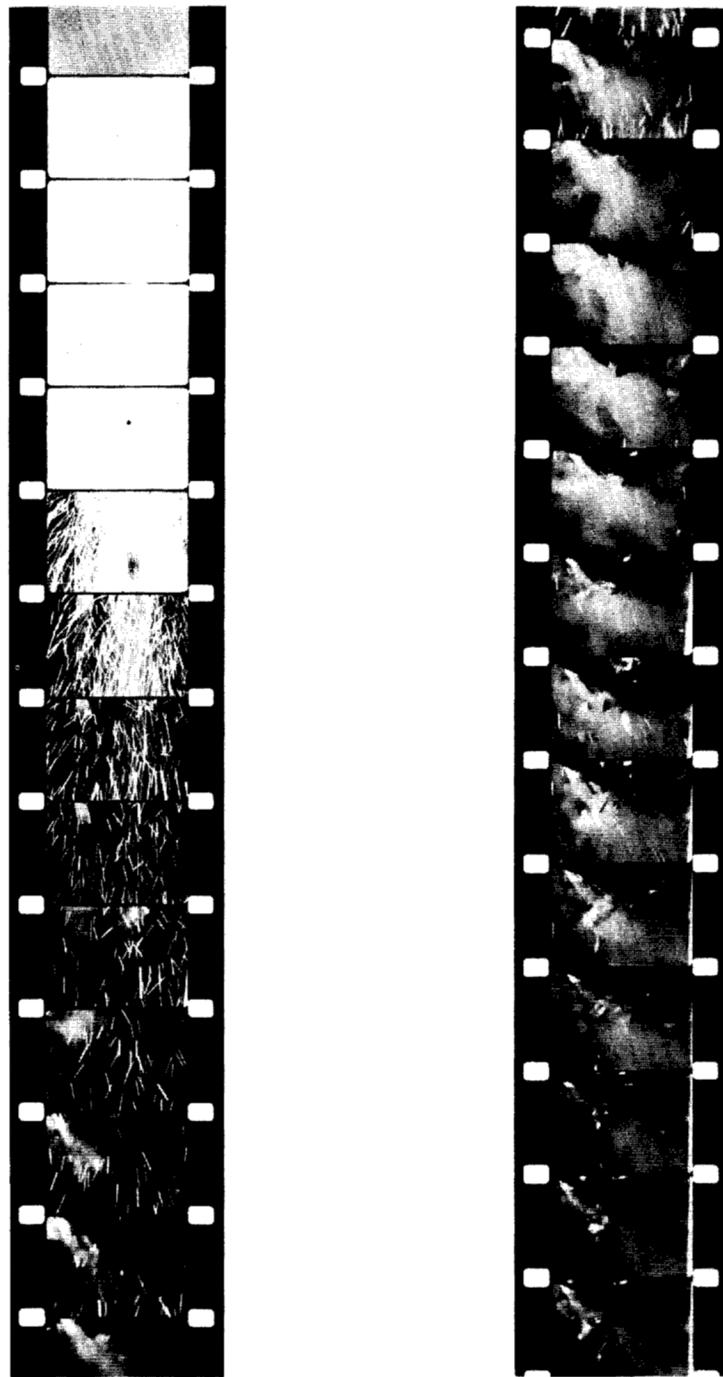
Figure F3.5-12 shows the conduit and chamber interface burnthrough scenes taken from the external movie coverage. The time for this sequence (24 frames) is 1 second. The small amount of external burning resulted

Figure F3.5-12.- External views of chamber-conduit interface at time of failure.

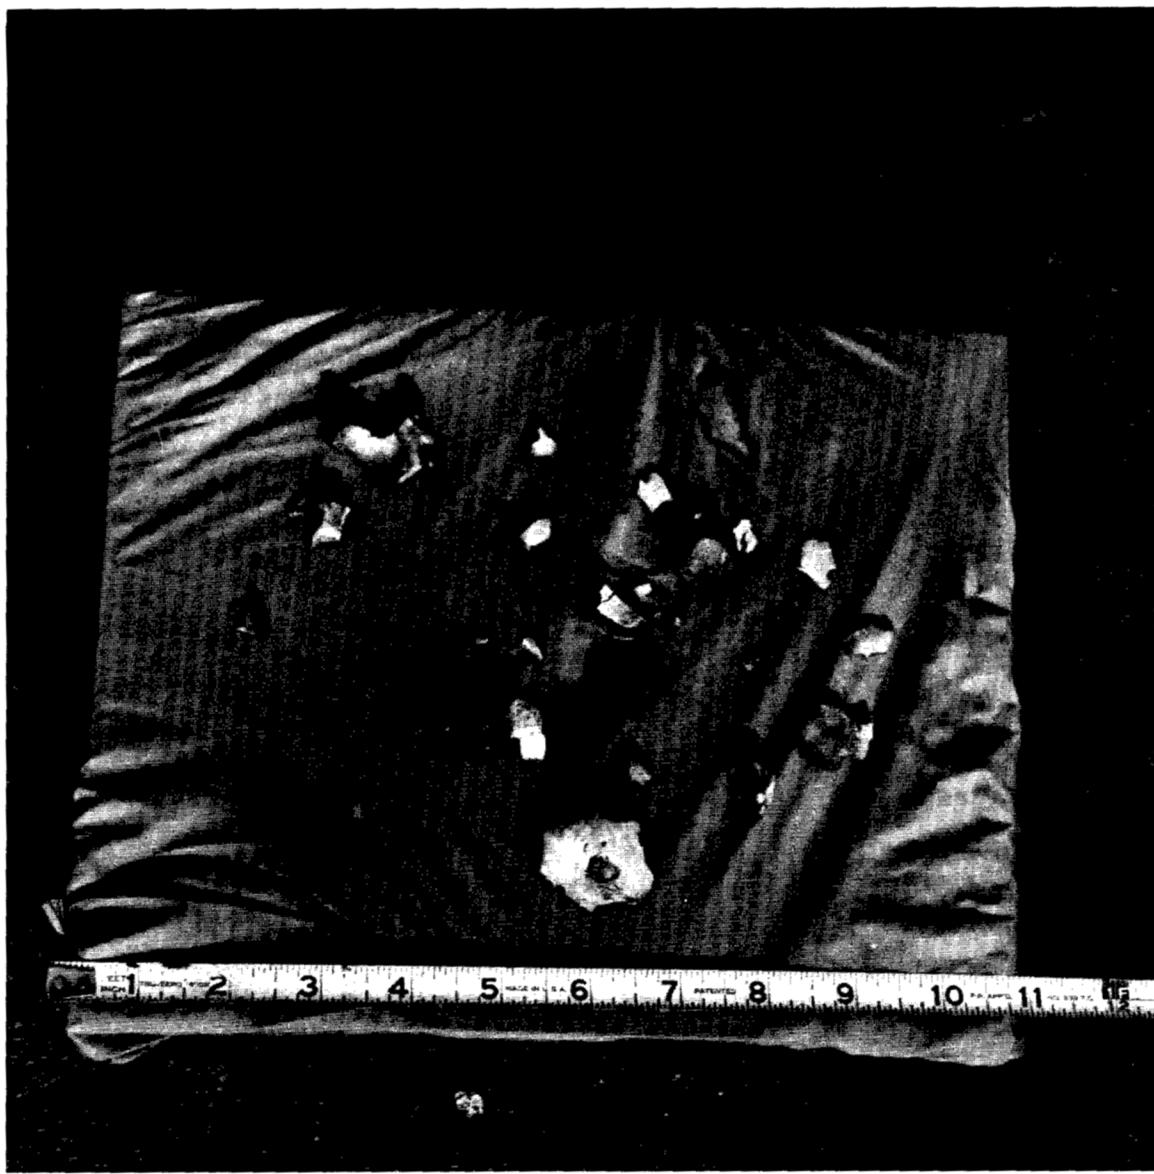
After the test, the section of conduit was found approximately 8 feet from the chamber. Several pieces of the Teflon insulator, two pieces of the conduit swedgelock nut, and one piece of conduit tubing were gathered from a 20-foot radius around the test area (fig. F3.5-13). The only item remaining in the test chamber was a portion of the Inconel section of the capacitance probe (fig. F3.5-14). The stainless steel portion was completely gone and a portion of the Inconel was burned. No remains of the aluminum portion of the probe could be found. The conduit-chamber interface was torched out to a maximum diameter of 1-7/8 inches (see figs. F3.5-15 and F3.5-16).

Figure F3.5-13.- Parts of probe insulator and tubing collected from area around test chamber.

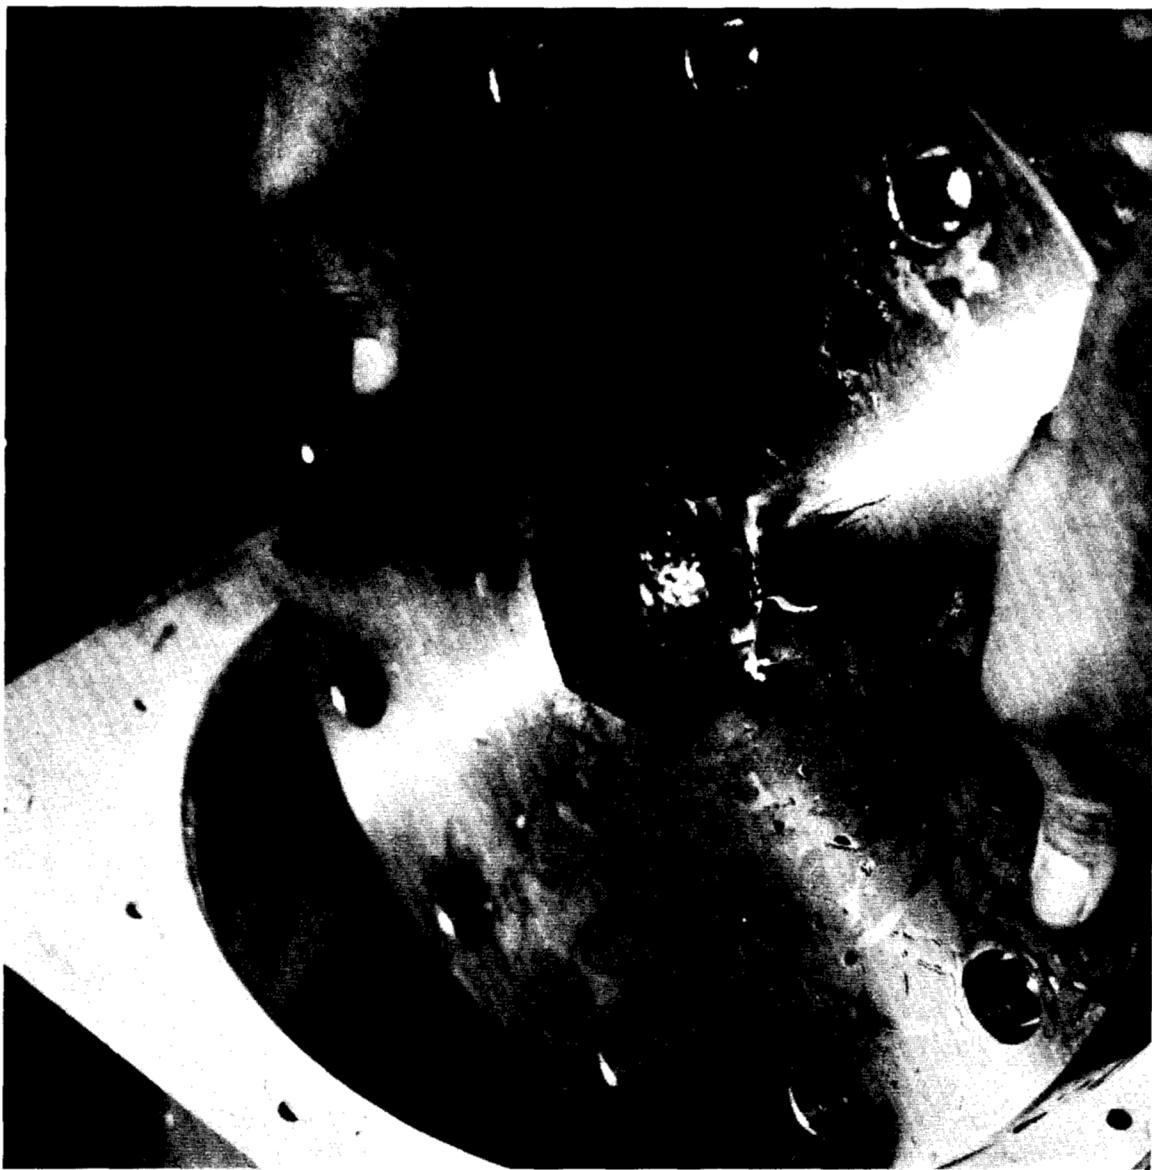
Figure F3.5-15.- External view of chamber flange on which conduit-quantity probe interface was mounted (after test).

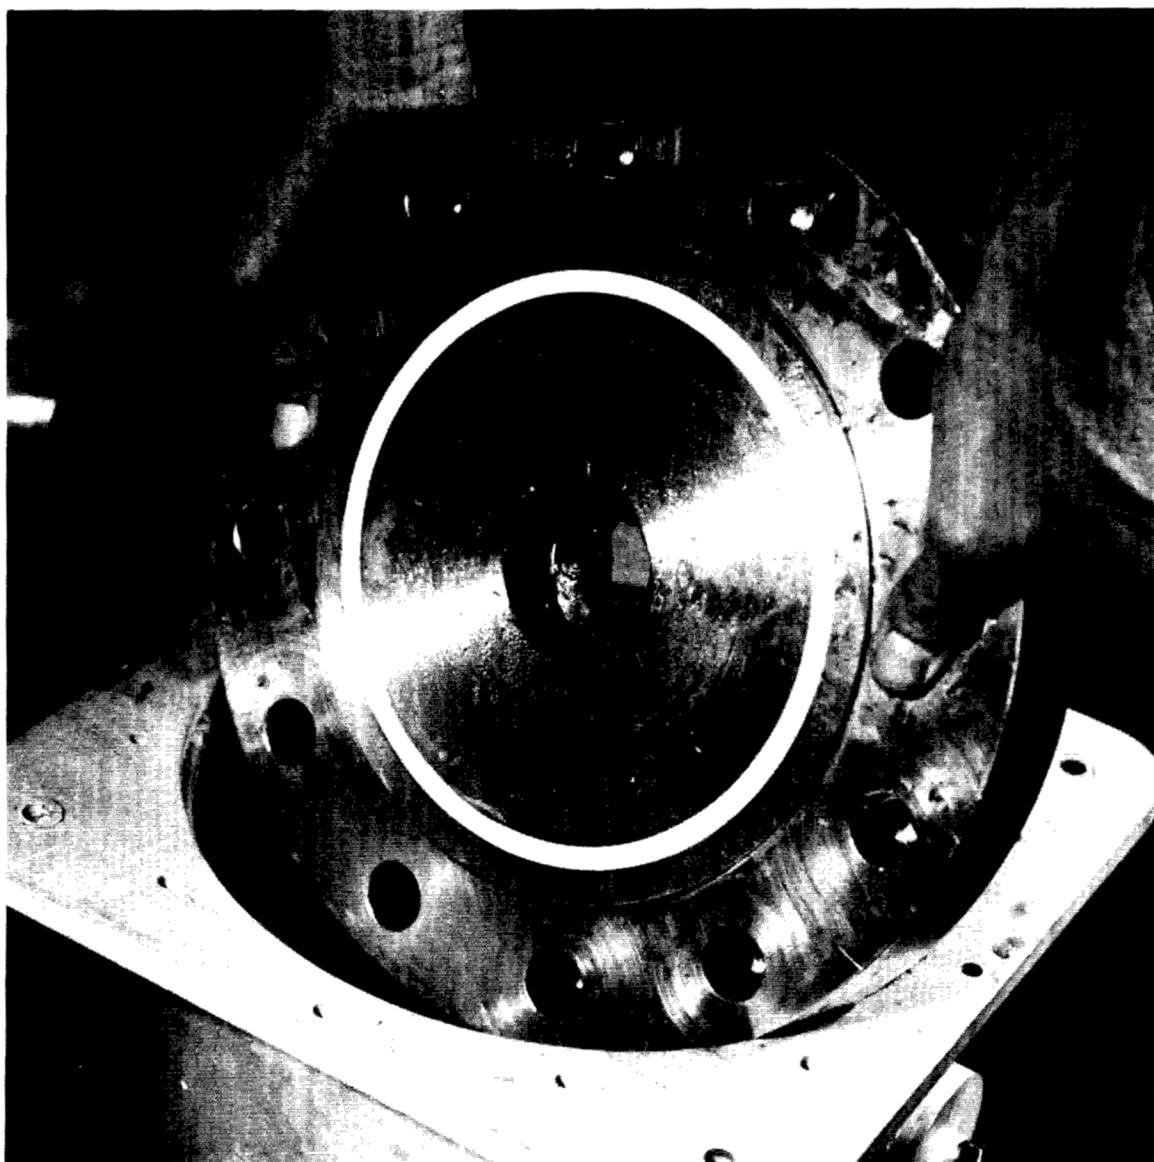
Figure F3.5-16.- View of chamber flange internal surface after test.

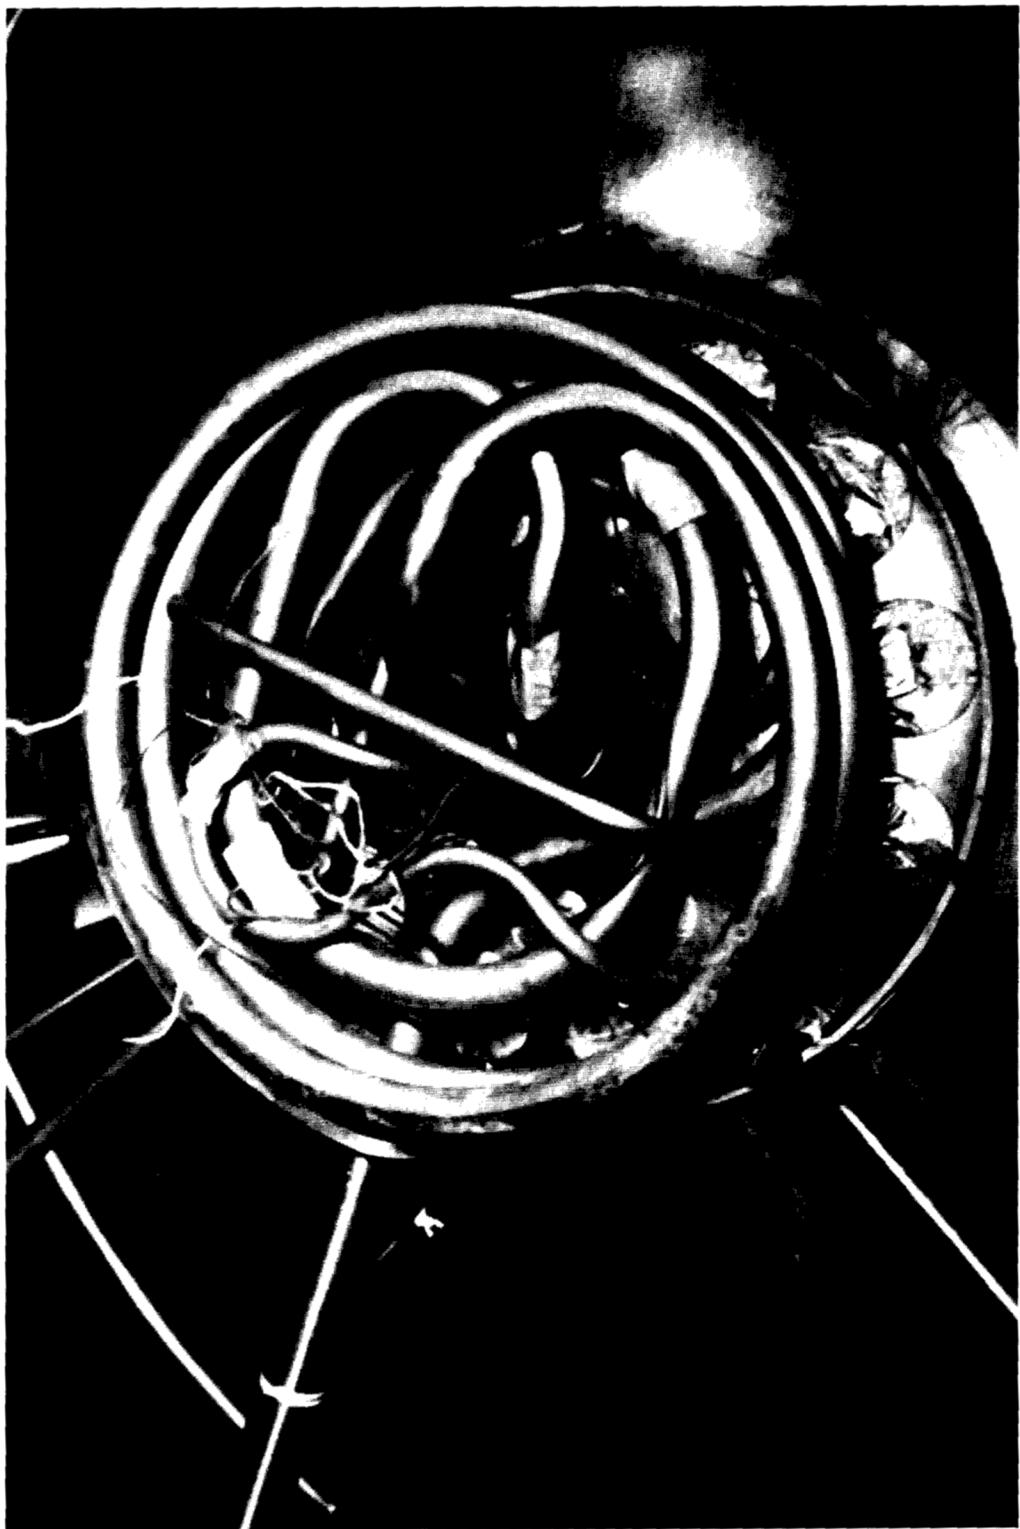
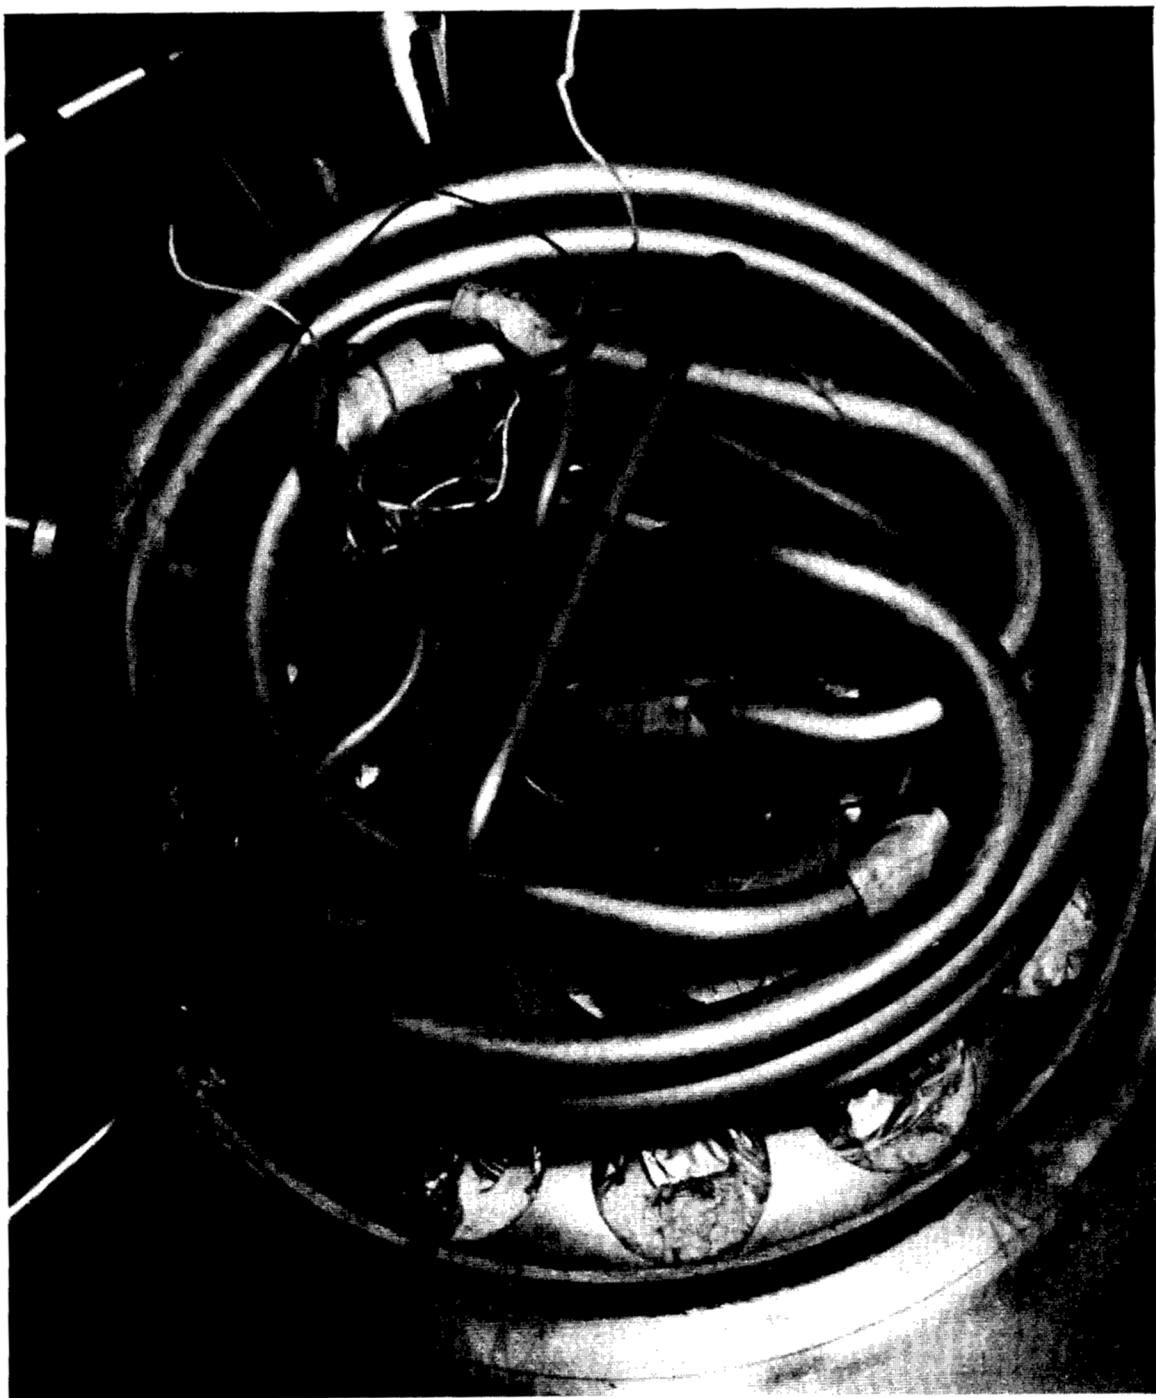
(a) Wide-angle view.  
Figure F3.7-3.- View of failed conduit.

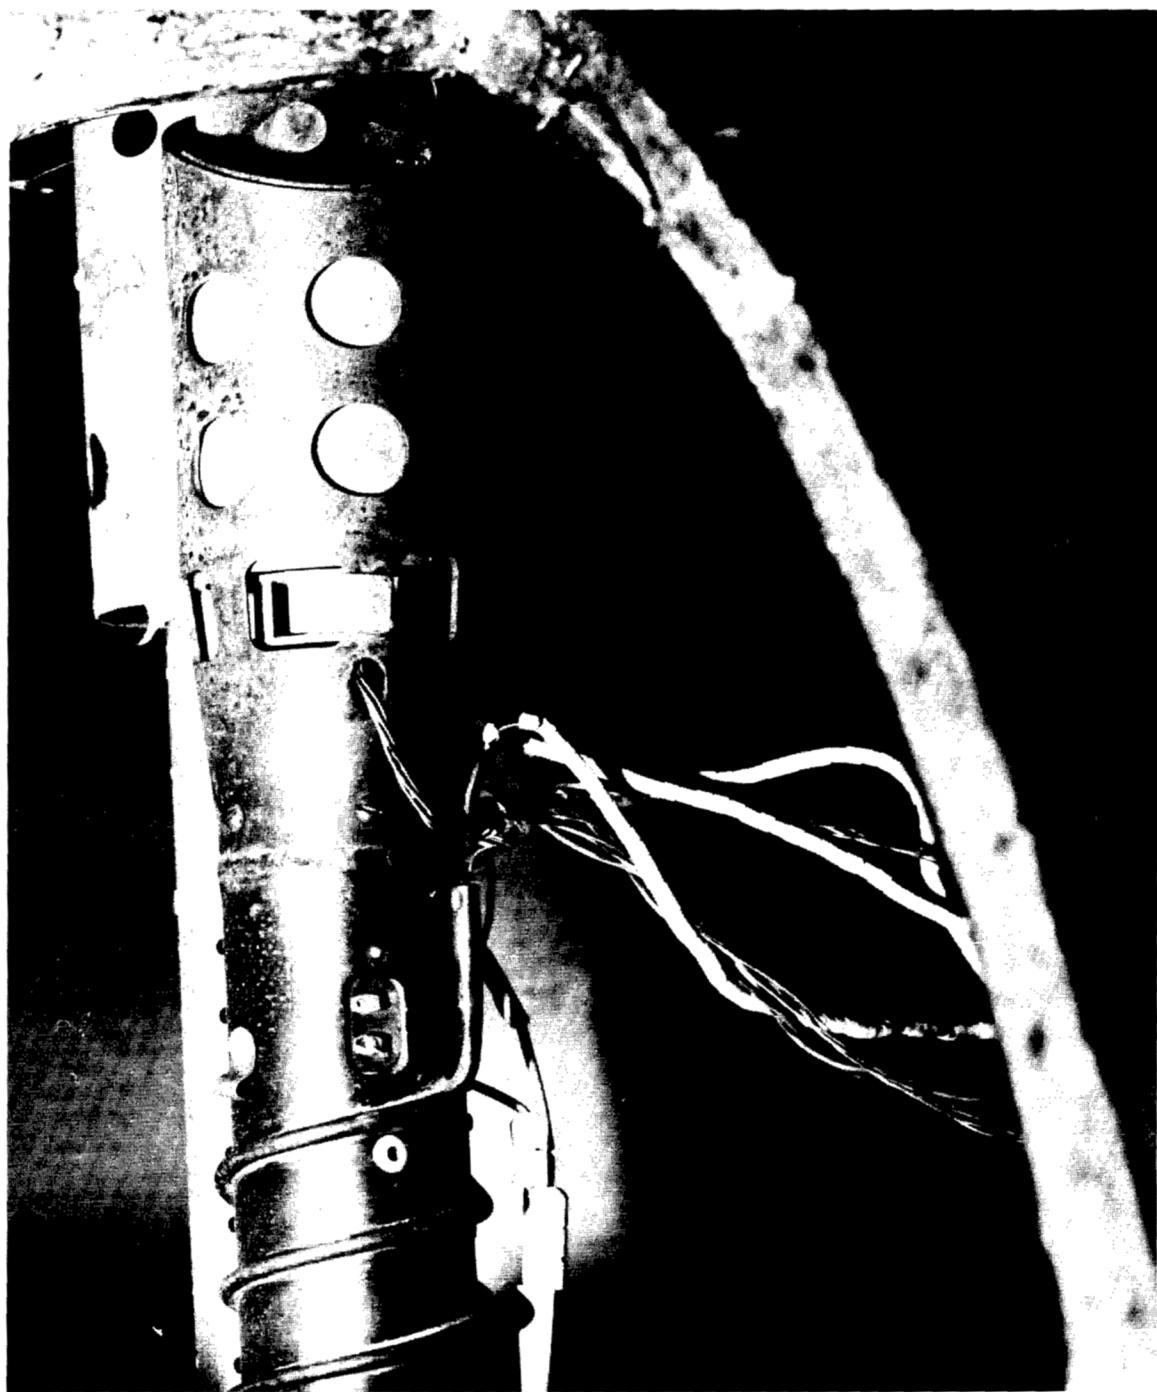
Figure F3.7-4.- Posttest internal view of tank components.

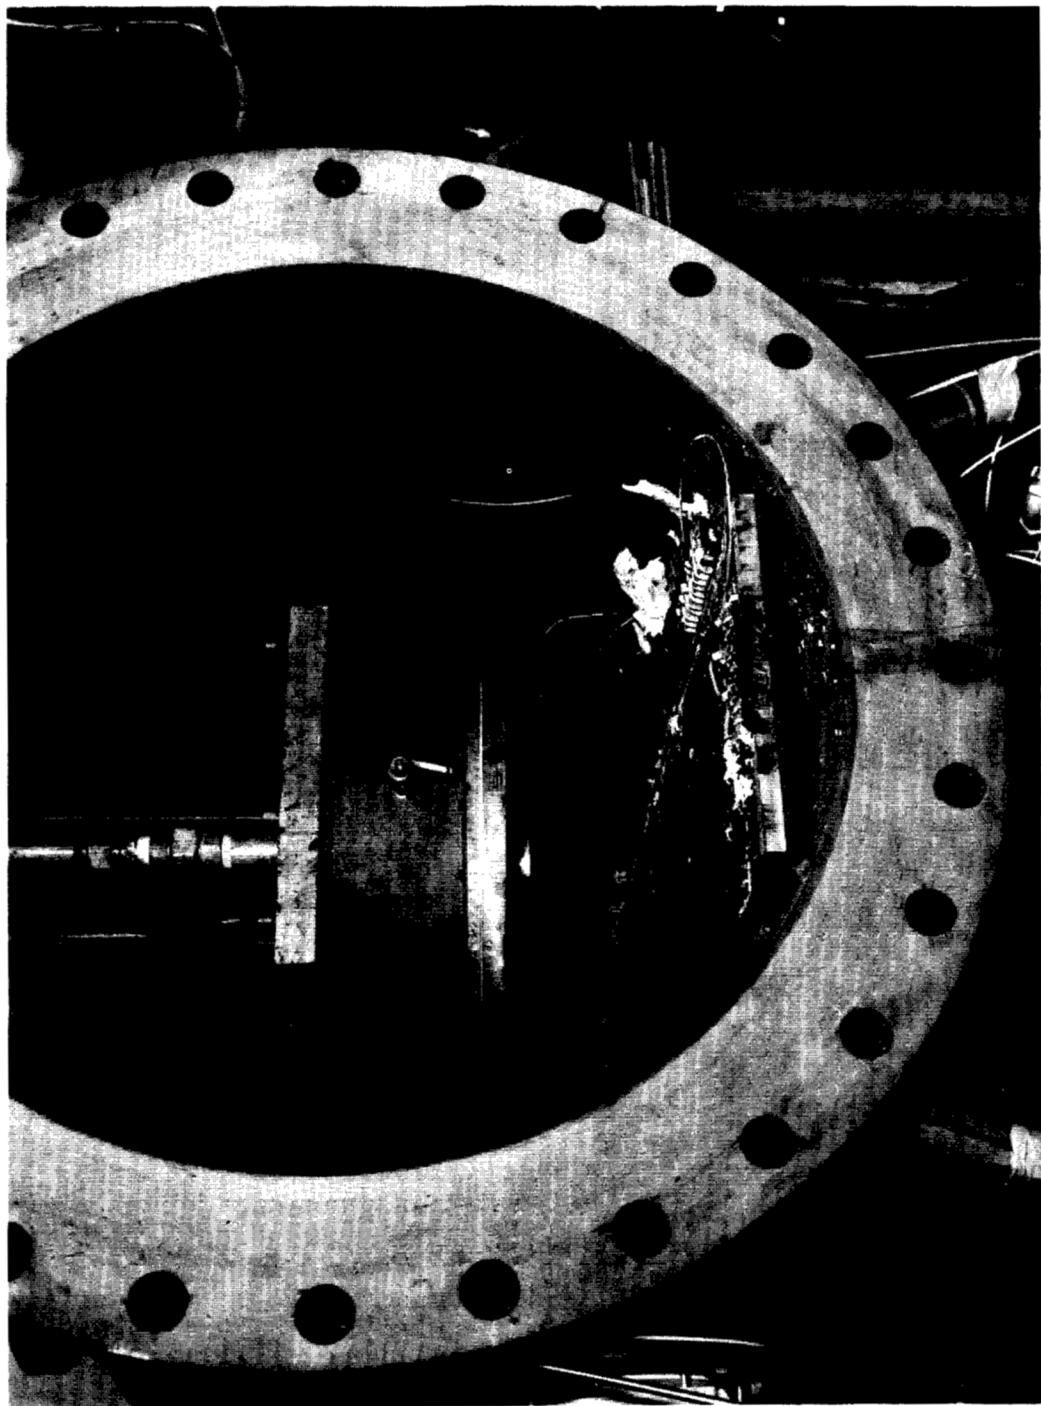
The Mylar insulation blanket burns completely when ignited locally and exposed simultaneously to oxygen from a 1000 psi/-190° F source. The pressure rise rate increases from 6 psi/sec without combustion to about 42 psi/sec with the combustion of Mylar. A substantial increase in the pressure rise rate in the oxygen tank shelf space due to Mylar combustion might therefore be expected. From tests conducted elsewhere, it is further concluded that an ignition source is required to achieve Mylar/oxygen combustion.

Figure F3.9-5.—View of chamber conditions after test.

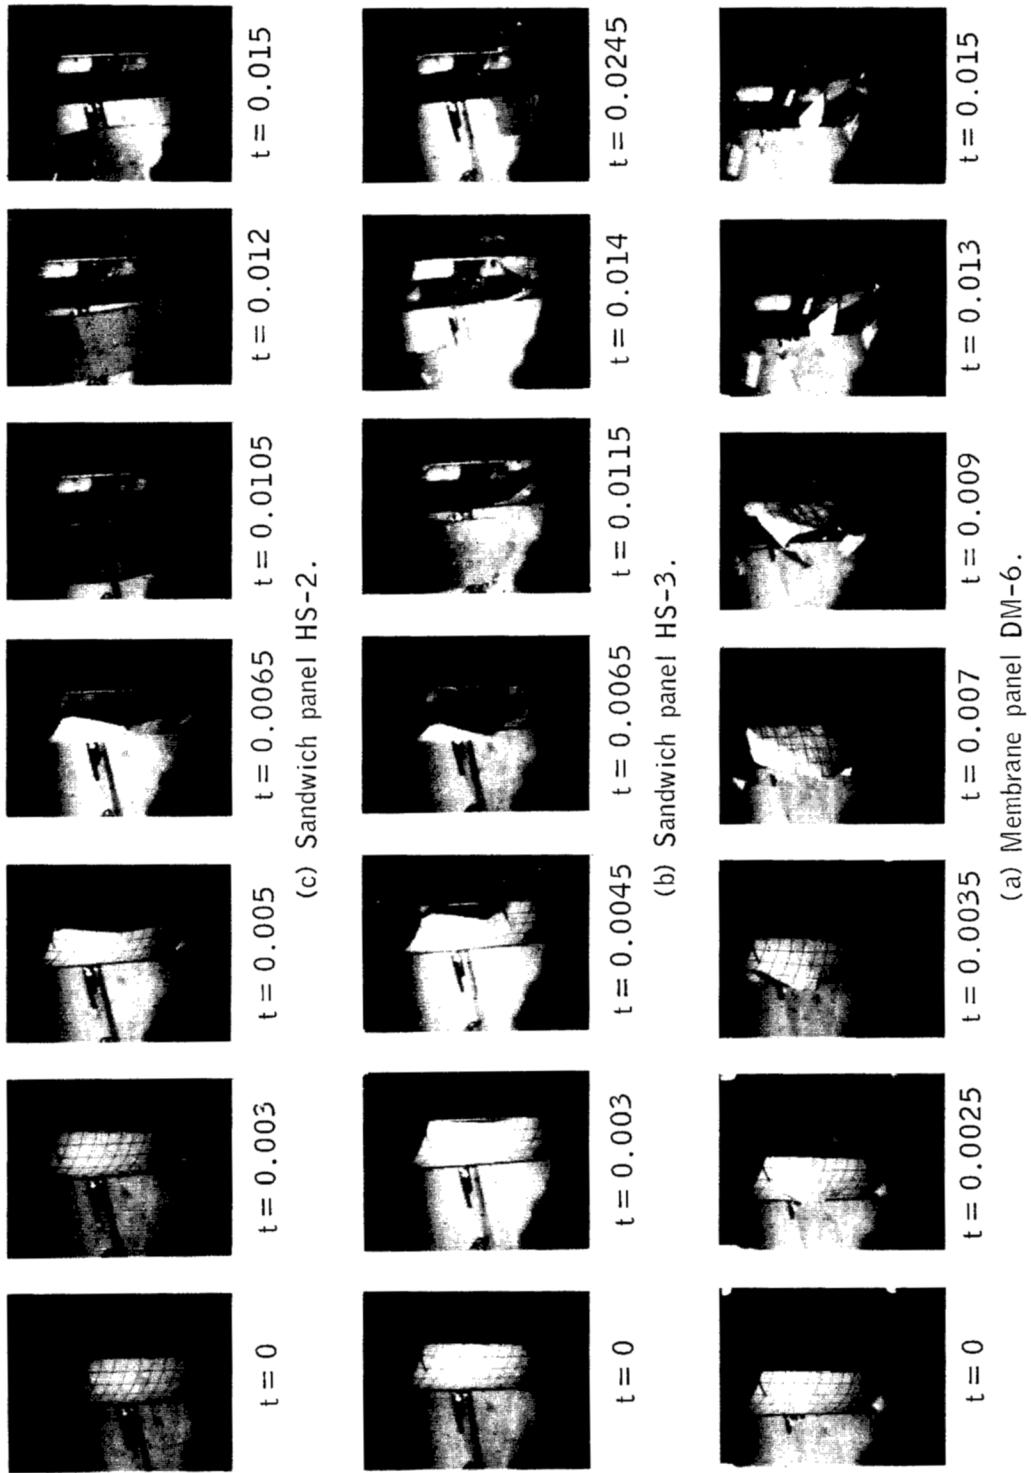
Demonstration of panel separation.- Panel separation has been demonstrated with both membrane and sandwich panels. Two sandwich panels separated completely from the test fixture during vacuum tests. Two membrane panels, although less representative of flight conditions, also separated completely in vacuum tests. However, similar tests with membrane panels in atmosphere left portions of panels attached to the test fixture as illustrated in figures F3.10-4(b) and (c). Complete separation in atmosphere could not be achieved due to mass and drag of the air.

Figure F3.10-5.- Sequential failure of two sandwich and one membrane panel ( $t$  = time from first observed failure).
