S E R V I C E H I N T S

M O D E L H T E L E V I S I O N

1 9 5 1

ZENITH RADIO DISTRIBUTING CORPORATION,
920 WEST WASHINGTON BOULEVARD,
CHICAGO 7, ILLINOIS.

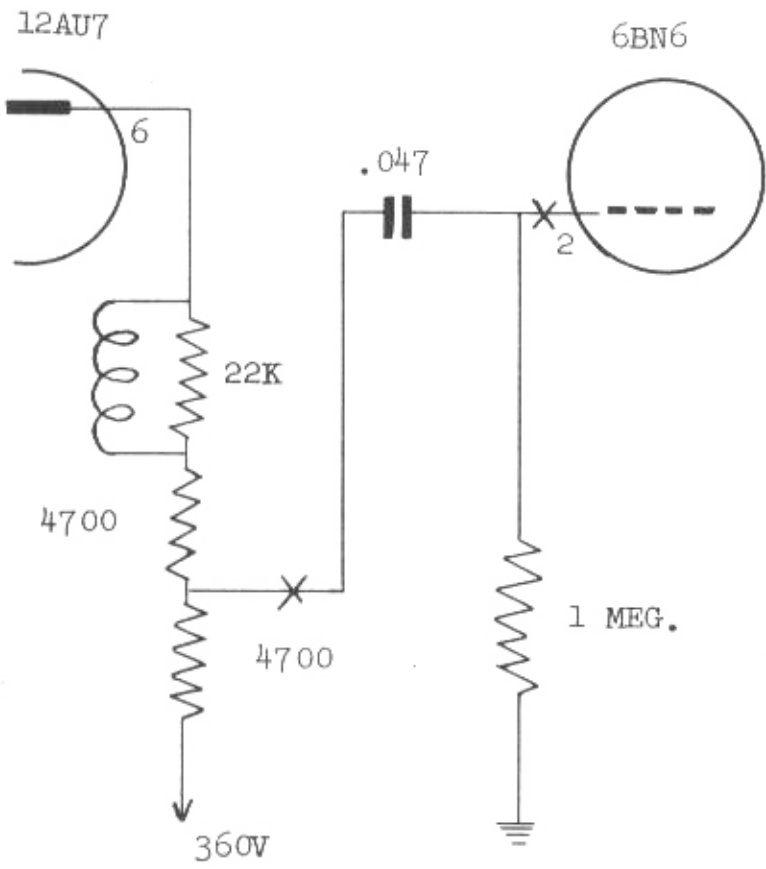
ORIGINAL

A. In weak signal areas, it is possible for ignition noise to cause vertical jitter in the H model receivers. The circuit changes diagramed on the following page are recommended for improving this condition. Caution do not use this circuit in strong signal areas.

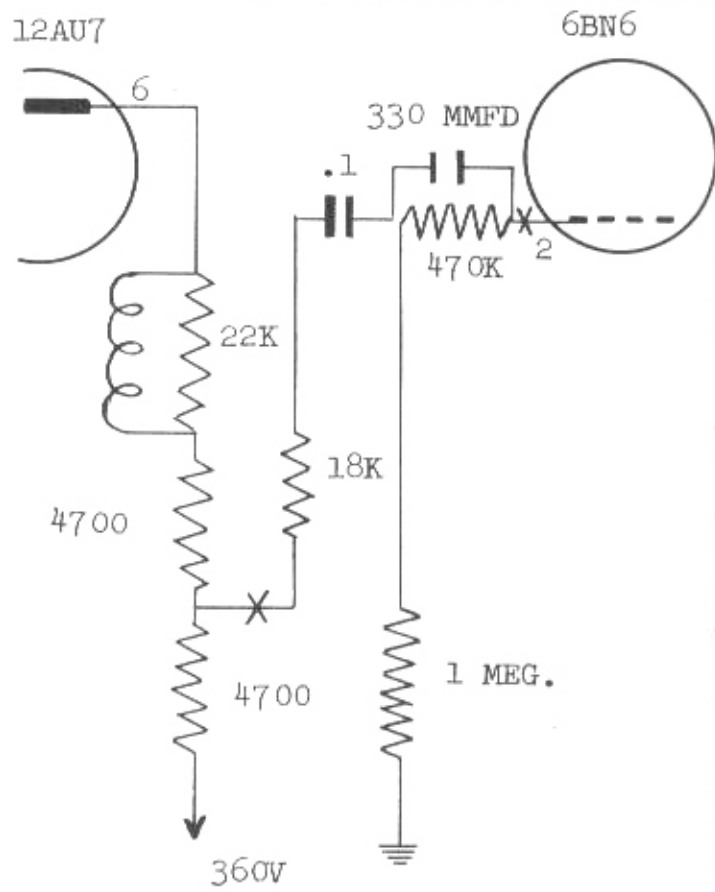
CHANGE

19. Circuit change for improving sync stability.
Fringe Area Only
