MSC-00171

APOLLO 11 MISSION REPORT

MANNED SPACECRAFT CENTER  
HOUSTON, TEXAS  
NOVEMBER 1969

Mission Evaluation Team

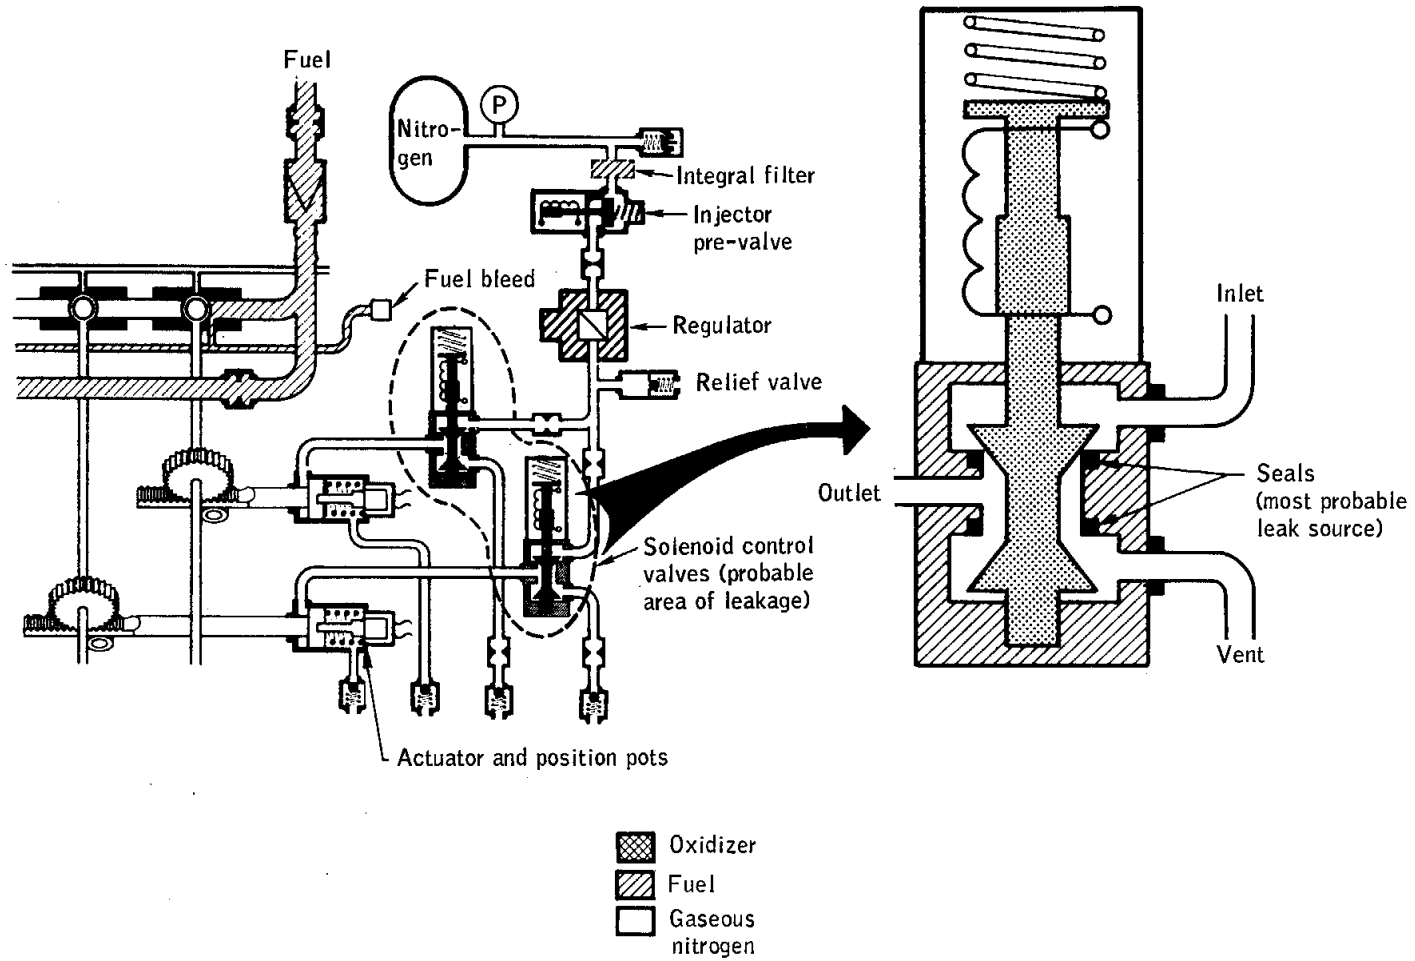
The fuel and oxidizer valves are controlled by actuators driven by nitrogen pressure. Figure 16-2 is representative of both nitrogen control systems. When power is applied to the service propulsion system in preparation for a maneuver, the injector pre-valve is opened; however, pressure is not applied to the actuators because the solenoid control valves are closed. When the engine is commanded on, the solenoid control valves are opened, pressure is applied to the actuator, and the rack on the actuator shaft drives a pinion gear to open the fuel and oxidizer valves. When the engine is commanded off, the solenoid control valve vents the actuator and closes the fuel and oxidizer valves.

It is concluded that the leakage was due to a contamination-induced failure of a solenoid control valve. The source of contamination is unknown; however, it was apparently removed from the sealing surface during the valve closure for the first lunar orbit insertion maneuver (fig. 16-2). A highly suspect source is a contaminated facility manifold at the vendor's plant. Although an investigation of the prior failure indicated the flight valve was not contaminated, the facility manifold is still considered a possible source of the contaminants.

Figure 16-2.- Control for service propulsion propellants.

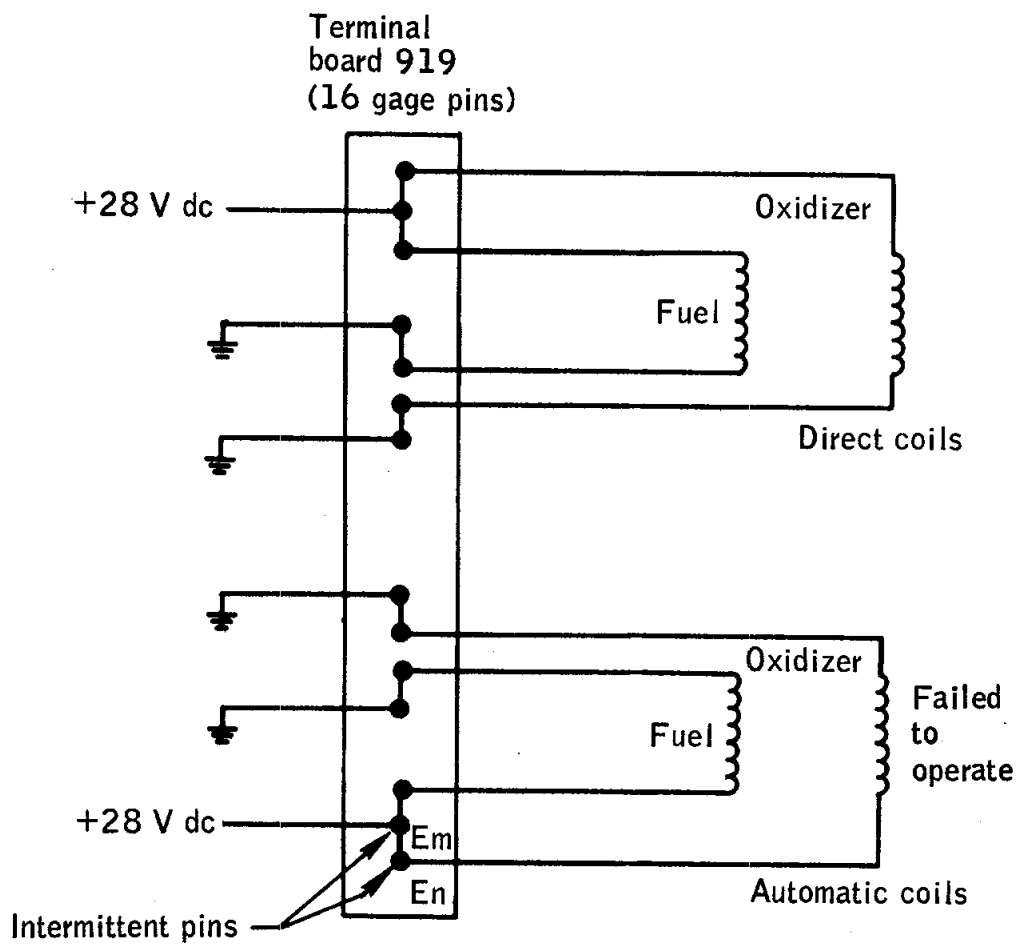
Postflight tests showed that two pins in the terminal board (fig. 16-3) were loose and caused intermittent continuity to the automatic coils of the engine valve. This type failure has previously been noted on terminal boards manufactured prior to November 1967. This board was manufactured in 1966.

Figure 16-3.- Terminal board schematic for minus-yaw engine, command module reaction control system 1.

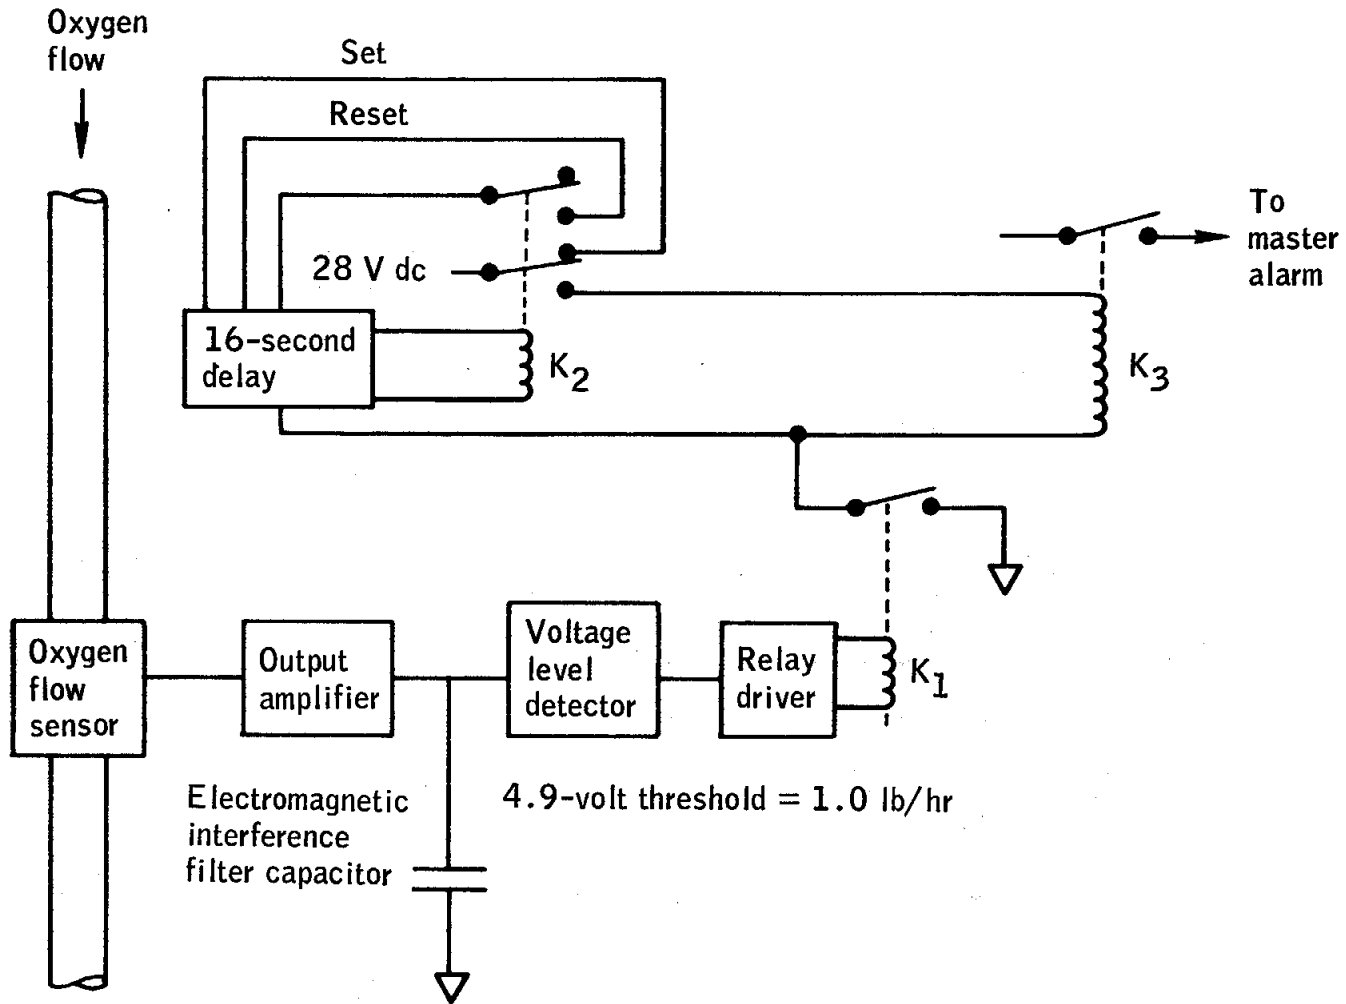
During the initial lunar module pressurization, two master alarms were activated when the oxygen flow rate was decreasing from full-scale. The same condition had been observed several times during altitude-chamber tests and during subsequent troubleshooting. The cause of the problem could not be identified before launch, but the only consequence of the alarms was the nuisance factor. Figure 16-4 shows the basic elements of the oxygen flow sensing circuit.

Note in figure 16-4 that in order for a master alarm to occur, relay K1 must hold in for 16 seconds, after which time relays K2 and K3 will close, activating a master alarm.

Figure 16-4.- Oxygen flow sensing circuit.

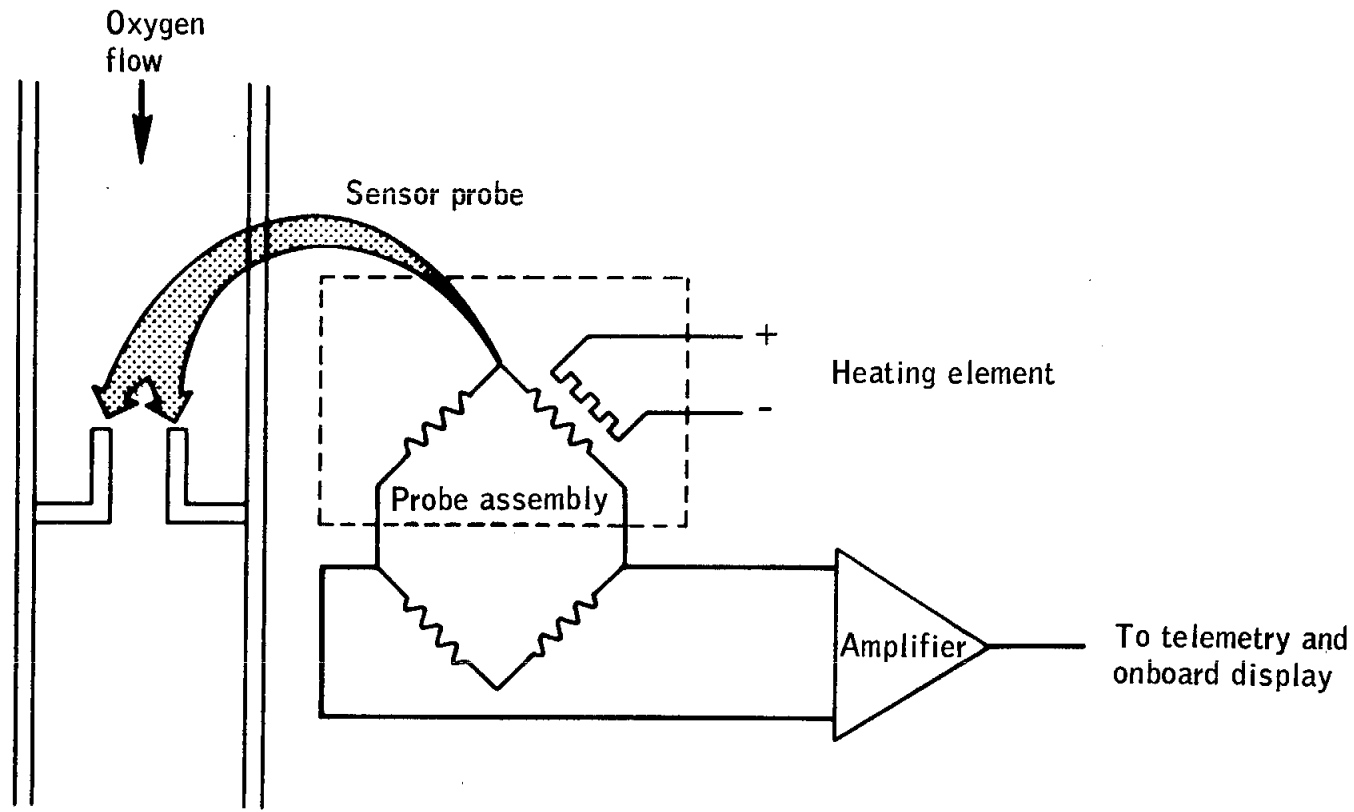
Analysis of associated data indicated that the oxygen flow was normal, but that the indicated flow rate was negatively biased by approximately 1.5 lb/hr. Postflight tests of the transducer confirmed this bias, and the cause was associated with a change in the heater winding resistance within the flow sensor bridge (fig. 16-5). The resistance of the heater had increased from 1000 ohms to 1600 ohms, changing the temperature of the hot wire element which supplies the reference voltage for the balance of the bridge. Further testing to determine the cause of the resistance change is not practical because of the minute size of the potted resistive element. Depotting of the element would destroy available evidence of the cause of failure. Normally, heater resistance changes have occurred early in the 100-hour burn-in period when heater stability is achieved.

Figure 16-5.- Oxygen flow sensor.

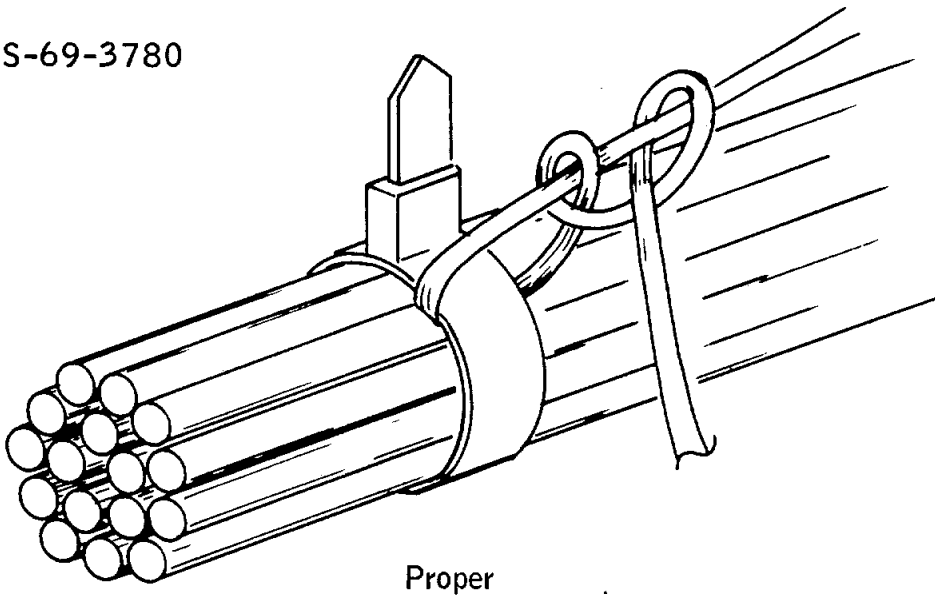
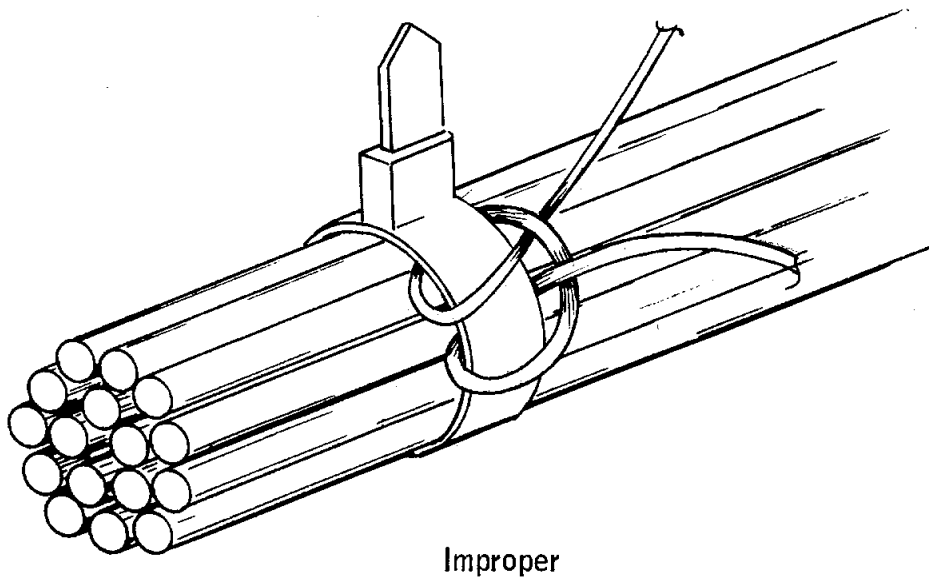
The knots should be two closely tied half-hitches which secure the tie-wrap to the lanyard (fig. 16-6). Examination of the Apollo 10 lanyard indicates that these knots were not two half-hitches but a clove hitch (see figure). After the lanyard breaks the tie-wraps, if the fragment of tie wrap pulls out of the knot, the clove hitch knot can untie, thus lengthening the lanyard. Lengthening this lanyard as the umbilical cable pays out can allow transfer of some loading into the umbilical disconnects. Should a sufficient load be transferred to the disconnect fitting to cause shear pins to fail, a disconnect of the forward heat shield mortar umbilical could result prior to the mortar firing. This would prevent deployment of the forward heat shield separation augmentation parachute, and there would be a possibility of forward heat shield recontact with the command module. Examination of the forward heat shield recovered from Apollo 10 confirmed that the mortar had fired and the parachute was properly deployed.

Figure 16-6.- Tie-wraps on lanyards.

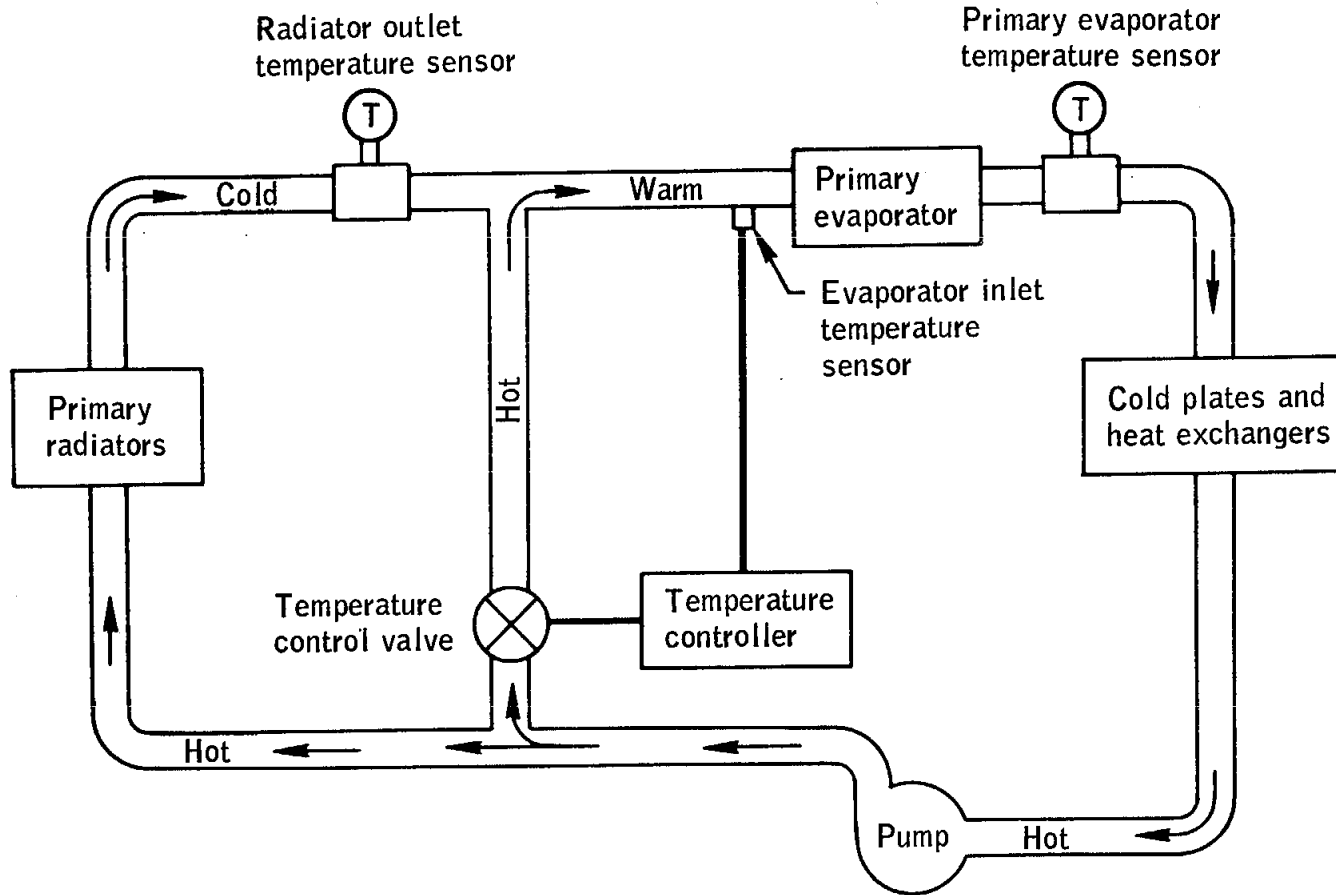
An apparent anomaly exists with the glycol temperature control valve or the related temperature control system. Temperature of the water/glycol entering the evaporator is normally maintained above 42° F by the glycol temperature control valve, which mixes hot water/glycol with water/glycol returning from the radiators (see fig. 16-7). As the radiator outlet temperature decreases, the temperature control valve opens to allow

Figure 16-7.- Primary water glycol coolant loop.

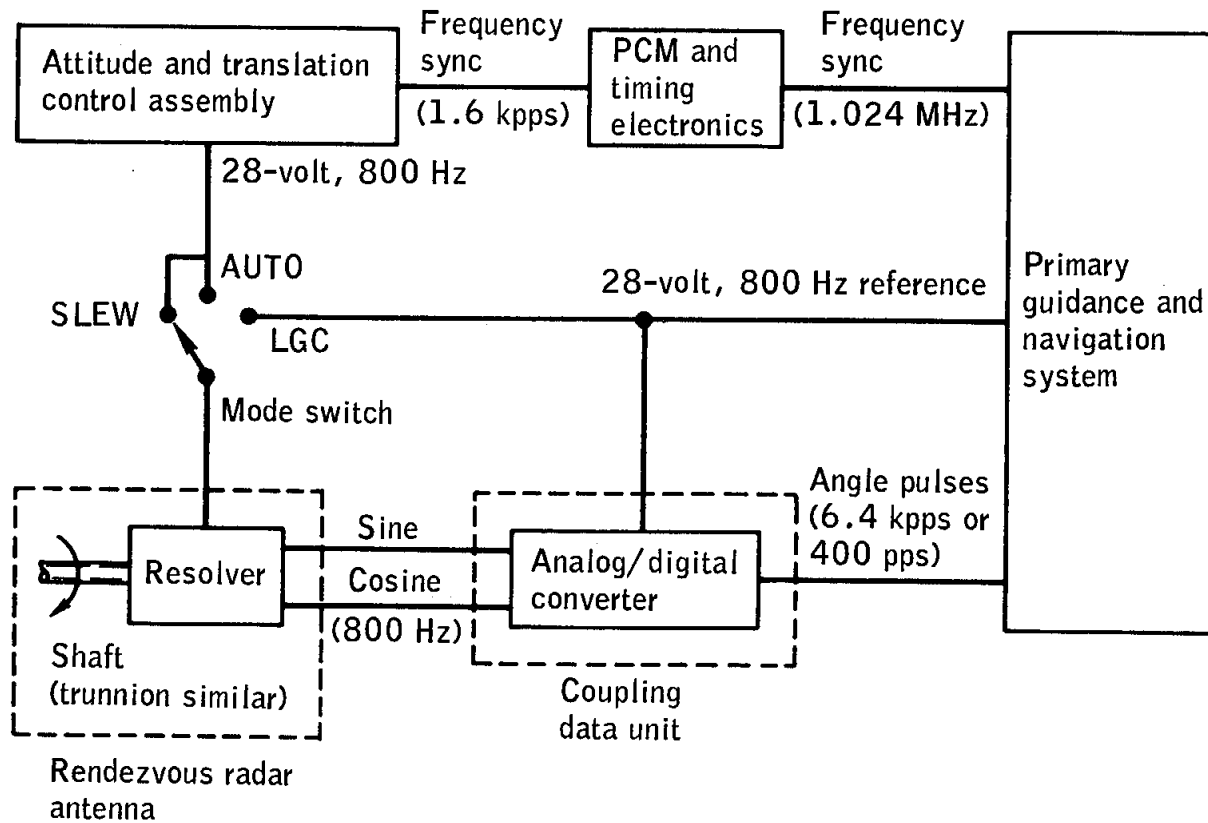
Figure 16-14.- Interfaces from rendezvous radar antenna to primary guidance system.

The alarms were of the Executive overflow type, which signify that the guidance computer cannot accomplish all of the data processing requested in a computation cycle. The alarms indicated that more than 10 percent of the computational capacity of the computer was preempted by unexpected counter interrupts of the type generated by the coupling data units that interface with the rendezvous radar shaft and trunnion resolvers (see fig. 16-14).

The interrupts during the powered descent resulted from the configuration of the rendezvous radar/coupling data unit/computer interface. A schematic of the interface is shown in figure 16-14. When the rendezvous radar mode switch is in the AUTO or SLEW position, the excitation for the radar shaft and trunnion resolvers is supplied by a 28-volt, 800-hertz signal from the attitude and translation control assembly. When the switch is in the LGC position, the positioning of the radar antenna is controlled by the guidance computer, and the resolver excitation is supplied by a 28-volt, 800-hertz source in the primary guidance and navigation system. The output signals of the shaft and trunnion resolvers interface with the coupling data units regardless of the excitation source. The attitude and translation control assembly voltage is locked in frequency with the primary guidance and navigation system voltage through the system's control of the PCM and timing electronics frequency, but it is not locked in phase. When the mode switch is not in LGC, the attitude and translation control assembly voltage is the source for the resolver output signals to the coupling data units while the primary guidance and navigation system 800-hertz voltage is used as a reference voltage in the analog-to-digital conversion portion of the coupling data unit. Any difference in phase or amplitude between the two 800-hertz voltages will cause the coupling data unit to recognize a change in shaft or trunnion position, and the coupling data unit will "slew" (digitally). The "slewing" of the data unit results in the undesirable and continuous transmission of pulses representing incremental angular changes to the computer. The maximum rate for the pulses is 6.4 kpps, and they are processed as counter interrupts. Each pulse received by the computer requires one memory cycle time (11.7 microseconds) to process. If a maximum of 12.8 kpps are received (two radar coupling data units), 15 percent of the available computer time will be spent in processing the radar interrupts. (The computer normally operates at approximately 90 percent of capacity during peak activity of powered descent.) When the capacity of the computer is exceeded, some repetitively scheduled routines will not be completed prior to the start of the next computation cycle. The computer then generates a software restart and displays an Executive overflow alarm.

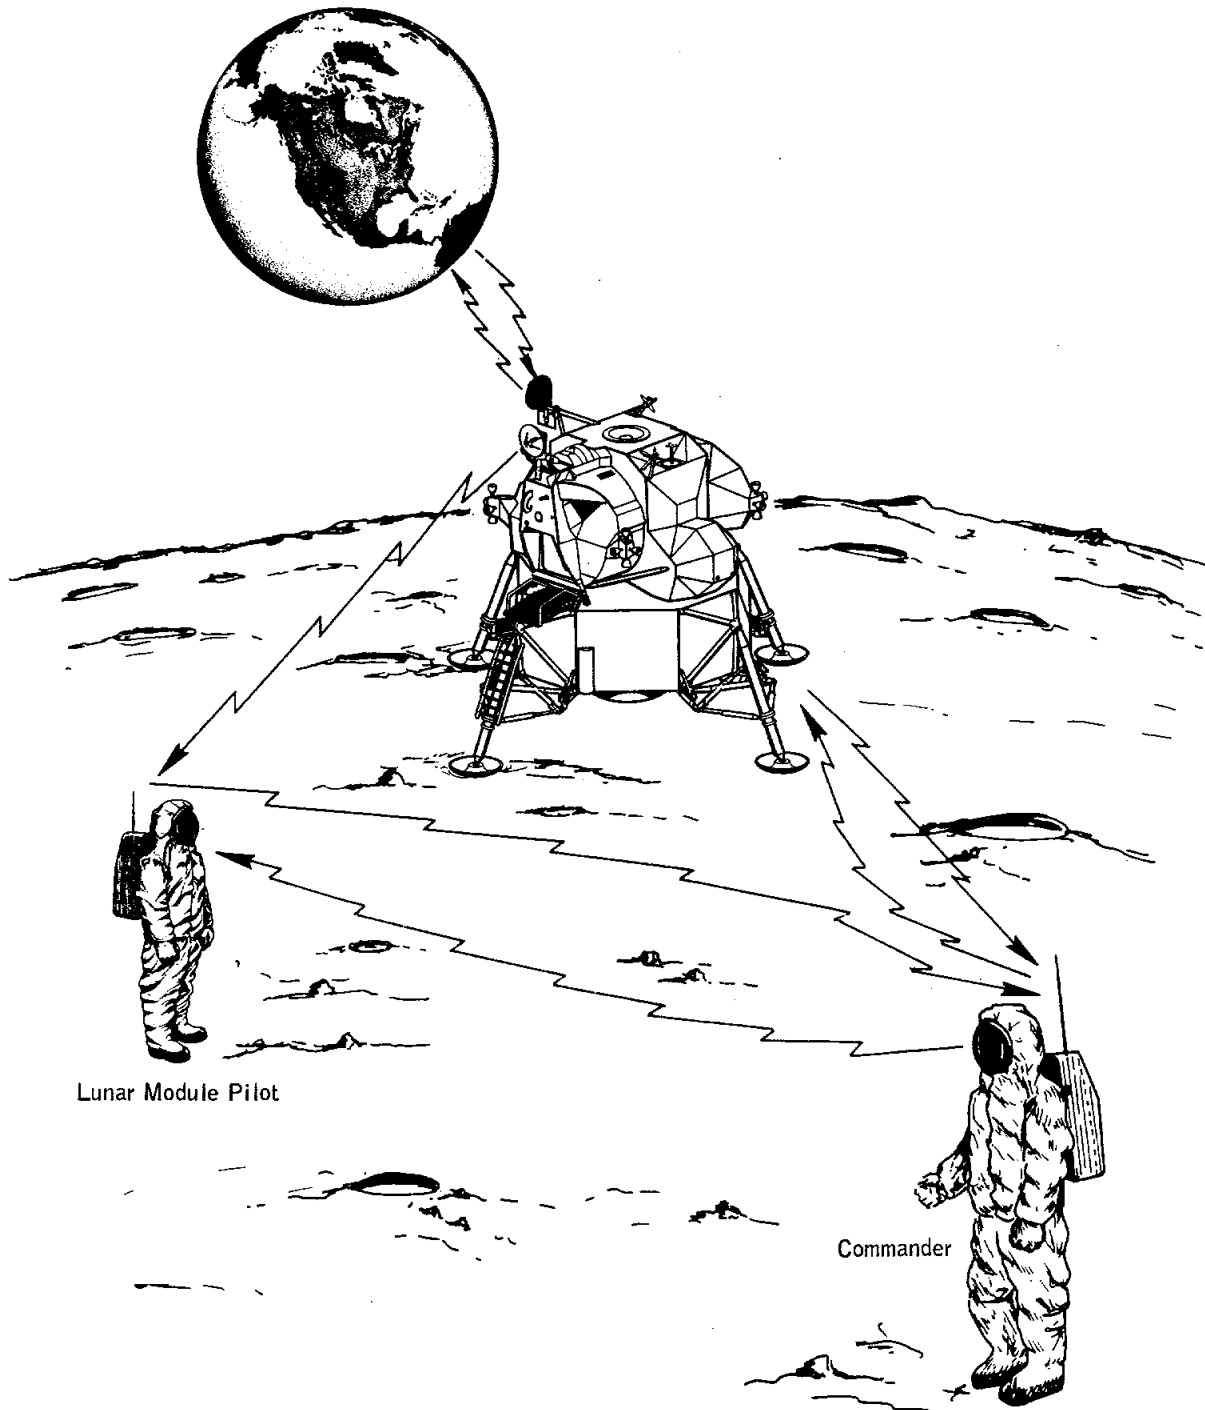
Figure 16-16.- Communications relays during extravehicular activity.

A voice turnaround (echo) was heard during extravehicular activity. At that time, the lunar module was operating in a relay mode. Uplink voice from the S-band was processed and retransmitted to the two extravehicular crewmen via the lunar module VHF transmitter. Crew voice and data were received by the lunar module VHF receiver and relayed to the earth via the lunar module S-band transmitter (see fig. 16-16). The echo was duplicated in the laboratory and resulted from mechanical acoustical coupling between the communications carrier earphone and microphone (fig. 16-17). The crew indicated that their volume controls were set at maximum during the extravehicular activity. This setting would provide a level of approximately plus 16 dBm into each crewman's earphones. Isolation between earphones and microphones, exclusive of air path coupling, is approximately 48 dB. The ground voice signal would therefore appear, at the microphone output, at a level of approximately minus 32 dBm. Assuming extravehicular communication keying is enabled, this signal would be processed and transmitted by the extravehicular communications system and would provide a level of approximately minus 12 dBm at the output of the lunar module VHF receiver. If the lunar module relay is enabled, this signal would be amplified and relayed to earth via S-band at a nominal output level.

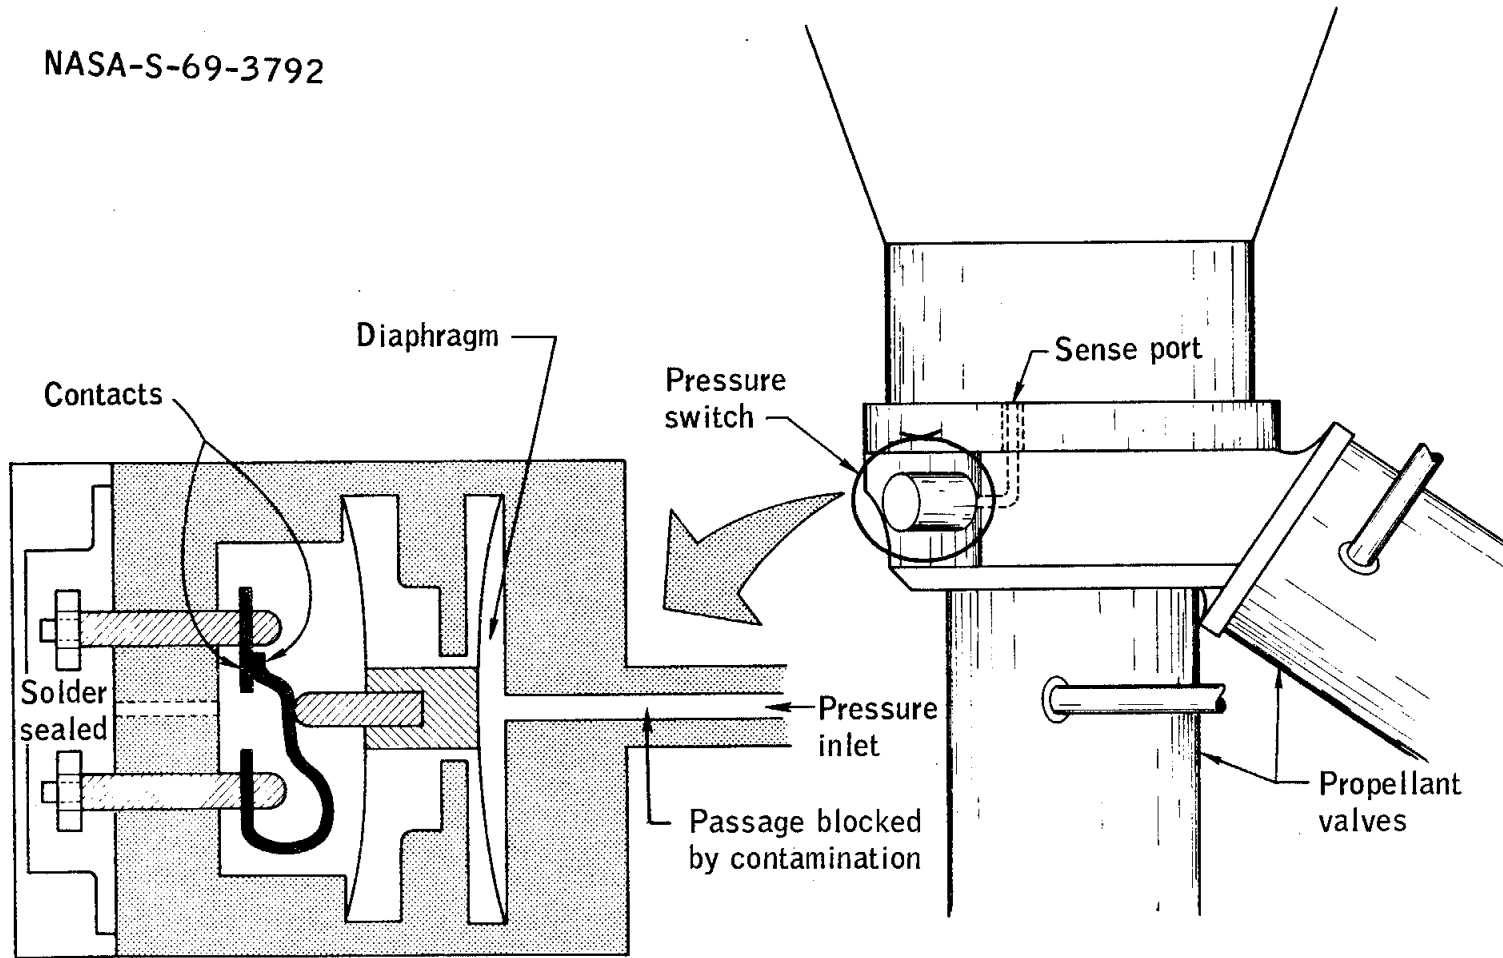
Figure 16-18.- Chamber pressure switch.

The switch used to monitor the quad 2 aft-firing engine (A2A) exhibited slow response to jet driver commands during most of the mission. During an 18-minute period just prior to terminal phase initiation, the switch failed to respond to seven consecutive minimum impulse commands. This resulted in a master alarm and a thruster warning flag, which were reset by the crew. The engine operated normally, and the switch failure had no effect on the mission. The crew did not attempt any investigative procedures to determine whether the engine had actually failed. A section drawing of the switch is shown in figure 16-18.

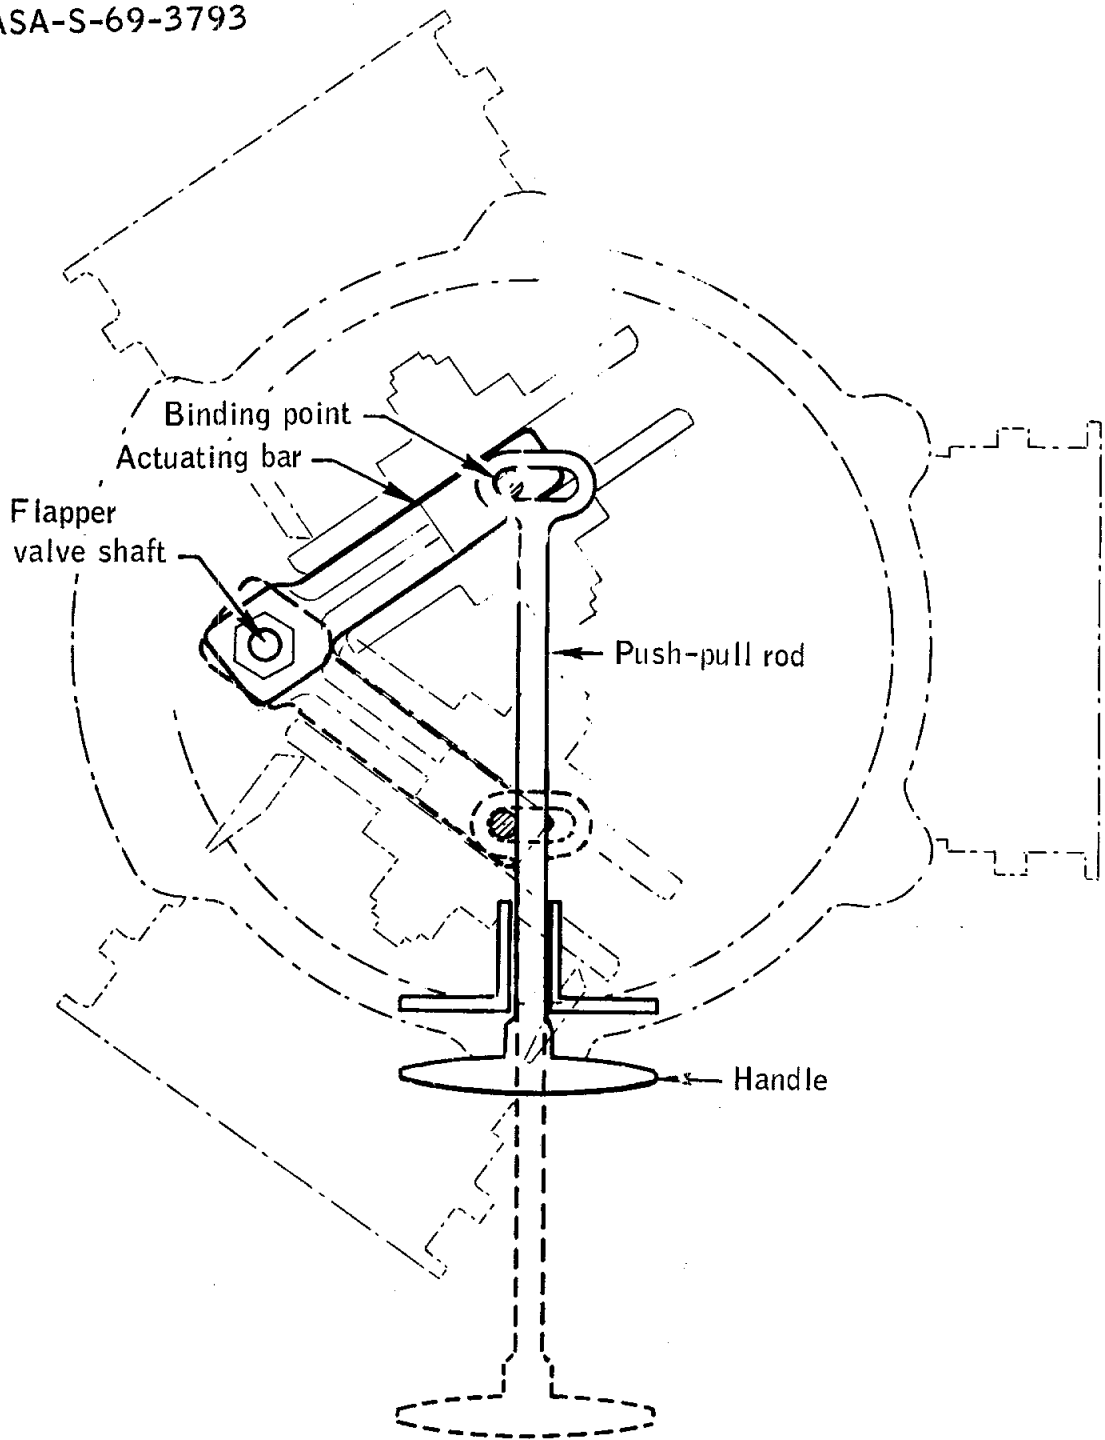
Figure 16-19.- Water separator selector valve.

The flapper type valve is located in a Y-duct arrangement and is used to select one of two water separators. Leakage of this valve would allow free water to bypass through the idle water separator and subsequently enter the suit hose. This leakage most probably resulted from a misalignment and binding in the slot of the selector valve actuation linkage (see fig. 16-19). The allowable actuation force after linkage rigging was 15 pounds. The usual actuation forces have been 7 to 8 pounds, but 12.5 pounds was required on Apollo 11. The allowable actuation force has been lowered to 10 pounds, and inspections for linkage binding have been incorporated into procedures at the factory and the launch site.

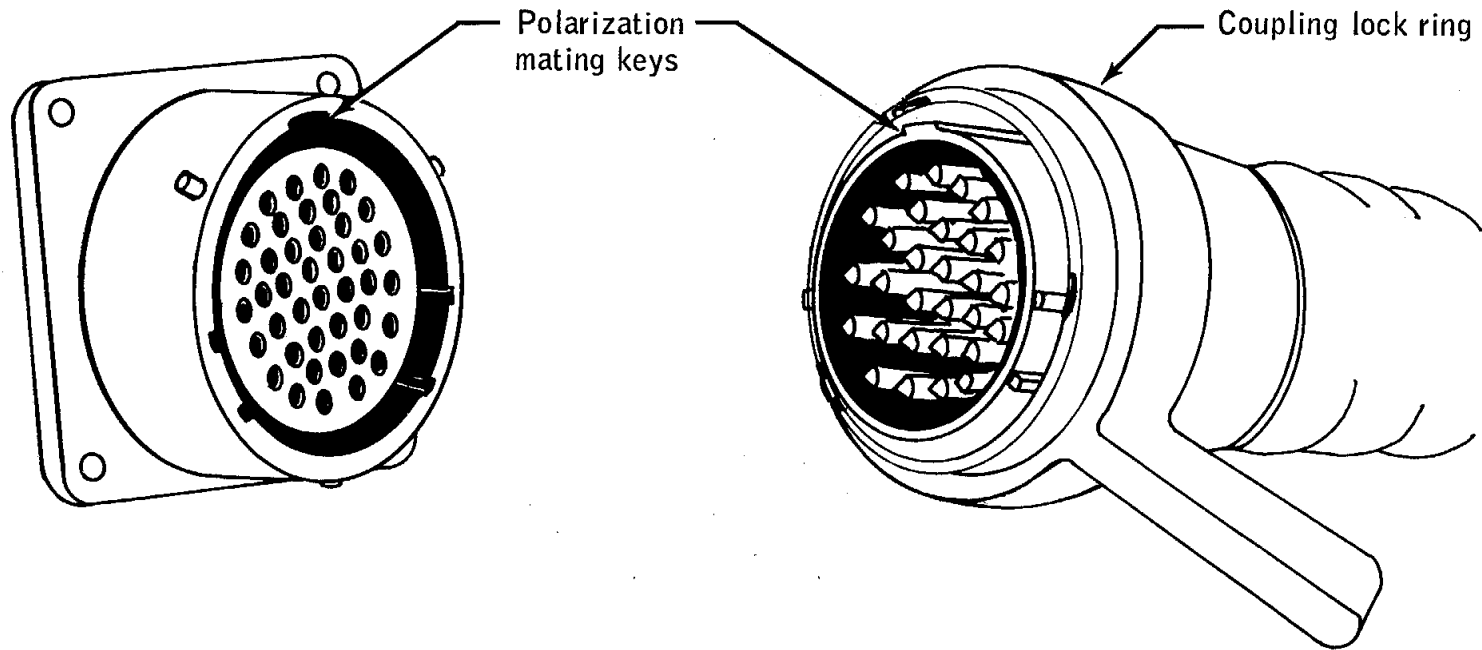
Figure 16-22.- Connector between remote control unit and portable life support system.

During preparation for extravehicular activity, the crew experienced considerable difficulty in mating the electrical connectors from the remote control unit to the portable life support system. For rotational polarization alignment, it was necessary to grasp the cable insulation because the coupling lock ring was free for unlimited rotation on the connector shell (see fig. 16-22).
