## CHAPTER 4

### REVIEW AND ANALYSIS OF APOLLO 13 ACCIDENT

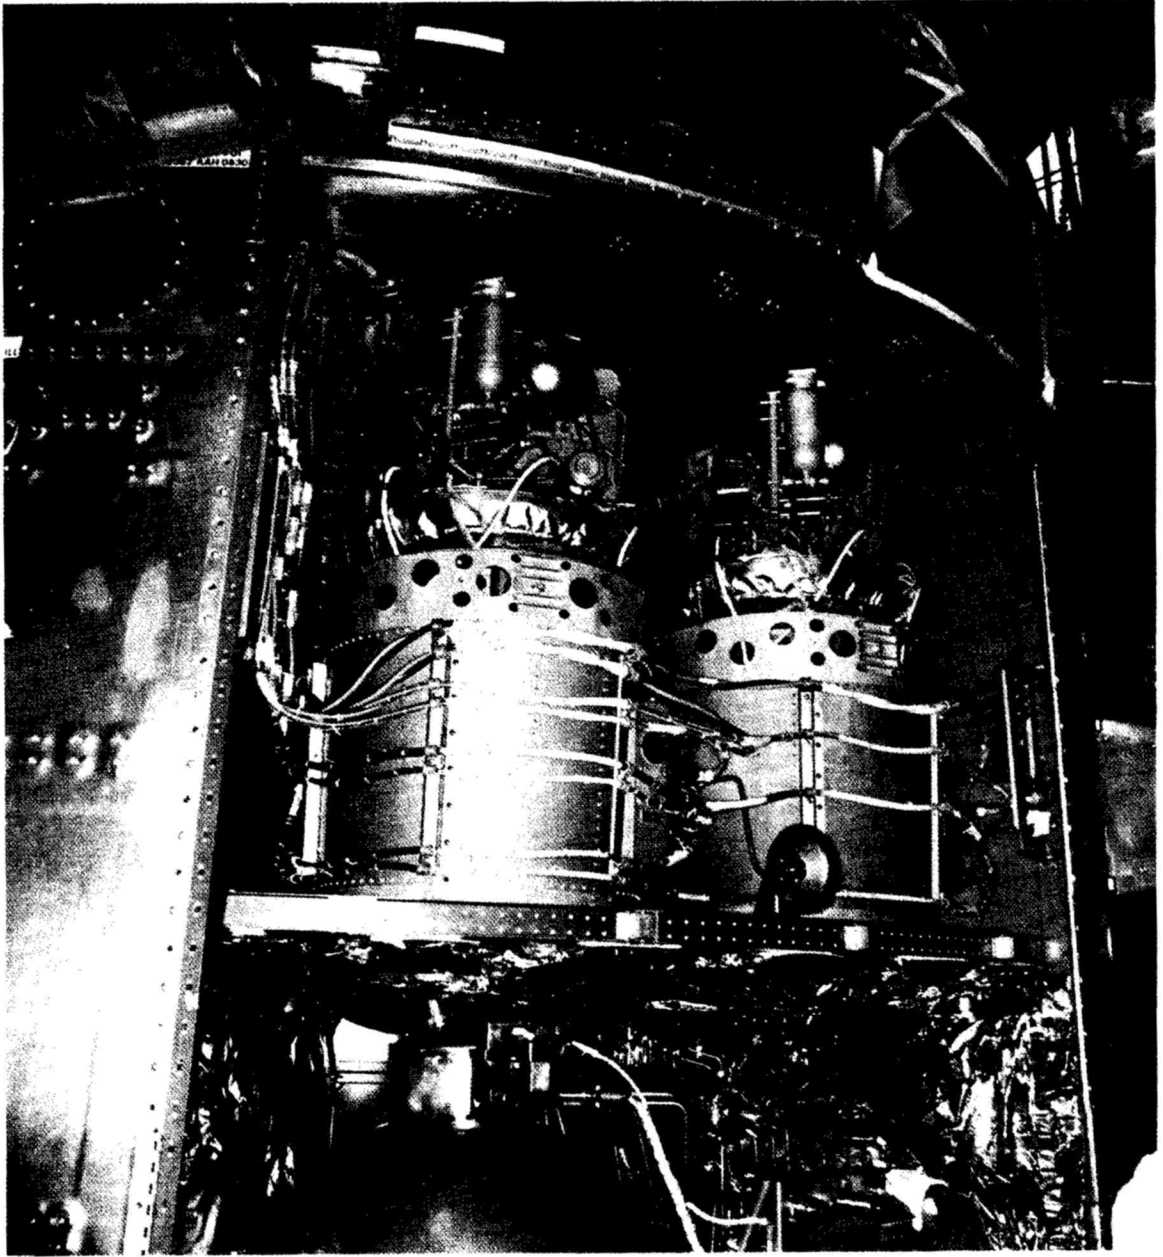
Figure 4-5.- Fuel cells shelf.

of the Apollo 13 service module (SM 109) at the North American Rockwell plant prior to shipment to KSC. Figure 4-5 shows the fuel cell shelf, with fuel cell 1 on the right, fuel cell 3 on the left, and fuel cell 2 behind cells 1 and 3. The top of oxygen tank no. 2 can be seen at the lower left. Figure 4-6 shows the oxygen tank shelf, with oxygen tank no. 2 at left center. Figure 4-7 shows the hydrogen tank shelf with hydrogen tank no. 1 on top and hydrogen tank no. 2 below. The bottom of the oxygen shelf shows some of the oxygen system instrumentation and wiring, largely covered by insulation. Figure 4-8 is a photograph of the bay 4 panel, which was missing from the service module after the accident.

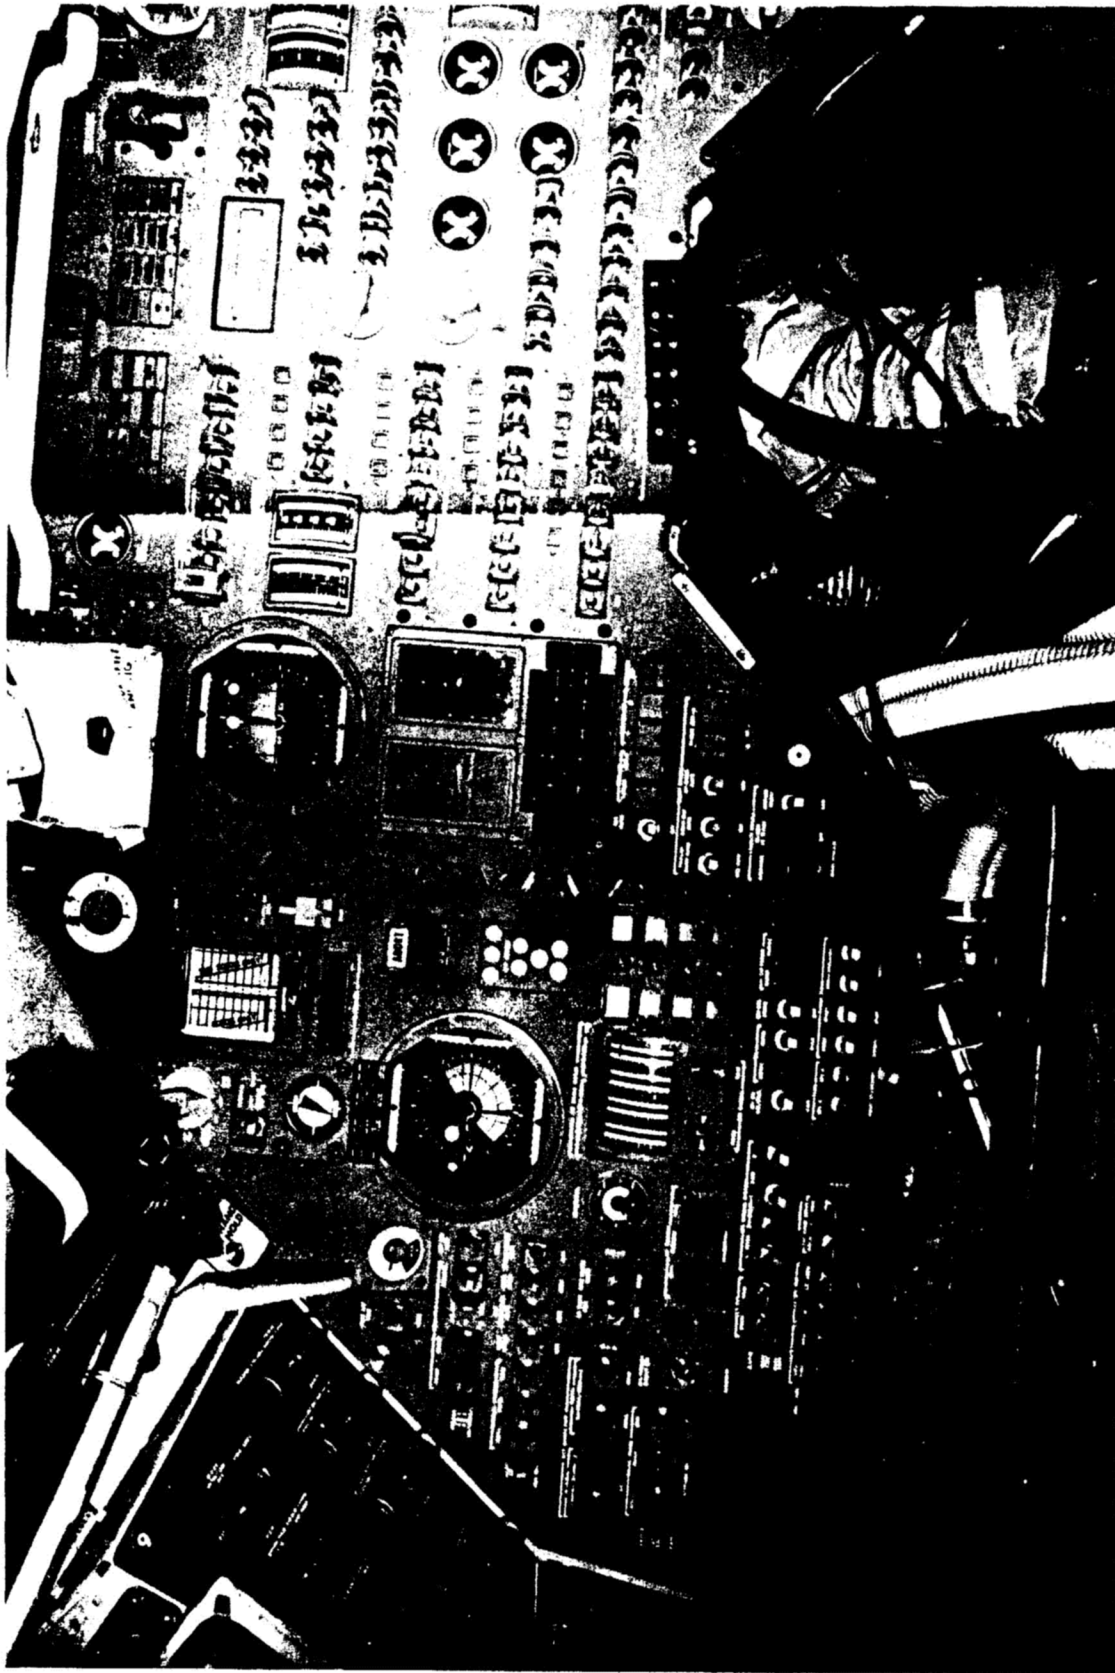
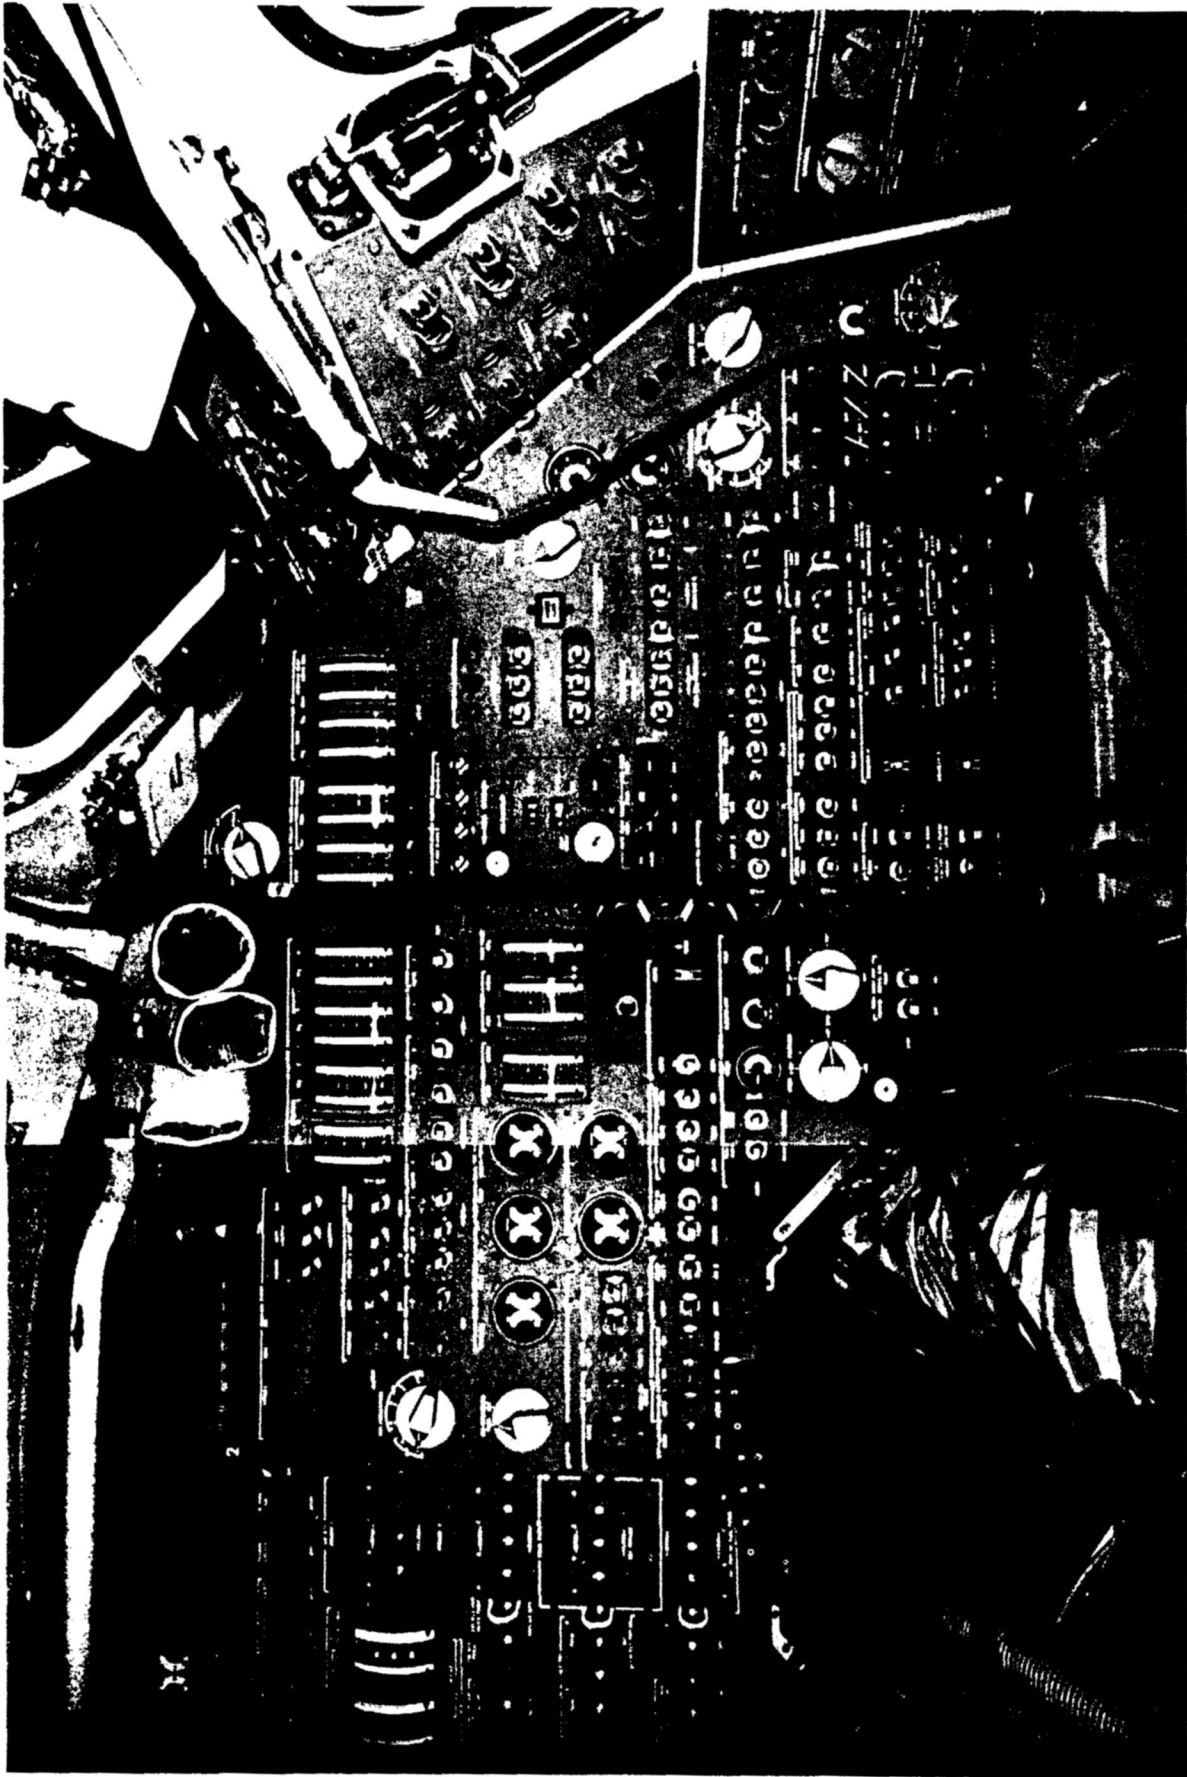
Figure 4-13.- Main display panel.

The Lunar Module Pilot was in the tunnel between the CSM and the LM, returning to the CSM. The Command Module Pilot was in the left-hand couch, monitoring spacecraft performance. Because of the master alarm indicating low voltage, the CMP moved across to the right-hand couch where CSM voltages can be observed. He reported that voltages were "looking good" at 55:56:10. At this time, main bus B had recovered and fuel cell 3 did not fail for another 1-1/2 minutes. He also reported fluctuations in the oxygen tank no. 2 quantity, followed by a return to the off-scale high position. (See fig. 4-13 for CM panel arrangement).

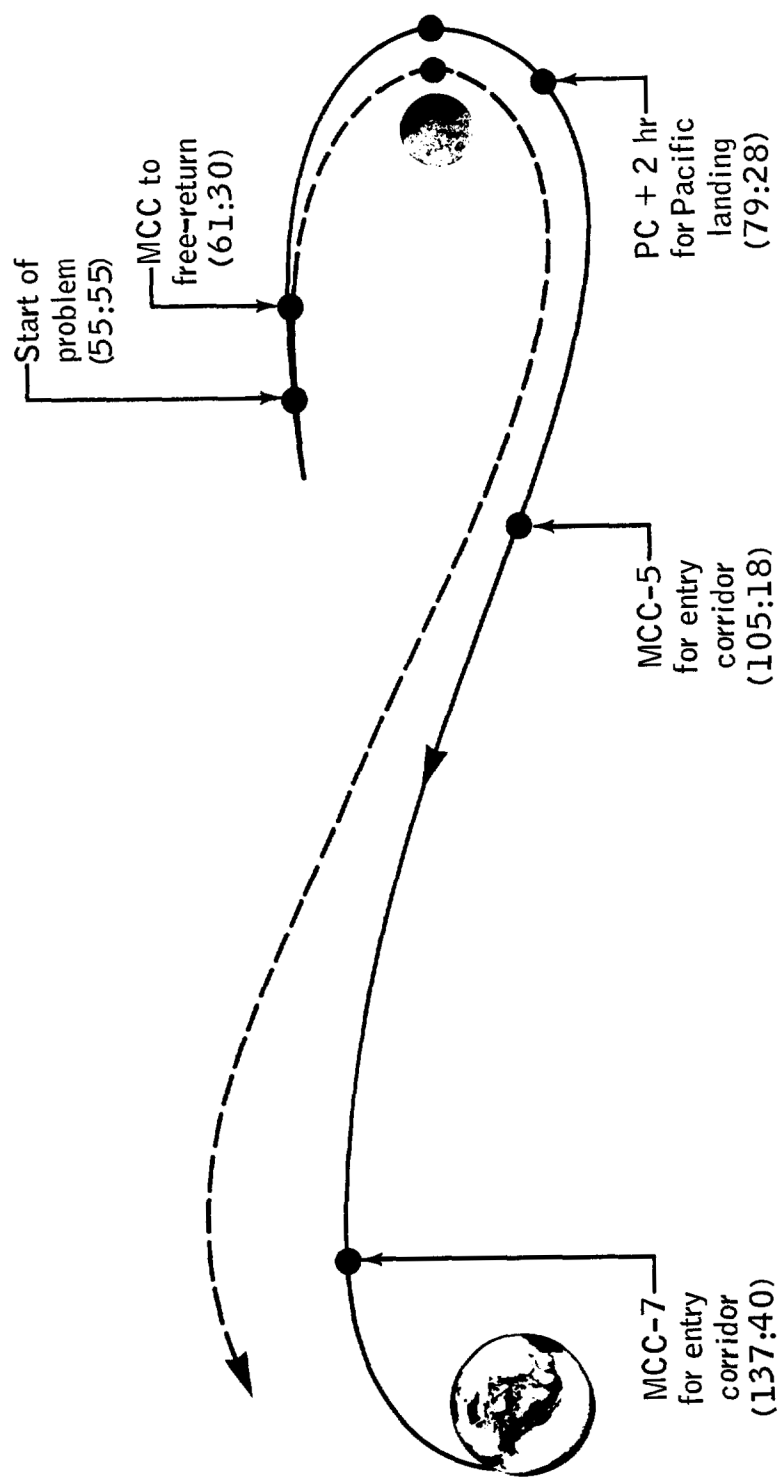
Figure 4-14.- Translunar trajectory phase.

The minimum practical return time was 133 hours g.e.t. to the Atlantic Ocean, and the maximum was 152 hours g.e.t. to the Indian Ocean. Recovery forces were deployed in the Pacific. The return path selected was for splashdown in the Pacific Ocean at 142:40 g.e.t. This required a minimum of two burns of the LM descent engine. A third burn was subsequently made to correct the normal maneuver execution variations in the first two burns. One small velocity adjustment was also made with reaction control system thrusters. All burns were satisfactory. Figures 4-14 and 4-15 depict the flight plan followed from the time of the accident to splashdown.
