# **REPORT OF APOLLO 13 REVIEW BOARD**

**APPENDIX B - REPORT OF MISSION  
EVENTS PANEL**

**APPENDIX B**  
**REPORT OF MISSION EVENTS PANEL**

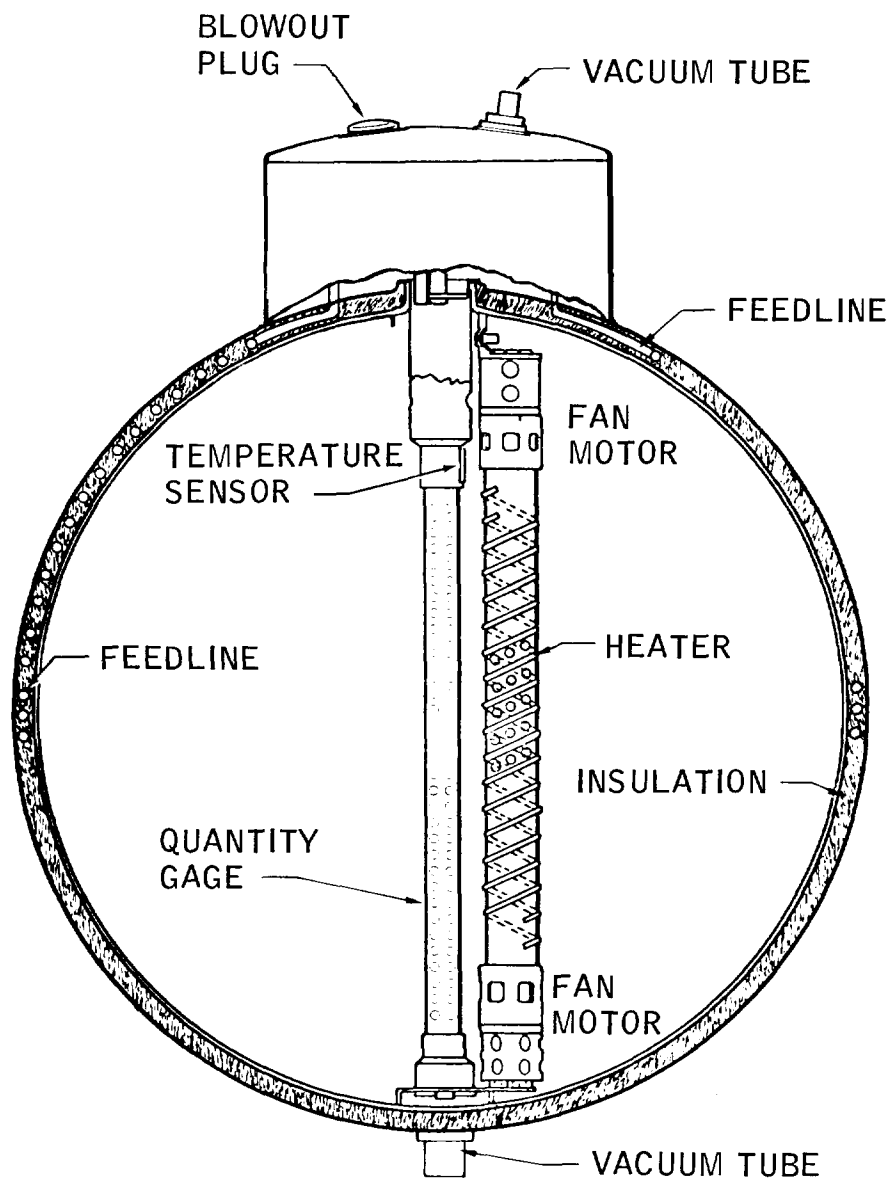
Figure B4-11.- Arrangement of components within oxygen tank.

At 47:40:08 the oxygen quantity changed from approximately 82 percent to 100 percent, or full-scale high. This change in reading or quantity system malfunction occurred just after or at the time the oxygen tank no. 2 fans were turned on. Because of the way the system recovered at the time of the accident, the data indicate that the probe or its associated wiring shorted. Since the instrumentation system was in low bit rate, it is possible to determine exactly when the oxygen

tank no. 1 and no. 2 fans were turned on. The electrical data indicate that the oxygen tank no. 1 and no. 2 fans were turned on between the times of 47:40:05 and 47:40:08. A plot of cryogenic pressures, quantities, total CSM current, and ac main bus 2 is shown in figure B<sup>4</sup>-12. Therefore, the oxygen tank no. 1 and no. 2 fans were turned on in a period of time between 3 seconds prior to the probe malfunction and the time that the probe malfunctioned.

When the oxygen tank no. 2 fans were turned on the next time at 47:54:50, the ac main bus 2 decreased 1.8 volts for one sample (0.1 second). At the same time the TVC command parameters indicated a negative initial transient. Because of the sampling rate (10 samples per second) of the instrumentation system and the small number of fan cycles examined in the high bit rate mode, it cannot be determined if this negative initial transient is characteristic of other fan turnon's or is an indication of a deteriorating fan or wiring.

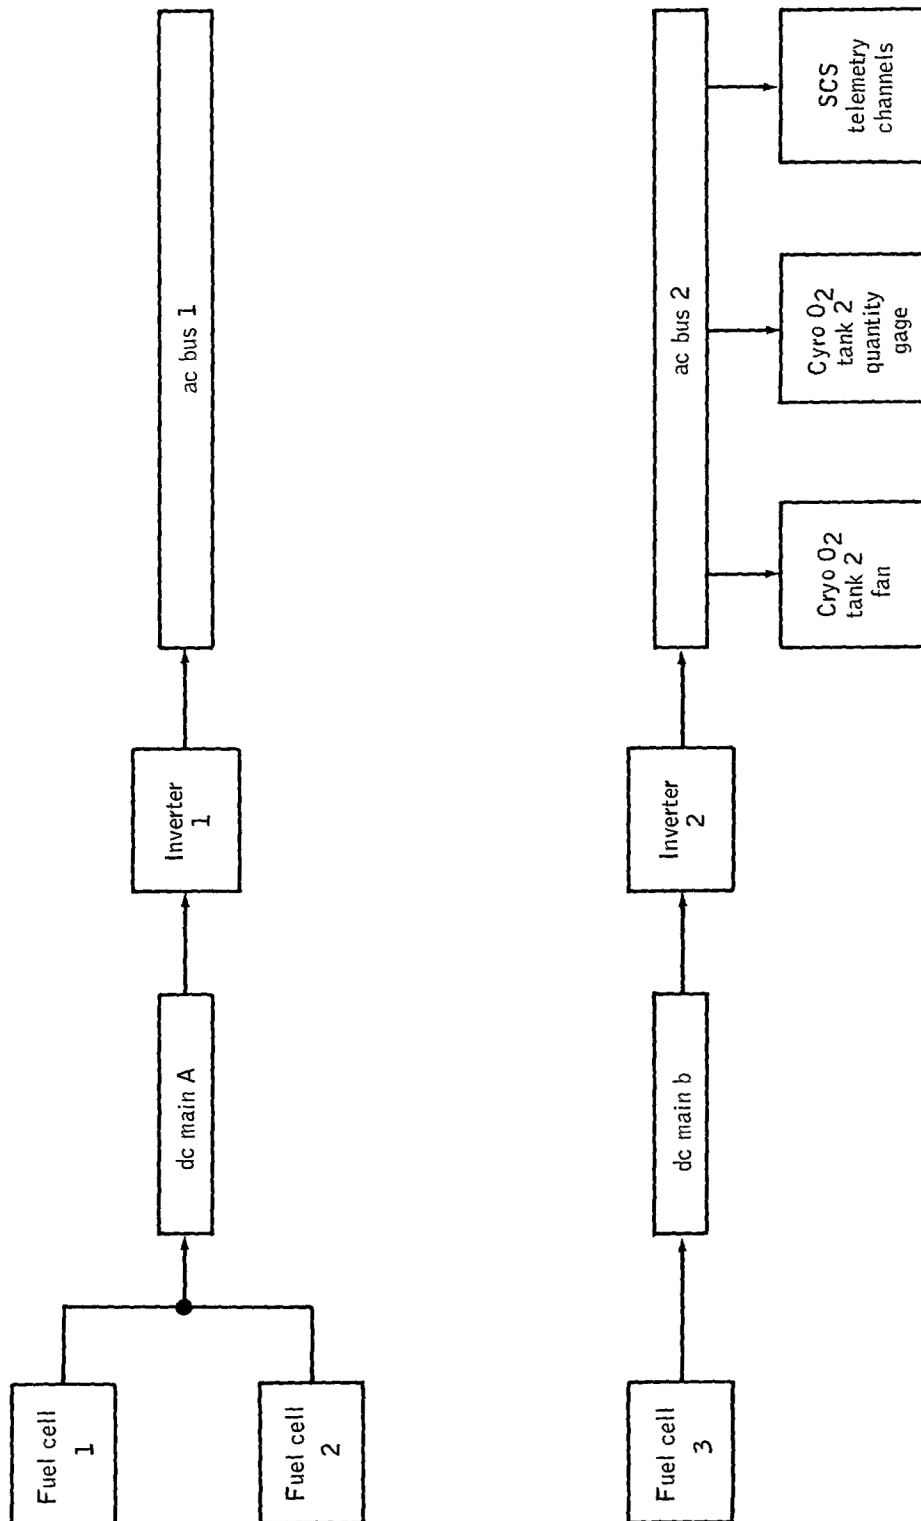
Figure B5-2.- Configuration of electrical power system at 55:53:20.

At 55:53:20 the crew turned on the cryogenic oxygen tank no. 2 fans. An increase in fuel cell current of 1-1/2 amperes, a drop in ac bus 2

The most probable cause of the electrical disturbances between 55:53:22 and 55:53:42 is that a short circuit occurred in the electrical

system of the cryogenic oxygen tank no. 2 fans. The short circuit was sufficiently severe to result in loss of part of the fan load at 55:53:22 and the remainder at 55:53:41. Reduction of the load could have been caused by fuses blowing or by wires opening.

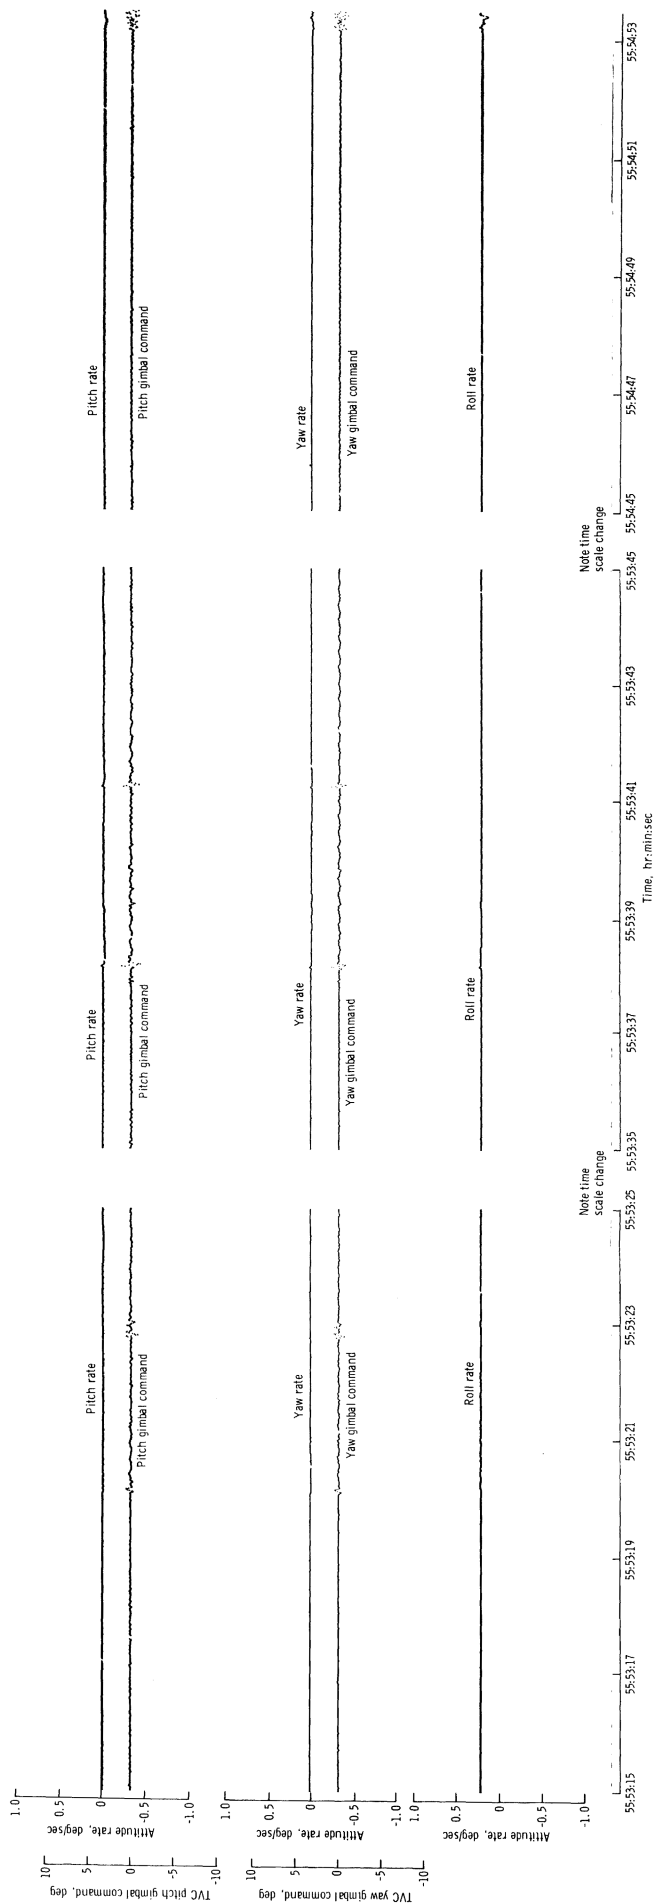
Figure B5-5.- Disturbances observed on thrust vector control gimbal command signals.

voltage of 0.6 volt, and a glitch in the stabilization control system telemetry indicated that the fans had been electrically energized. These events are shown in figures B5-4 and B5-5. However, it is not certain that the fans began rotating at this time, since the tank no. 2 pressure showed a minimum observable drop and the fan motor stall current does not significantly differ from the running current. The quantity gage in tank no. 2 was already in a failed condition, and the fuel cell flowmeters were already being affected by the fan operation in tank no. 1. so that neither of these instruments could positively verify rotation of the fans in tank no. 2. During the next 20 seconds a series of electrical anomalies occurred which cannot be explained as a result of known loads in the spacecraft. These anomalies are shown in figure B5-4. The first, at 55:53:23 was an 11-amp positive spike in the output current of fuel cell 3. Several events were associated with this spike:

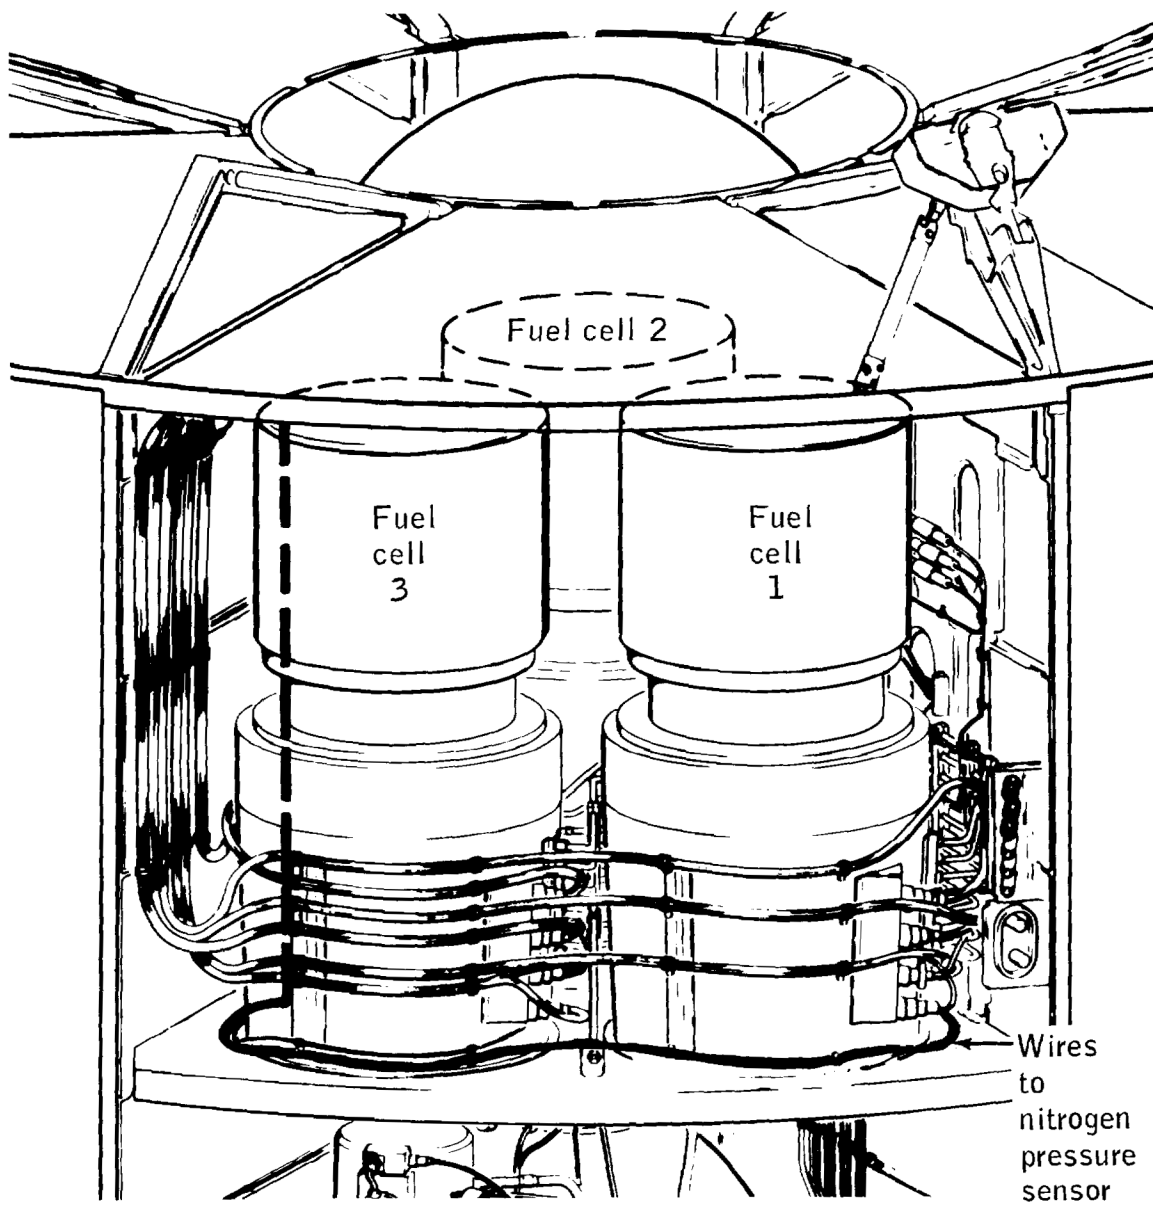
Figure B5-7.- Location of wiring to nitrogen pressure sensor in fuel cell 1.

| <u>Time, g.e.t.</u> | <u>Event</u> |
|---|---|
| 55:54:54.741 | Nitrogen pressure in fuel cell 1 is off-scale low indicating failed sensor. |

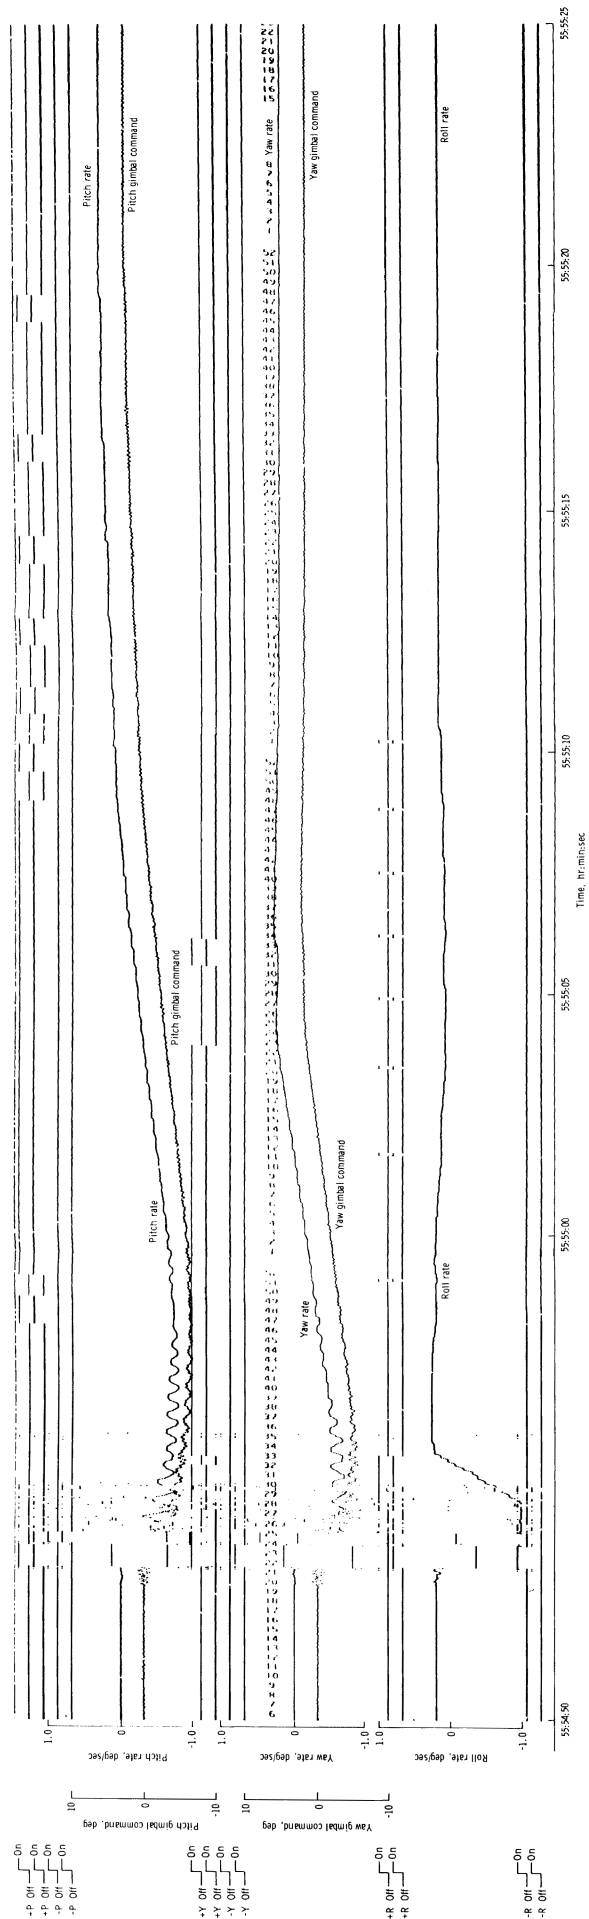
Figure B5-11.- Roll, pitch, and yaw rates.

The roll, pitch, and yaw rates were automatically compensated for by the attitude control system, as shown in figure B5-11.

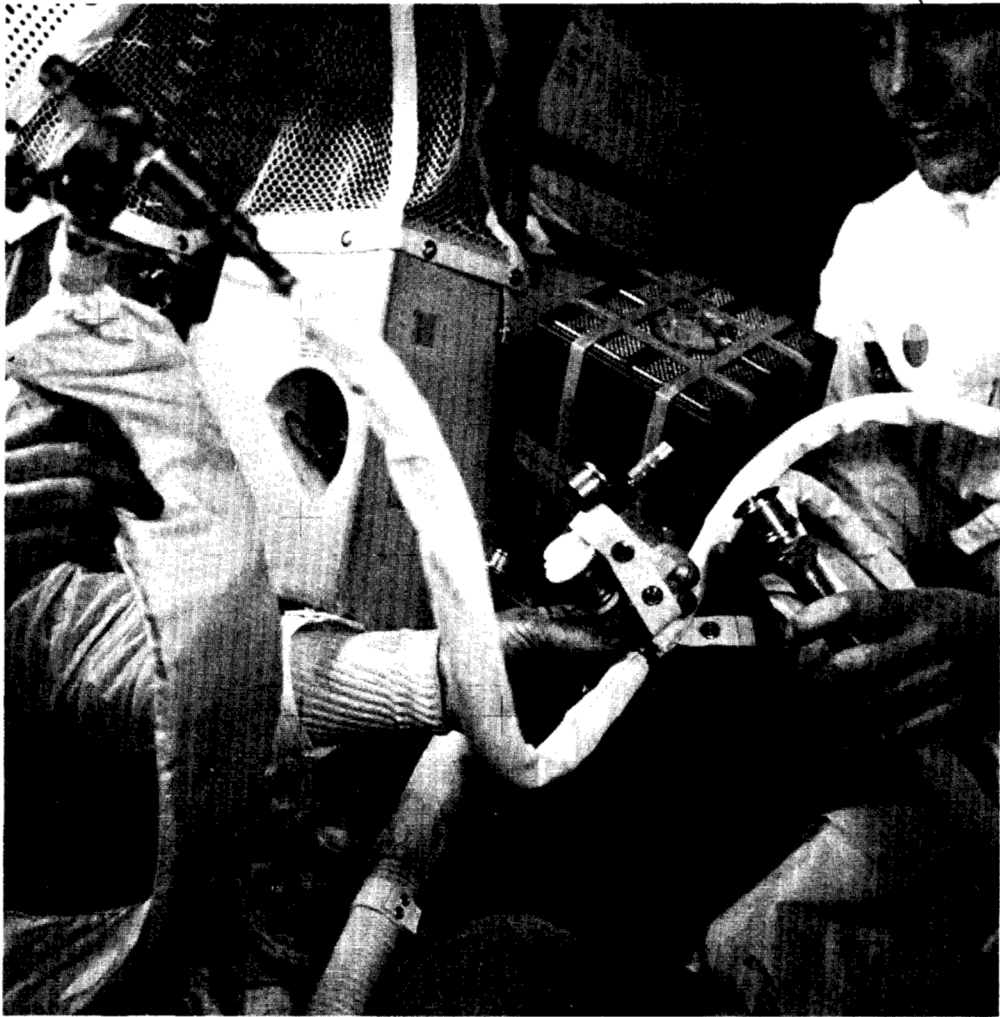
Figure B6-7.- View of CM LiOH cannister modification as installed in the LM.

The problem of removing carbon dioxide from the cabin oxygen was a serious one. The LM, like the CSM, uses lithium hydroxide (LiOH) cartridges to scrub the recirculated oxygen to remove odors and carbon dioxide. The LiOH cartridges are rated for a specified total man-hours capacity, and eventually must be replaced when they become saturated. The LM cartridges were not adequate for carbon dioxide removal for three men for the duration of the Earth-return trip. There were more than adequate cartridges in the CM, but they would not fit in the LM canisters. There were several methods suggested for solving the problem, including powering up the CM system to circulate cabin oxygen through its LiOH canisters. The method that was actually used was developed by Crew Systems Division personnel at MSC. It consisted of using tape, flight data file cards, and plastic bag material to connect the CM LiOH canisters to the LM oxygen circulation system. The crew implemented the modification and it worked very well. The partial pressure of carbon dioxide reading indicated by the onboard gage dropped rapidly from 8mm Hg to 0.1mm Hg soon after the rig was completed at 94 hours g.e.t. The modification was not tried until this time in order to get maximum use from the LM cartridges. About 20 hours later, the carbon dioxide partial pressure reading had increased to 1.8mm Hg, and a procedure for putting two additional cartridges in series to those in the CM canisters was given to the crew. This procedure was also developed by engineers at MSC (fig. B6-7). After this second modification was completed, the carbon dioxide partial pressure remained below 2mm Hg for the rest of the mission, without any further modifications necessary.

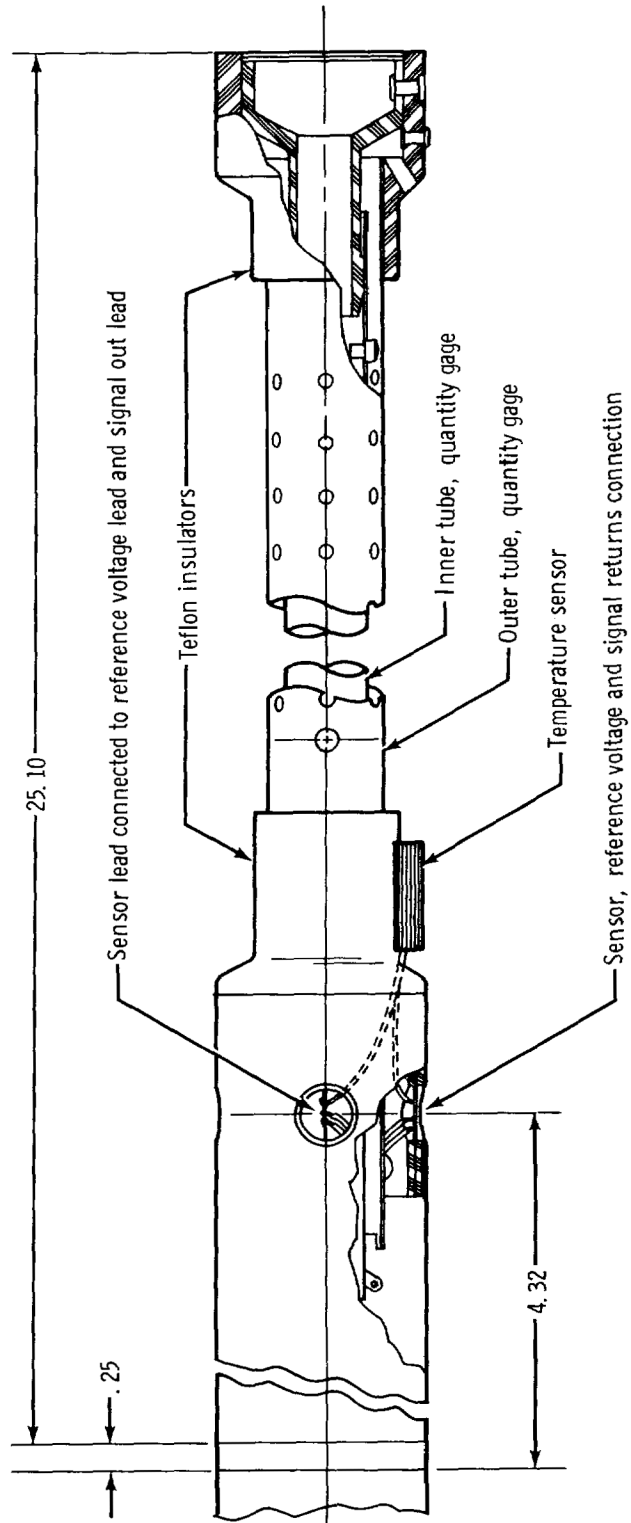
Figure B7-1. - Oxygen quantity gage and temperature sensor location.

The temperature measurement is made with a platinum resistance thermometer (R/T) encased in an Inconel sheath attached to the Teflon insulator part of the quantity probe (fig. B7-1). The resistance of the R/T and the transducer output voltage increase with temperature. The signal conditioner which serves as a reference voltage generator and amplifier is located on the oxygen tank shelf. An electrical schematic of the transducer is shown in figure B7-2.

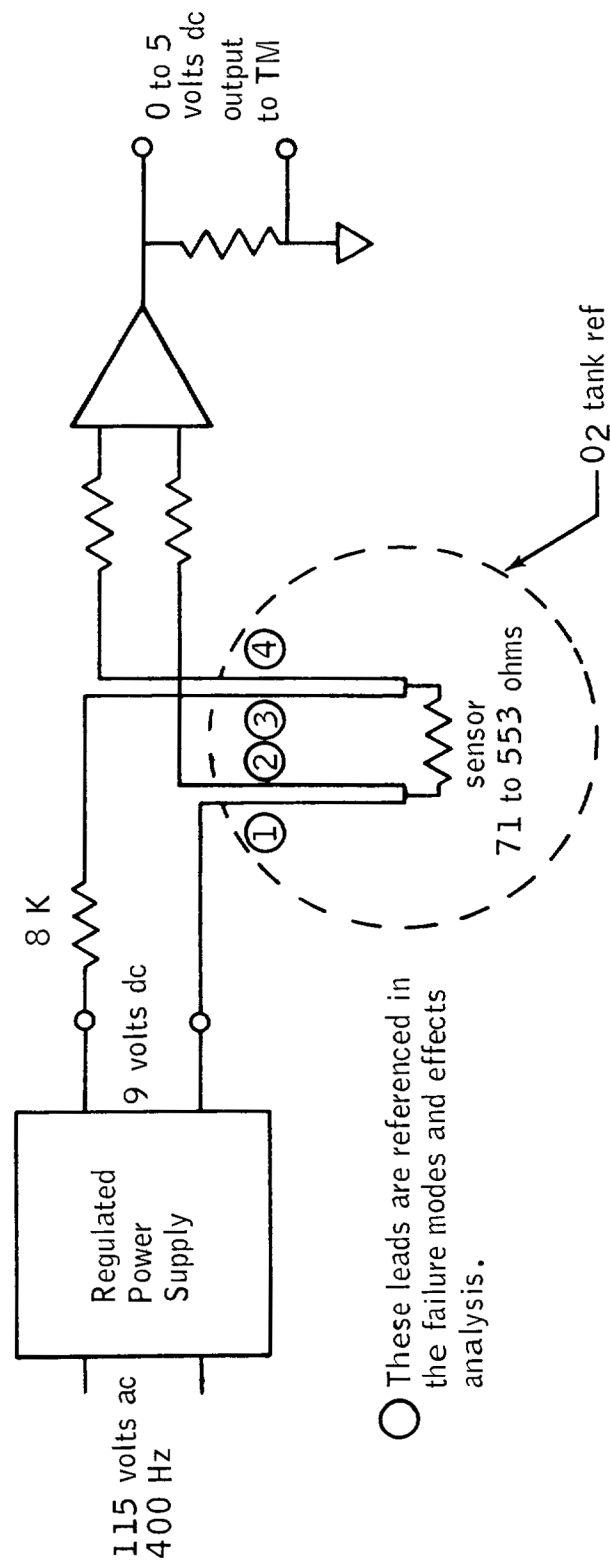
Figure B7-2.- Oxygen tank temperatures sensing circuit.

○ These leads are referenced in the failure modes and effects analysis.

Telemetry would indicate the temperature of the sensor itself, but under rapidly changing conditions the sensor could remain almost unaffected by local temperature changes in other parts of the tank. The effect of various failure modes on the transducer and its output signal are presented in table B7-I.

| Failure mode | Indication | Resulting damage |
|---|---|---|
| Any one of leads 1, 3, or 4 broken (open) (fig. B7-2) | Zero output | No circuit damage |

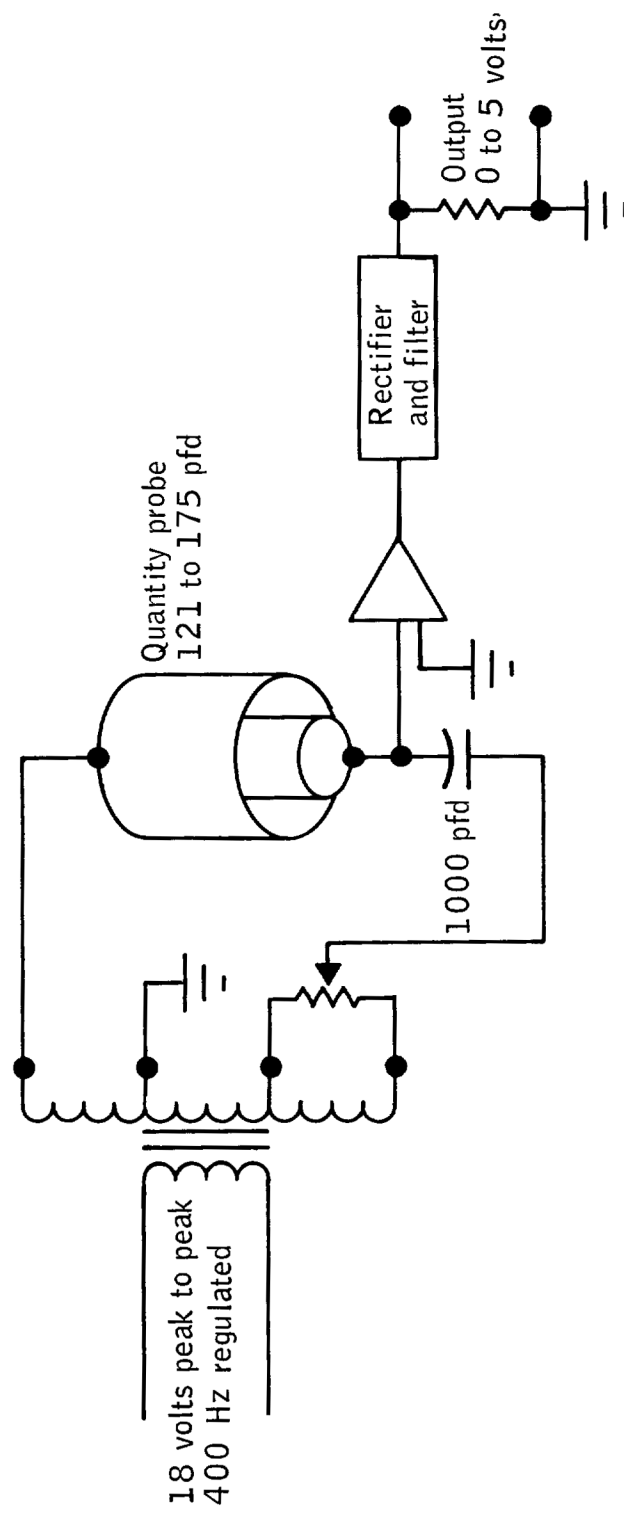
Figure B7-3.- Oxygen quantity gage block diagram.

This method of gaging works well for single-phase fluids in any gravity environment so long as the fluid is uniformly mixed with no significant density variations. But under zero-g, density and temperature variations can exist in the fluid, especially when heat is added without any fluid movement (convection). Under these conditions, the gage measures the average density of the oxygen between the two tubes which may or may not be representative of the average density in the tank.

If the gage is either opened or shorted, the signal conditioner is overdriven and a greater-than-100-percent quantity is indicated. Other malfunction characteristics follow.
