APPENDIX C
REPORT OF MANUFACTURING
AND TEST PANEL

TASK ASSIGNMENT AND IMPLEMENTATION

PART C-4

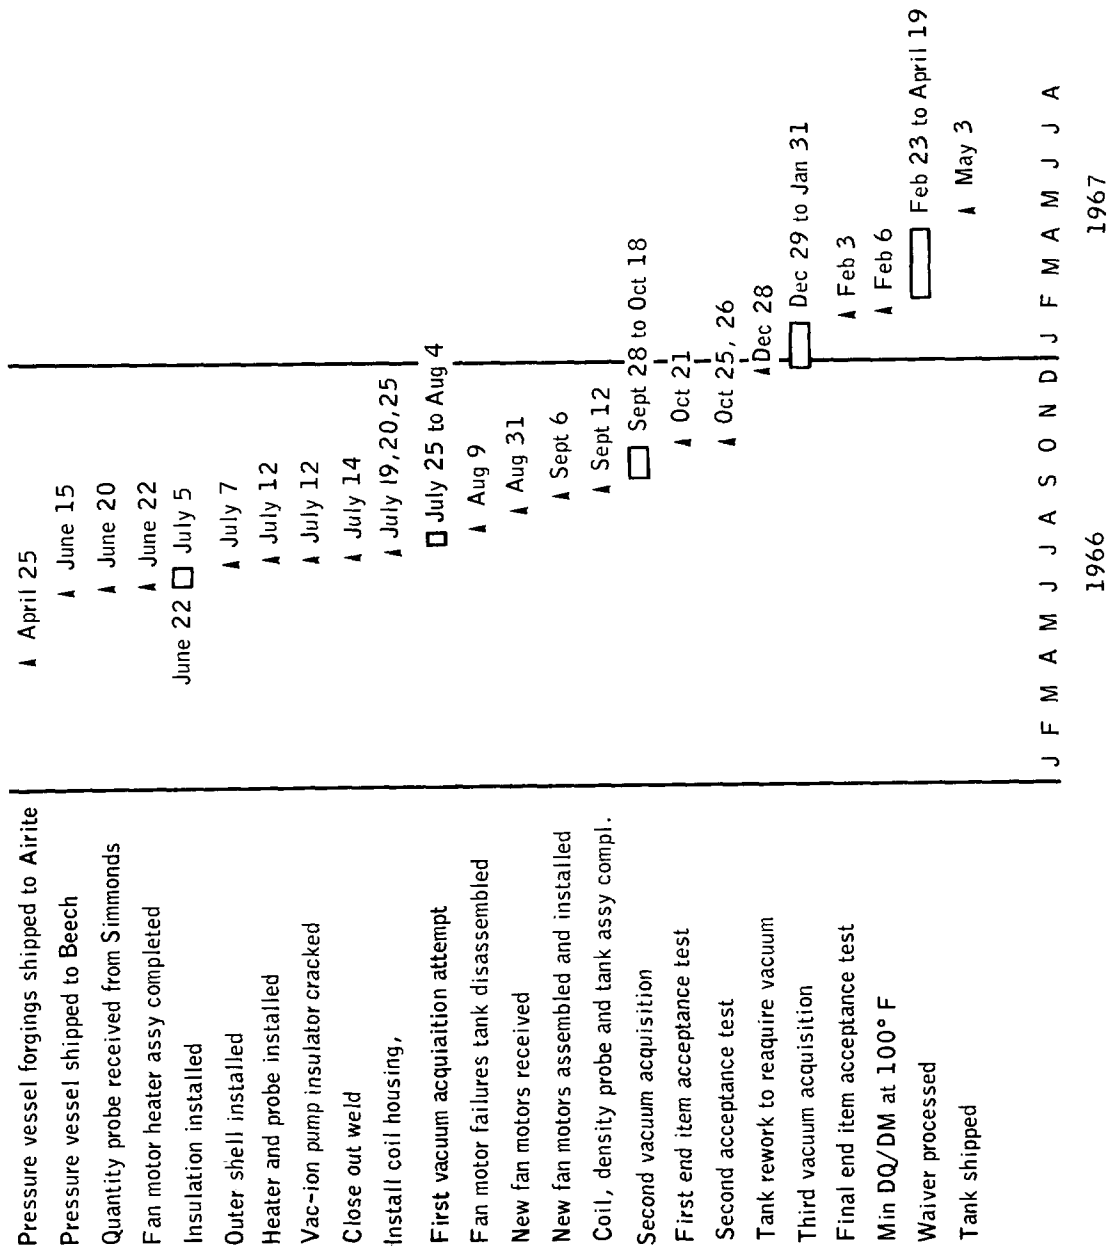
The manufacturing and test flow for cryogenic oxygen storage tank serial no. 10024XTA0008 is shown in figure C4-48. The item of particular significance is the recycle that was required in the manufacturing process brought on by motor failures.

Figure C4-48.- Manufacturing and test flow for the oxygen tank at Beech.

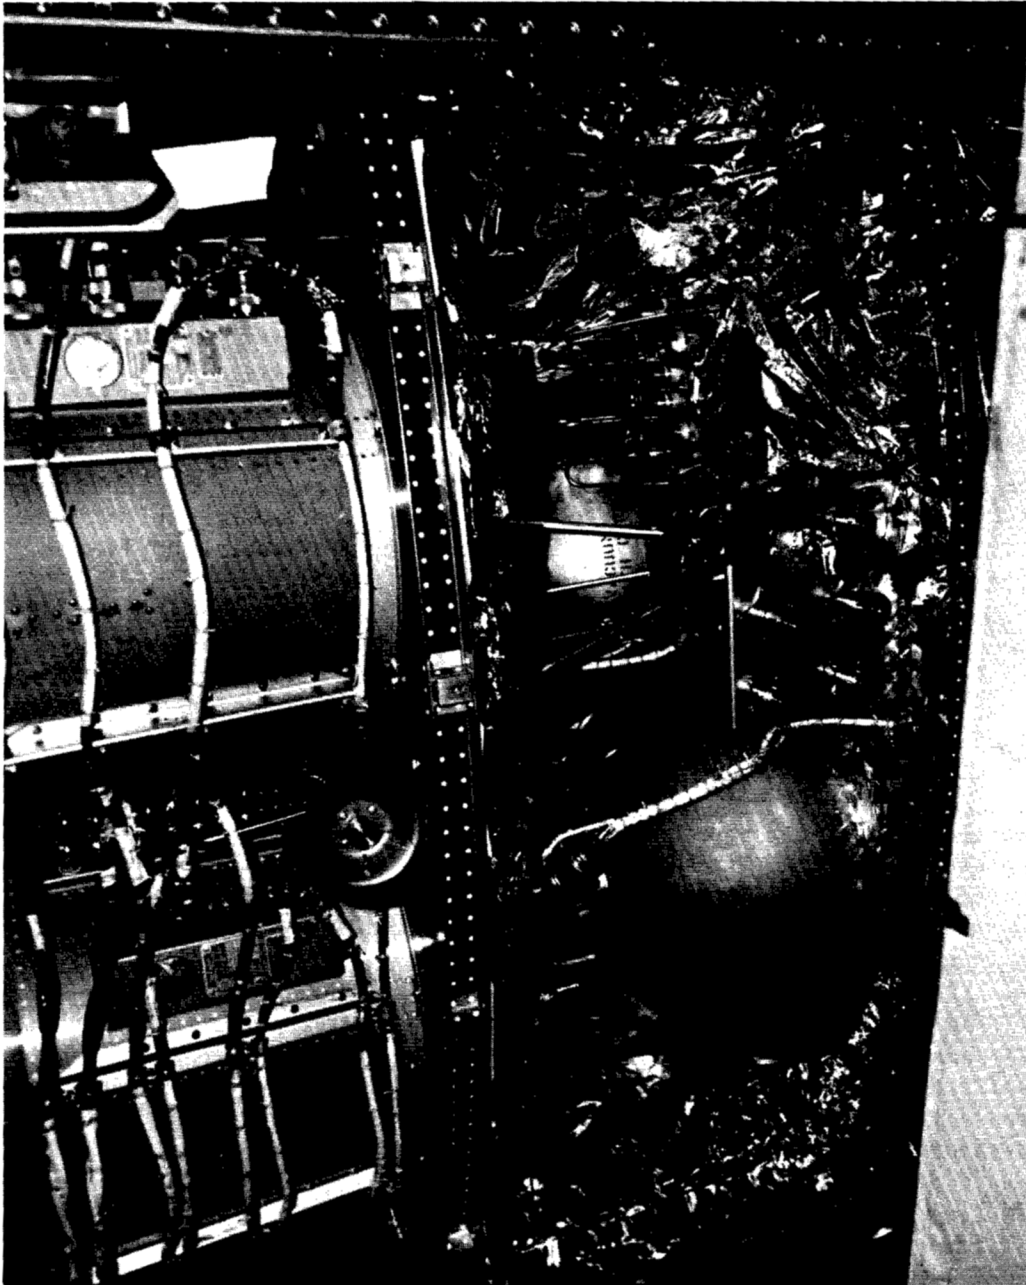
A progress photograph (fig. C4-57) taken at KSC on November 14, 1969, shows the visible condition of the oxygen shelf with tanks, valves, tubing, and cables.

Figure C4-57.- Progress photograph of oxygen shelf taken at KSC
November 14, 1969

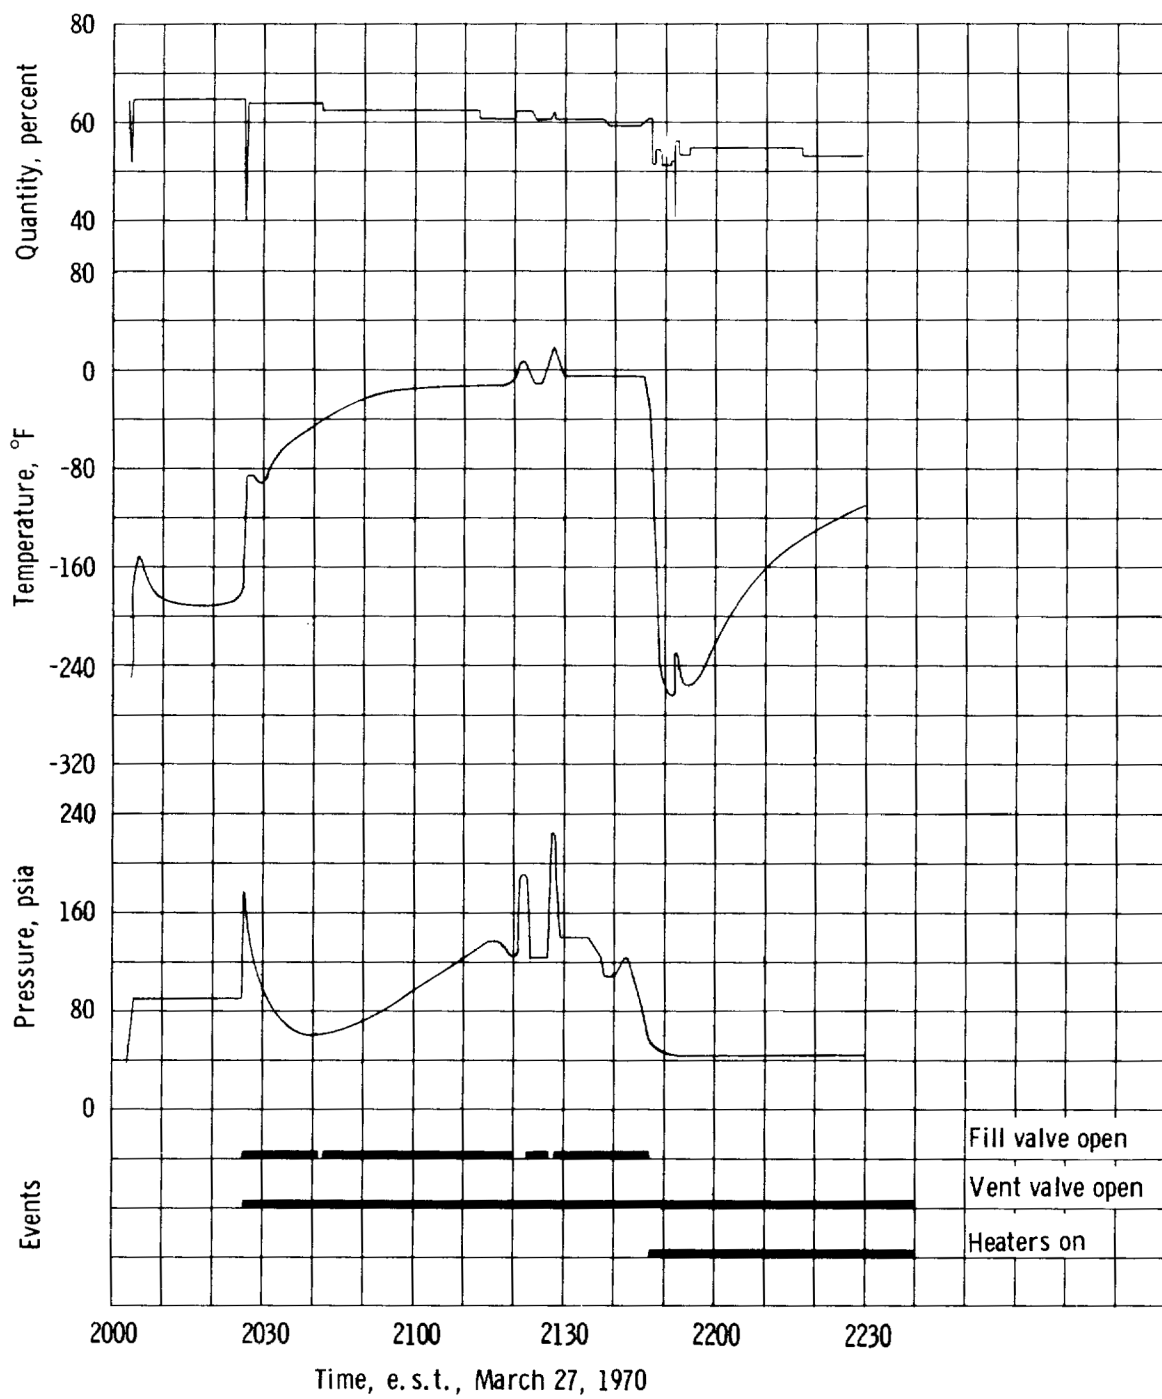
Attempts were made over an 80-minute period to deplete the oxygen content of tank no. 2 by cycling up to various pressures and down, but did not reduce the indicated quantity below 54 percent (fig. C4-59). An attempt was made to expedite oxygen expulsion through the use of the tank heaters operated at maximum voltage and the fans. These were turned on for nearly 6 hours while the vent port remained open (fig. C4-60). Still the indicated quantity remained above 30 percent.

Figure C4-59.- Oxygen detanking attempt using varying purge pressure.

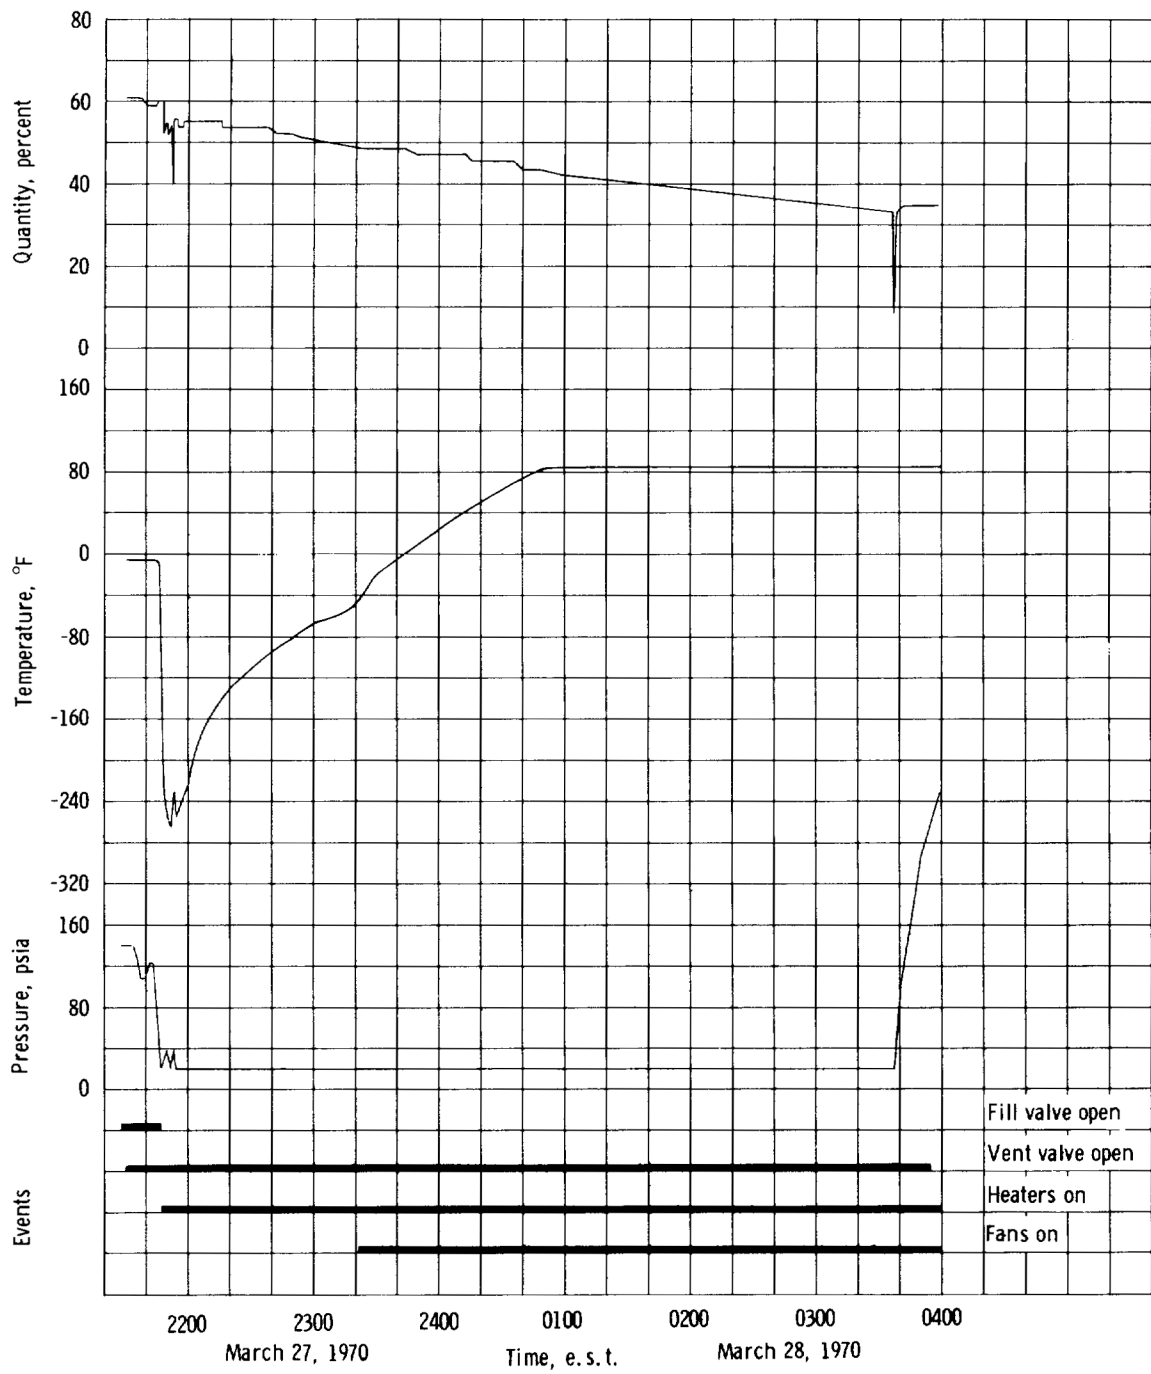
Figure C4-60.- Oxygen detanking attempt using tank heaters.

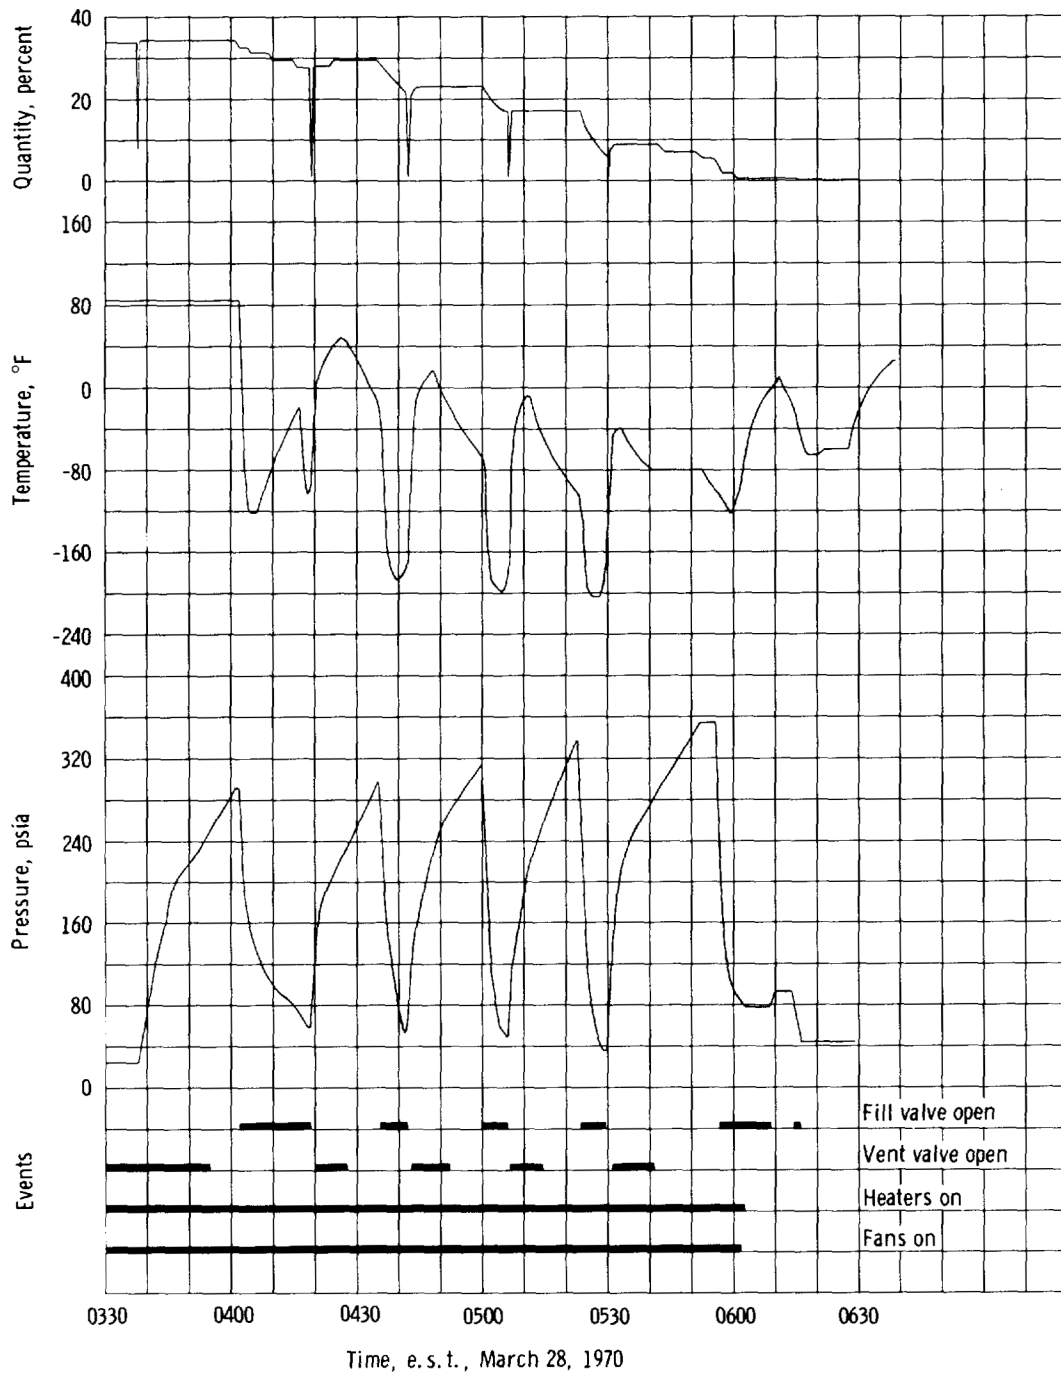
Then a pressure cycling technique was employed over a 2-1/2 hour period with maximum power being applied continuously to both tank heaters and fan circuits (fig. C4-61). This technique involved raising the tank pressure by external gaseous oxygen to approximately 300 psia and then opening the fill line to induce rapid boil-off. After five cycles, the oxygen tank quantity indicated zero.

Fan responses were observed to be normal throughout these operations. The temperature sensor on the quantity probe reached its indicating limit (+84° F) halfway through the 6-hour heating period. No observations of whether the heaters cycled on and off were made and subsequent review of the power supply voltage recording showed no indication of heater cycling.

Figure C4-61.- Oxygen detanking using pressure cycles and tank heaters.

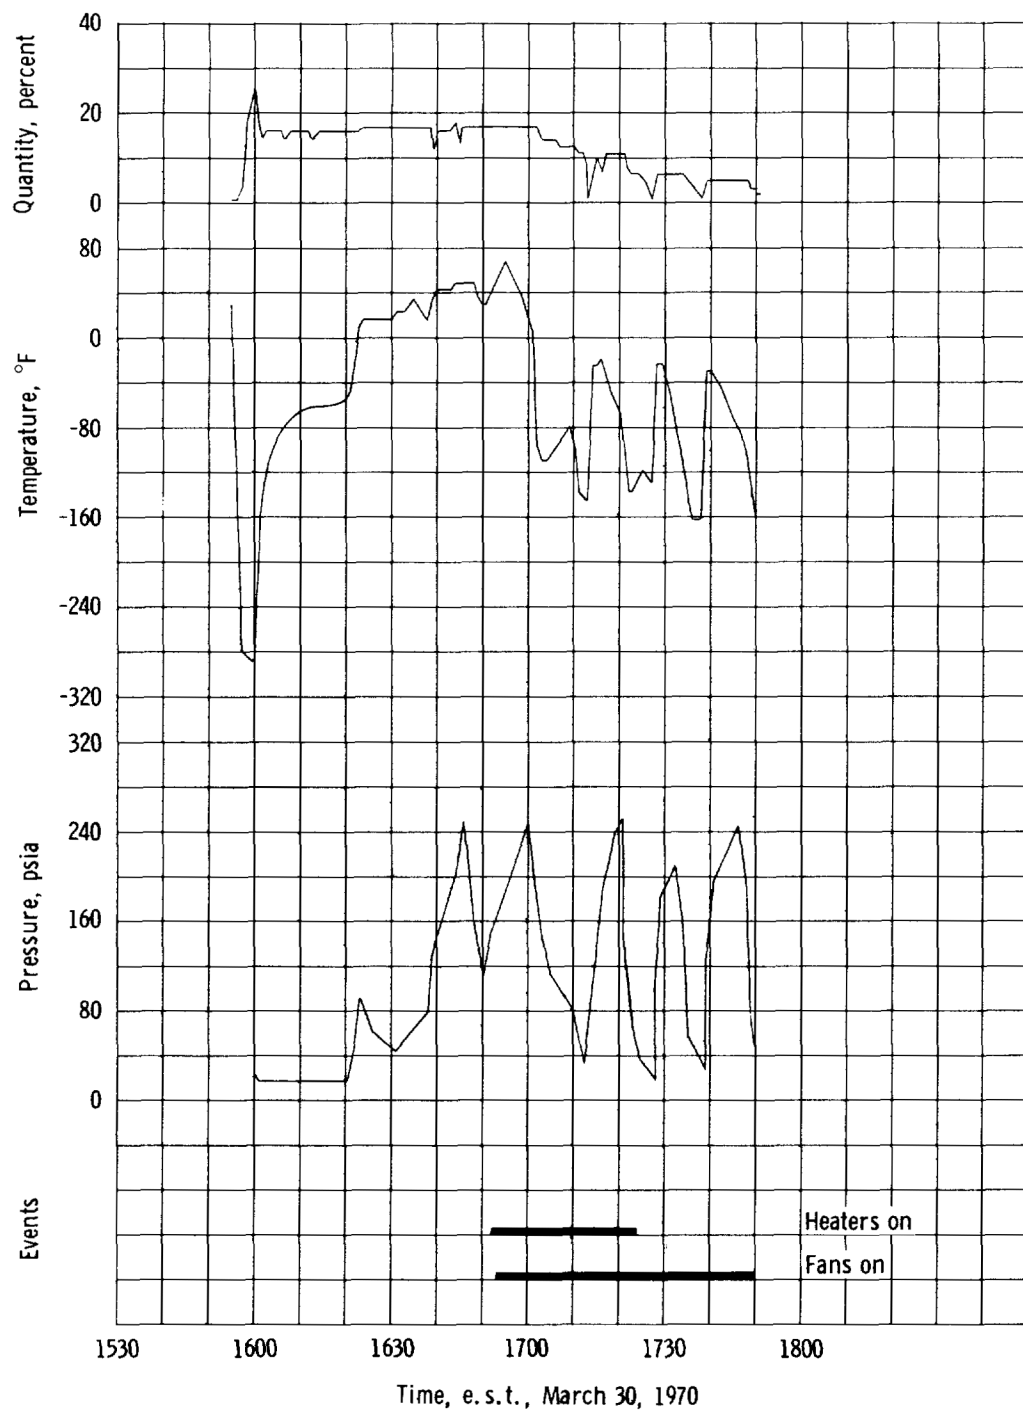
To verify this judgment and to assure countdown operability, both tanks were filled on March 30 to about 20 percent in approximately 2.5 minutes. Tank no. 1 detanked normally; tank no. 2 did not. Again the procedure of applying heat at maximum voltage and the cyclic application of gas pressure of approximately 250 psia and then venting was used. Five cycles were applied in a 1-1/4 hour period and tank no. 2 was emptied (fig. C4-63). The fan responses were observed to be normal and no indications of heater cycling were observed.

Figure C4-63.- Oxygen detanking using pressure cycles and tank heaters.

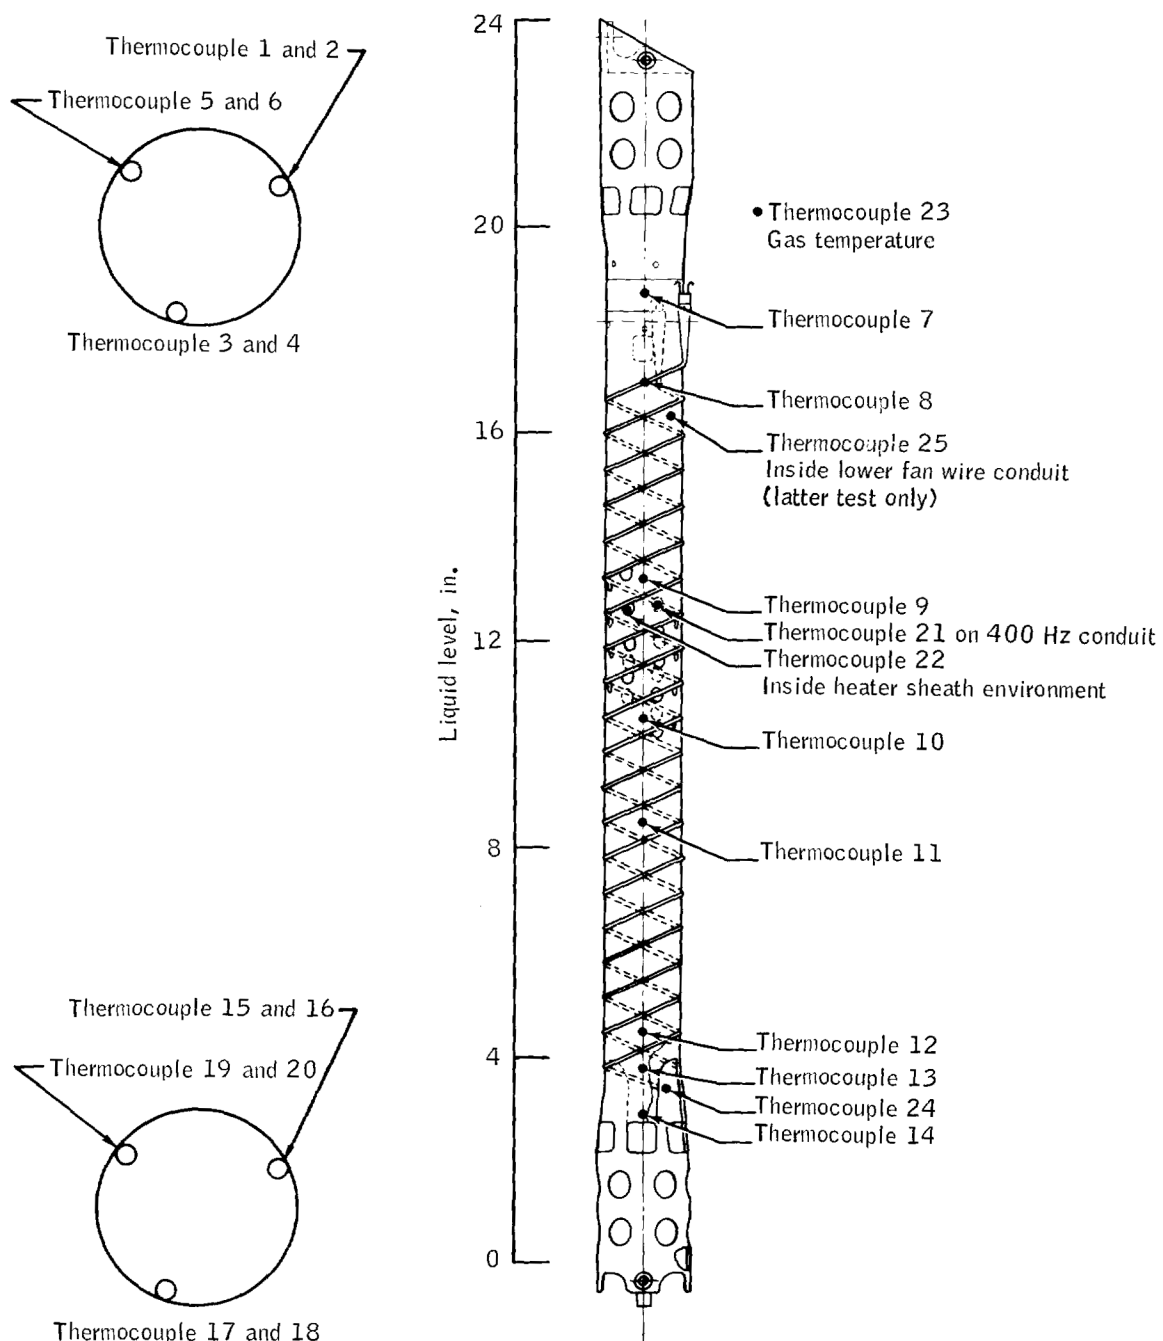
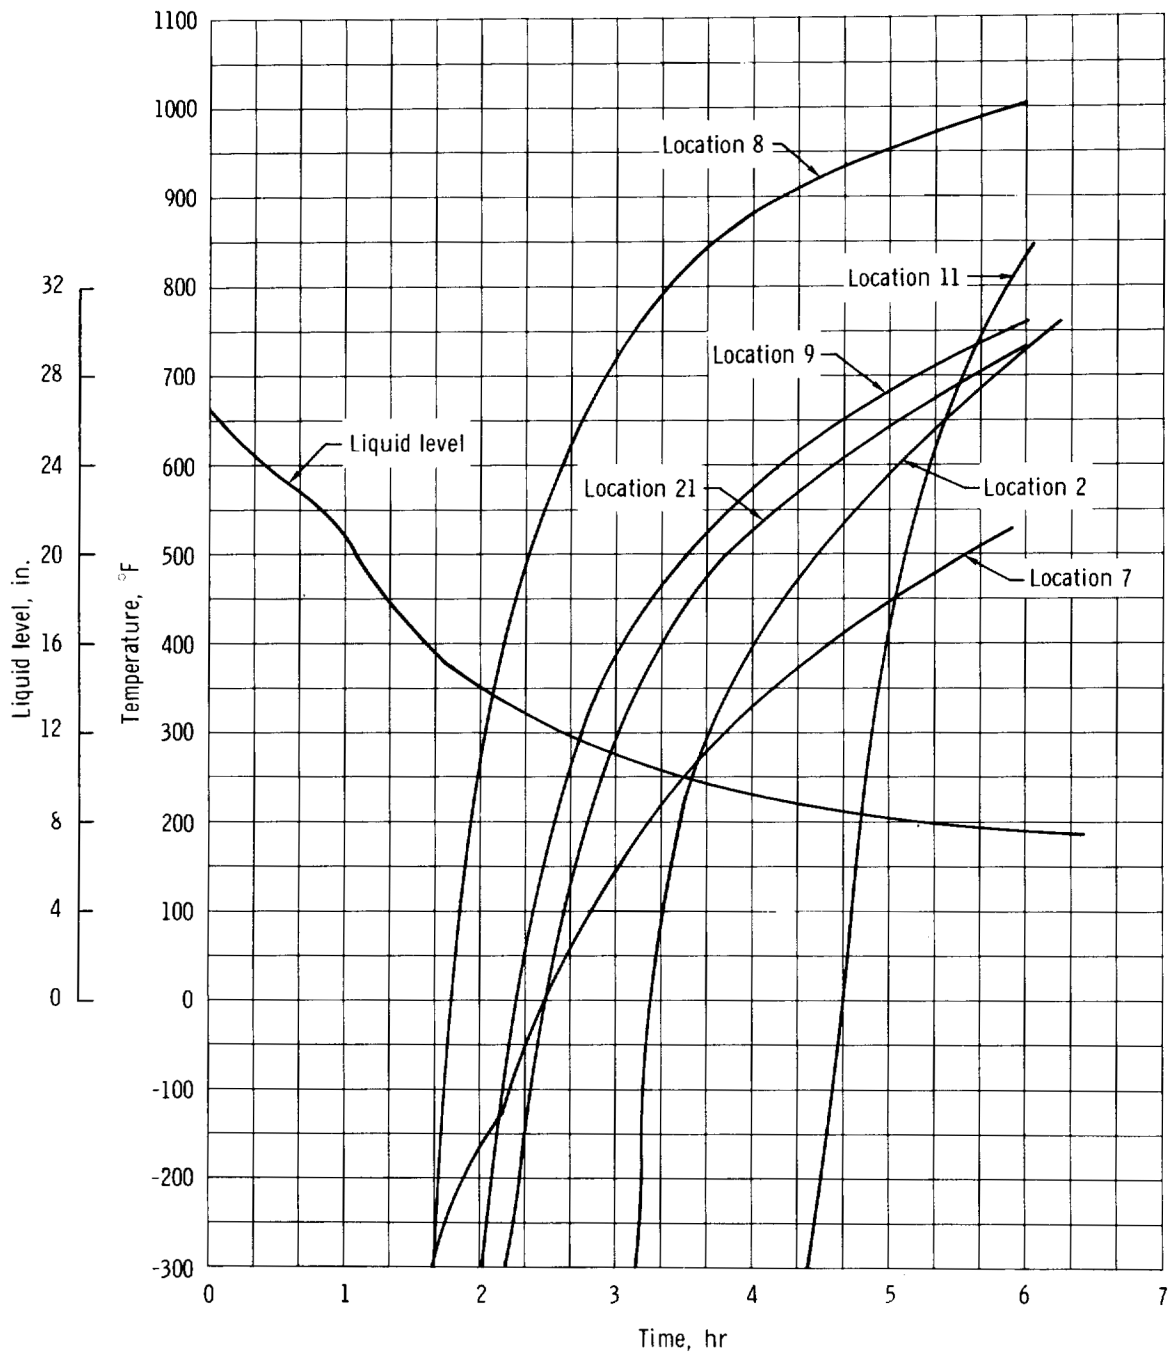
Figure C4-66.- Heater tube assembly temperature test.

(b) Typical test results.
Figure C4-66.- Concluded.

The test was started and after a few cycles in this mode the previously nonfunctioning (open) thermostat started indicating normal function. At this time it was decided to revert to the originally intended test configuration, i.e., the thermostats directly controlling the heaters. Data from that point on indicated that the thermostats were not cycling the heaters. The heater tube temperature data looked just like the nonthermostat test run. The test terminated at this point and the thermostats were removed and X-rayed. The X-rays indicated that the contact gap was bridged. One thermostat had its case carefully removed to examine the conditions of the contacts (fig. C4-67).
