**APPENDIX D**  
**REPORT OF DESIGN PANEL**

The Design Panel was assigned the task of reviewing the design of the systems involved in the Apollo 13 accident, including their qualification history. The service history of the specific components flown on Apollo 13 was also to be examined from a design point of view to ascertain whether any abnormal usage experienced might have had a detrimental effect on the functional integrity of the components. The Panel was also charged with review of other spacecraft systems of similar design or function to ascertain whether they contained potential hazards. Finally, the Panel was to analyze, as required by the Board, proposed failure mechanisms to the extent necessary to support the theory of failure.

Early in the proceedings of the Board, it became evident that the failure was centered in the cryogenic oxygen subsystem of the electrical power system of the spacecraft, and, more specifically, in the no. 2 cryogenic oxygen tank. For this reason, detailed examinations of the Panel were limited to this subsystem. Interfacing systems were examined only to the extent required to understand the function of the oxygen system and/or to relate data fr

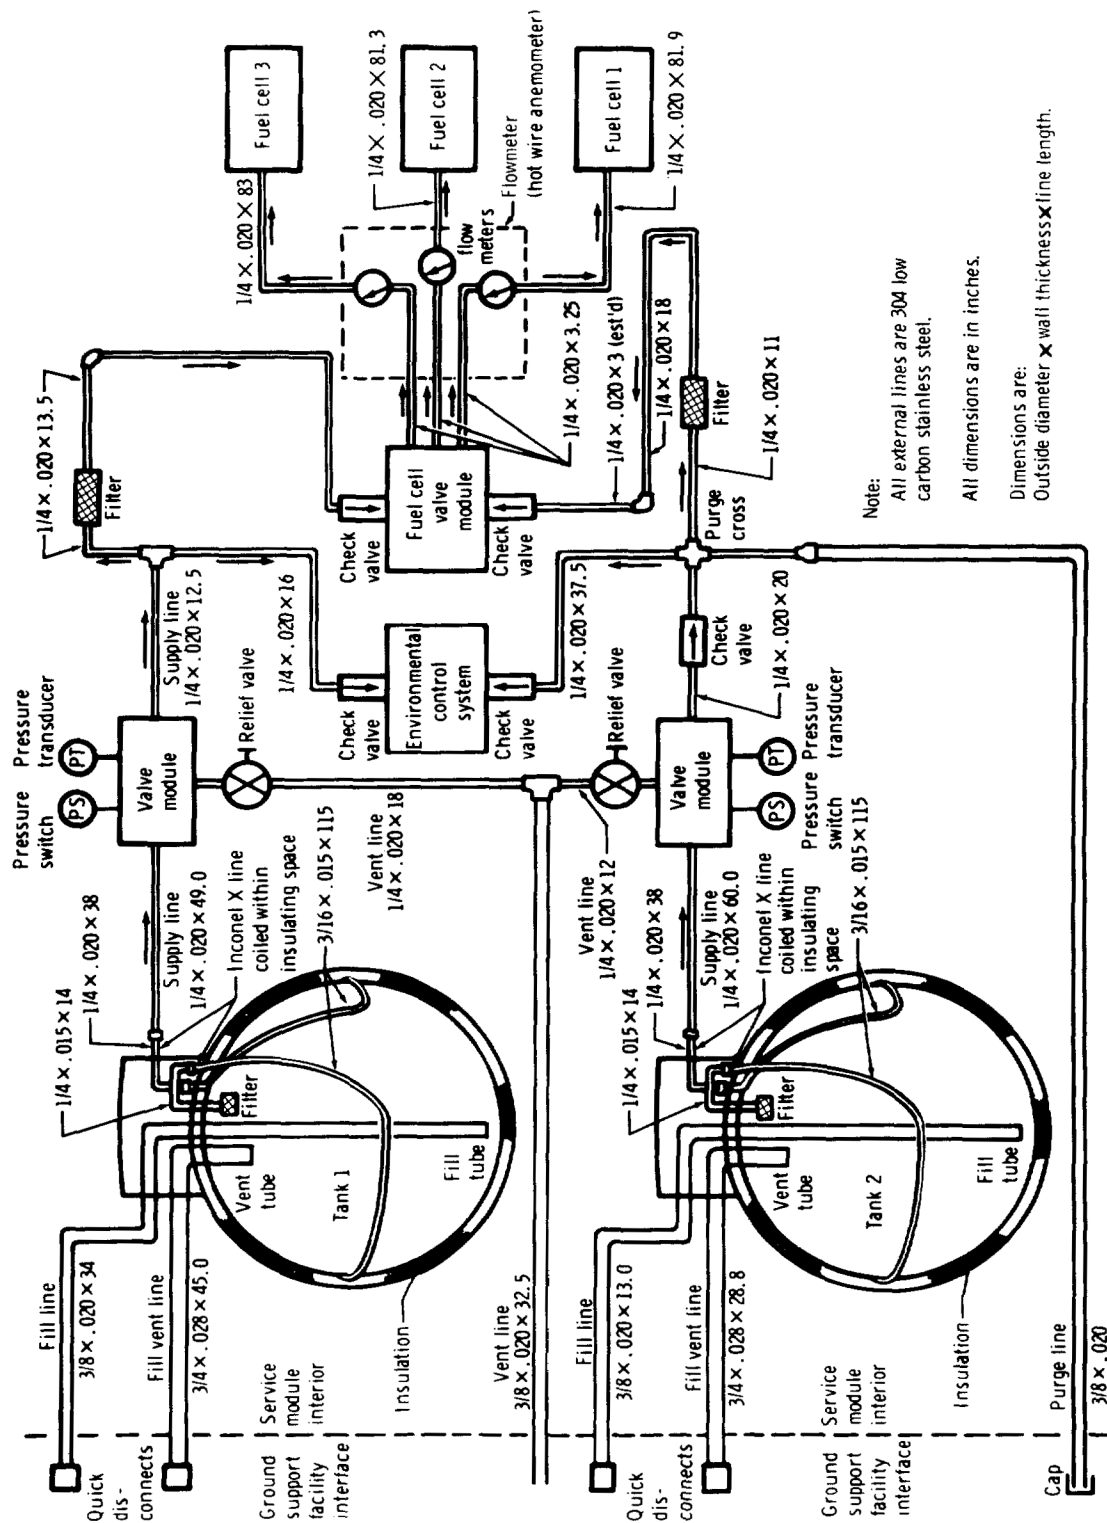
Figure D3-2.- Oxygen system.

their plumbing are identical except for one point in the feed line from tank no. 2, at which a ground service line tees into the feed line downstream of a check valve. This ground service line permits the operation of the fuel cells and the environmental control system (ECS) oxygen system from a ground source of oxygen without requiring the use of the flight tankage. This line terminates at the fitting designated OP in figure D3-3. The check valve prevents the pressurization of tank no. 2 from this ground source.

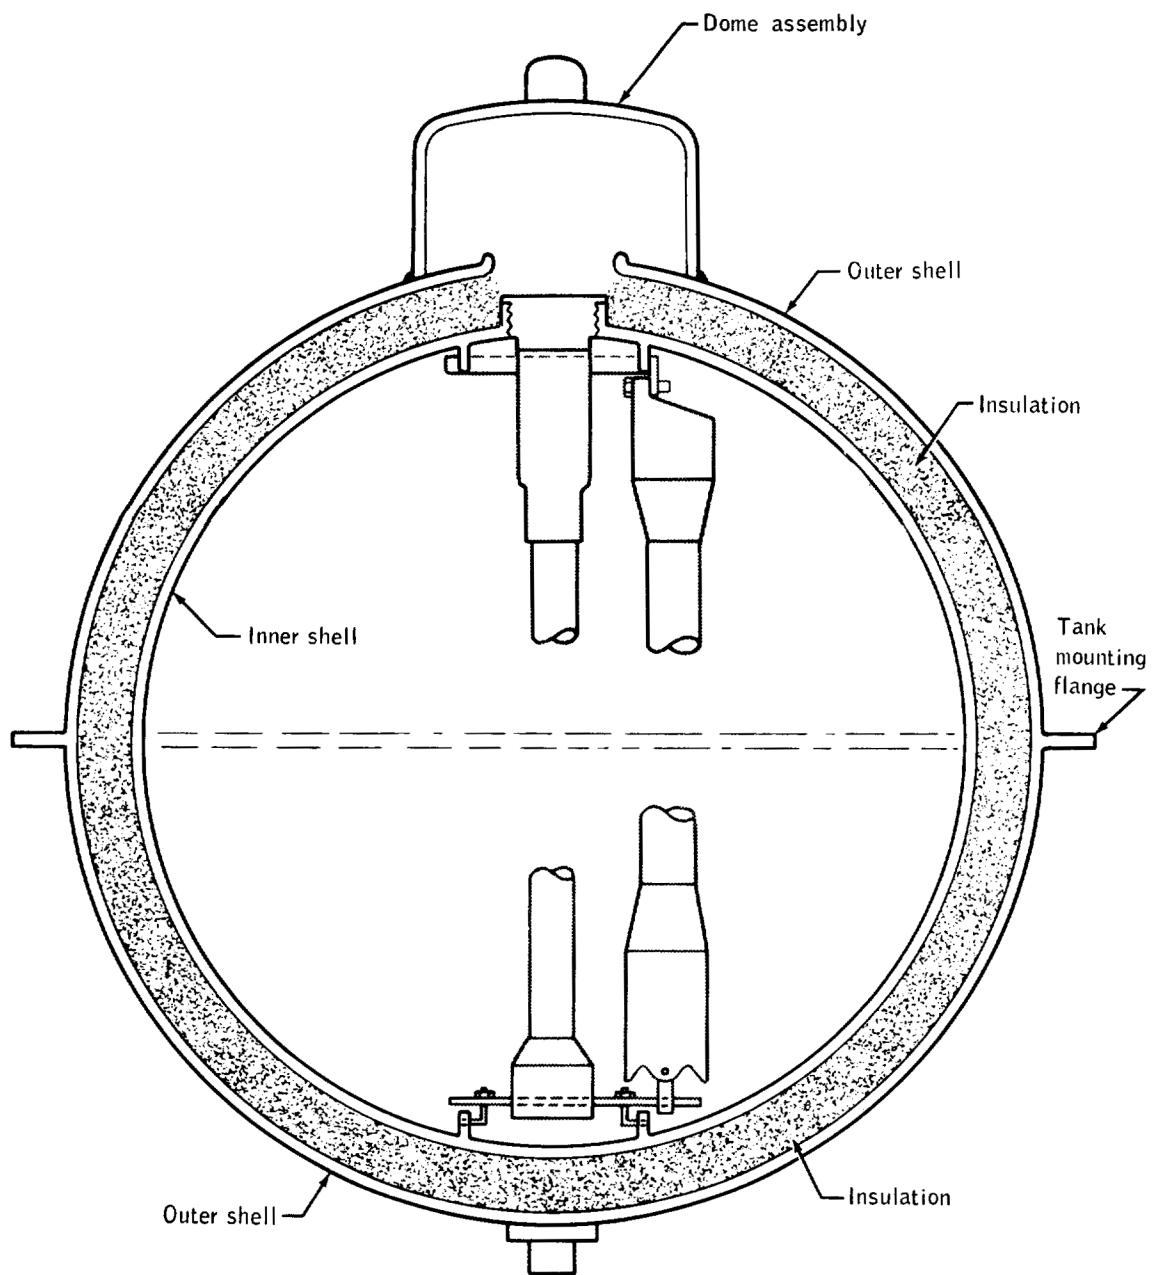
Figure D3-6.- Oxygen pressure vessel schematic.

All ruptures were similar; the failures apparently started about 2 or 3 inches from the pole of the tank on the top at the transition from the heavier section to the membrane section. The fractures progressed around the boss area, proceeded essentially perpendicular to the girth weld, and then crossed the girth weld in both ambient tests and in one of the cryogenic tests. In the other cryogenic temperature test vessel, a large fragment came out of the upper hemisphere. In no case was there violent fragmentation. After the burst of PV-1 at 2233 psig, initial failure was judged to have occurred at the end of the neck taper around the top pole. The rupture progressed downward, branching into a Y. After coming into contact with the weld, the rupture followed the weld fusion zone.

- (1) Burst failure initiated at the end of the boss taper in the upper hemisphere and resulted from plastic deformation beyond the tensile strength of the base material at ambient temperature.
- (2) Rupture was of a hydrostatic type.
- (3) The appearance of all failed areas was judged to indicate good ductility of the base metal and weldments.
- (4) No significant mismatch was observed on the specimens investigated.
- (5) All fractures across the weld were shear fractures and of a secondary nature.
- (6) The grain size throughout the vessel was fine (ASTM-5 to 8) and relatively equiaxed.
- (7) The ambient burst test was judged to be completely successful by Beech Aircraft Corporation Engineering, and the results of the test indicate approximately 100 percent efficiency for the material at the test temperature."

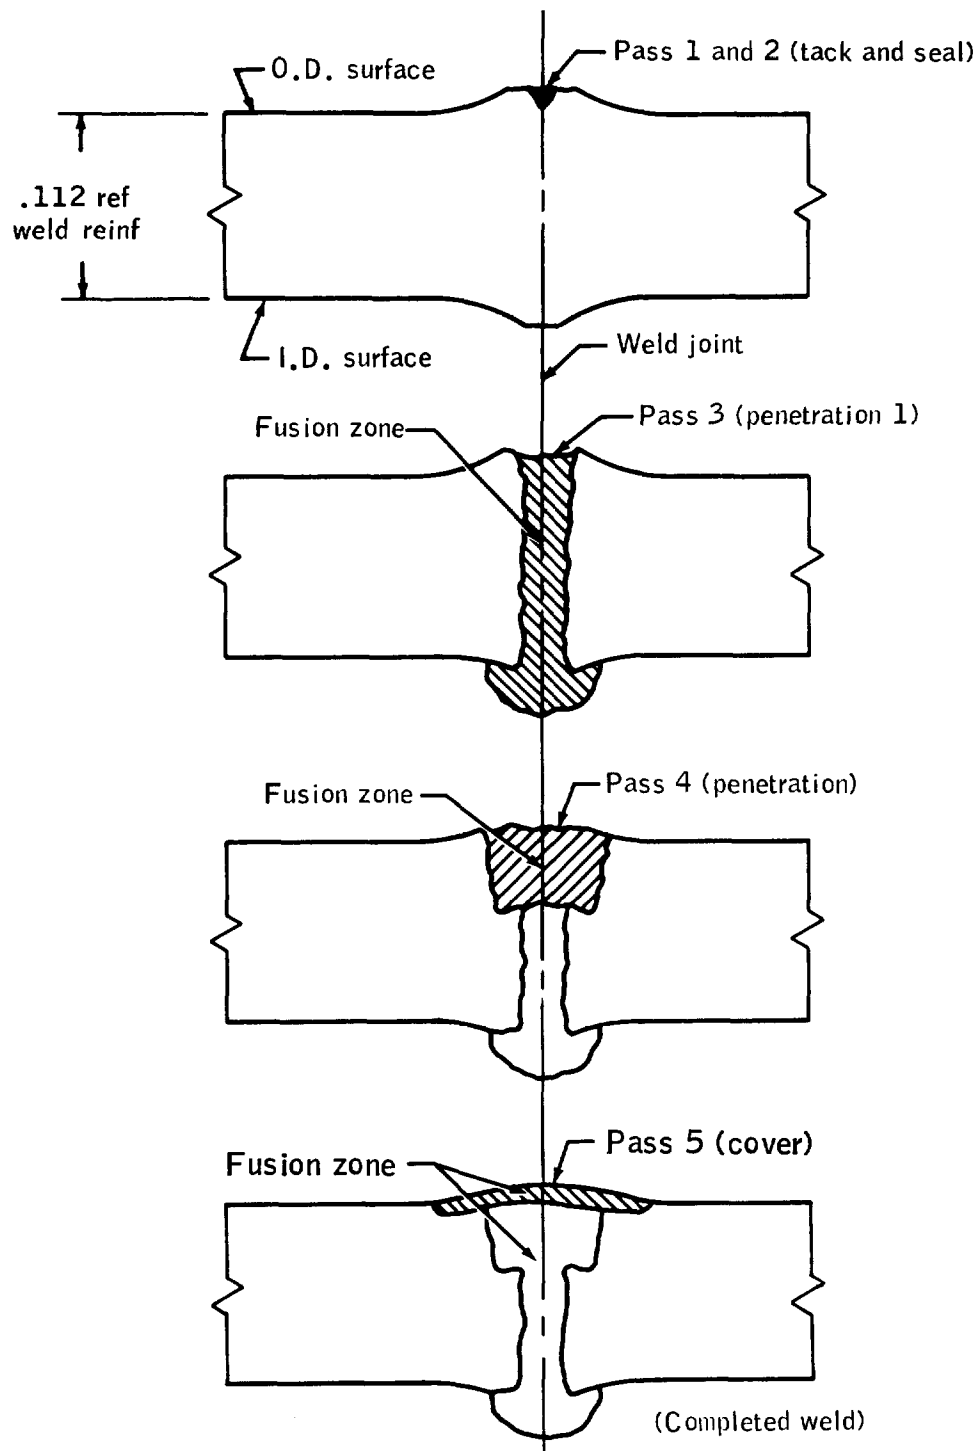
Figure D3-8.- Weld sequence.

A total of 39 data packages on oxygen pressure vessels were reviewed and it was ascertained that only 12 vessels had had weld discrepancies. Table D3-1 describes the weld discrepancies and their disposition. Neither of the two Apollo 13 oxygen tanks flown (S/N 10024XTA0008 and S/N 10024XTA0009) appear on this list. There were no recorded weld discrepancies during the manufacture of these tanks.

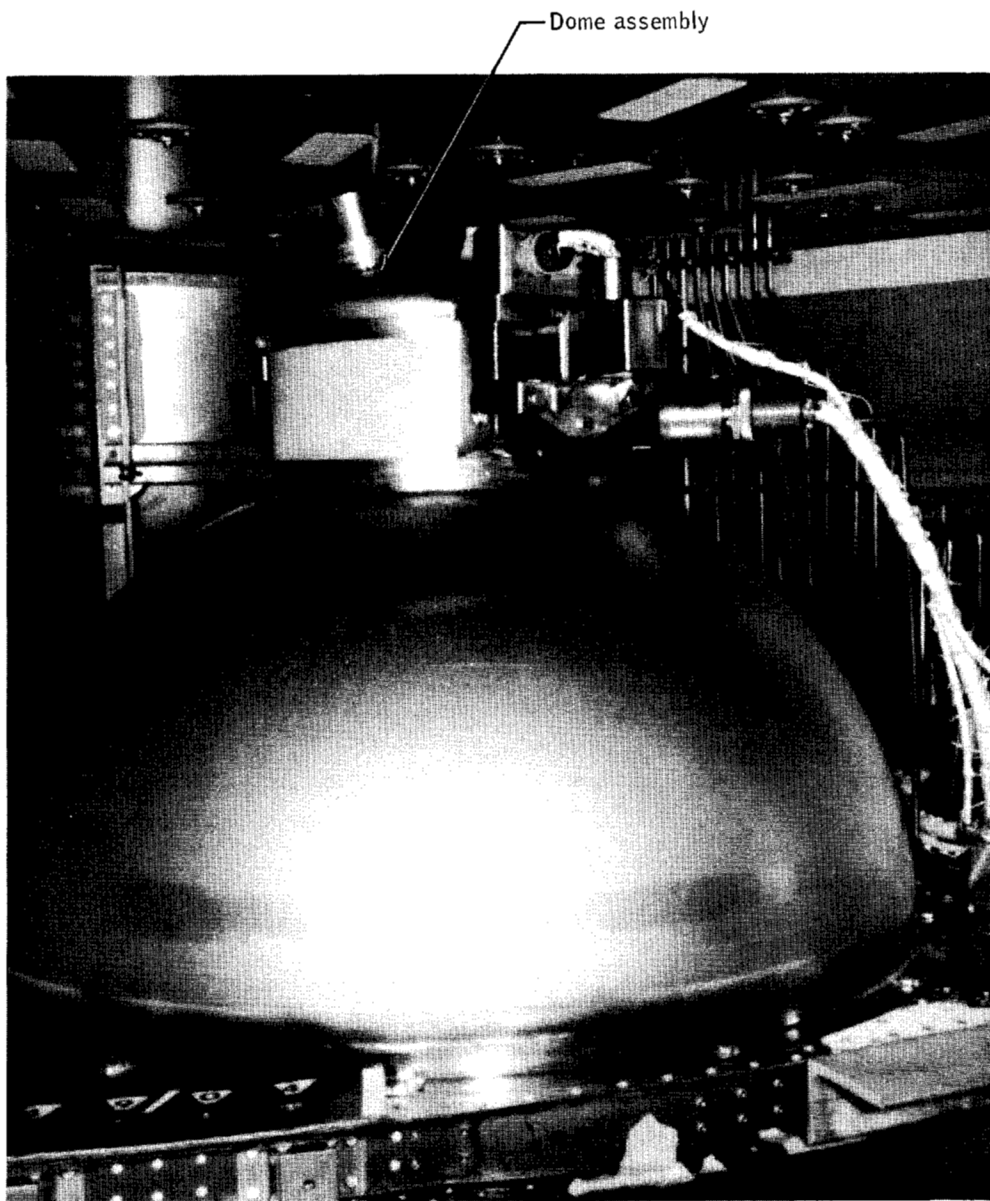
Figure D3-20.- Oxygen shelf showing location of tank dome assemblies.

the dome contains the upper pinch-off tube, through which the annulus is evacuated, and a burst disc (rated at 75 psi  $\pm$  7.5 psi) that provides burst protection for the outer shell in the event of leakage from the inner shell into the annulus. The arrangement of the fluid lines and electrical conduit within the dome is shown in figures D3-21 and D3-22. The coiling of these lines provides the high impedance path for heat leaks between the inner and outer shells of the tank. In the case of the large diameter vent line, this path is made longer by use of a double-walled tube outside the dome, with connection between inner and outer walls at the extremity of the projection of the tube from the tank.
