# **REPORT OF APOLLO 13 REVIEW BOARD**

**APPENDIX F - SPECIAL TESTS AND ANALYSES**

**APPENDIX F**  
**SPECIAL TESTS AND ANALYSES**

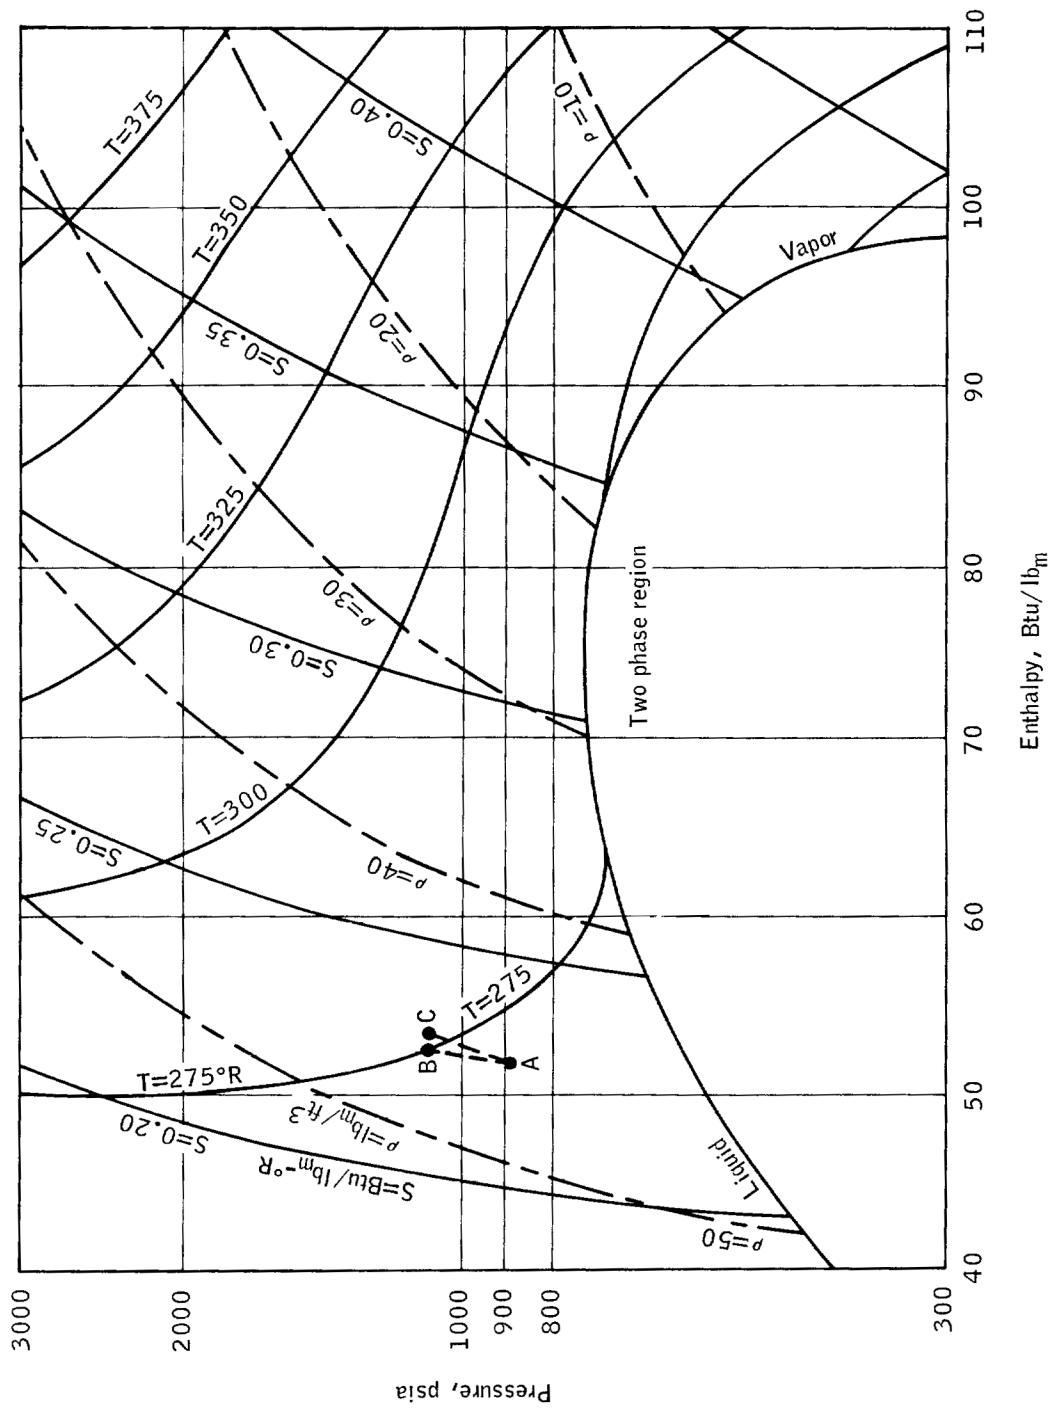
Figure F3.3-1.- Thermodynamic processes on pressure-enthalpy diagram.

Figure F3.3-1 also shows the constant density path along line AC from 887 psia to 1008 psia. This process could be achieved by complete mixing of the tank contents. The internal energy increase for this case (maximum energy) is about 130 Btu. The temperature increase for this process is 2.6° F. It should be noted that this energy addition is to the oxygen in the tank. It does not include energy that might be added to other tank components such as metal parts.

The measured temperature rise of 38° F (indicated by figure B5-3 in Appendix B) during the pressure rise to 1008 psia cannot be explained by

either of the above-mentioned thermodynamic processes because they give a rise of only  $1.8^{\circ}$  and  $2.6^{\circ}$  F. As figure B5-3 shows, the measured temperature rise lagged the pressure rise. Both this lag and the magnitude of the temperature rise can be explained by the passage of a combustion front near the temperature sensor.

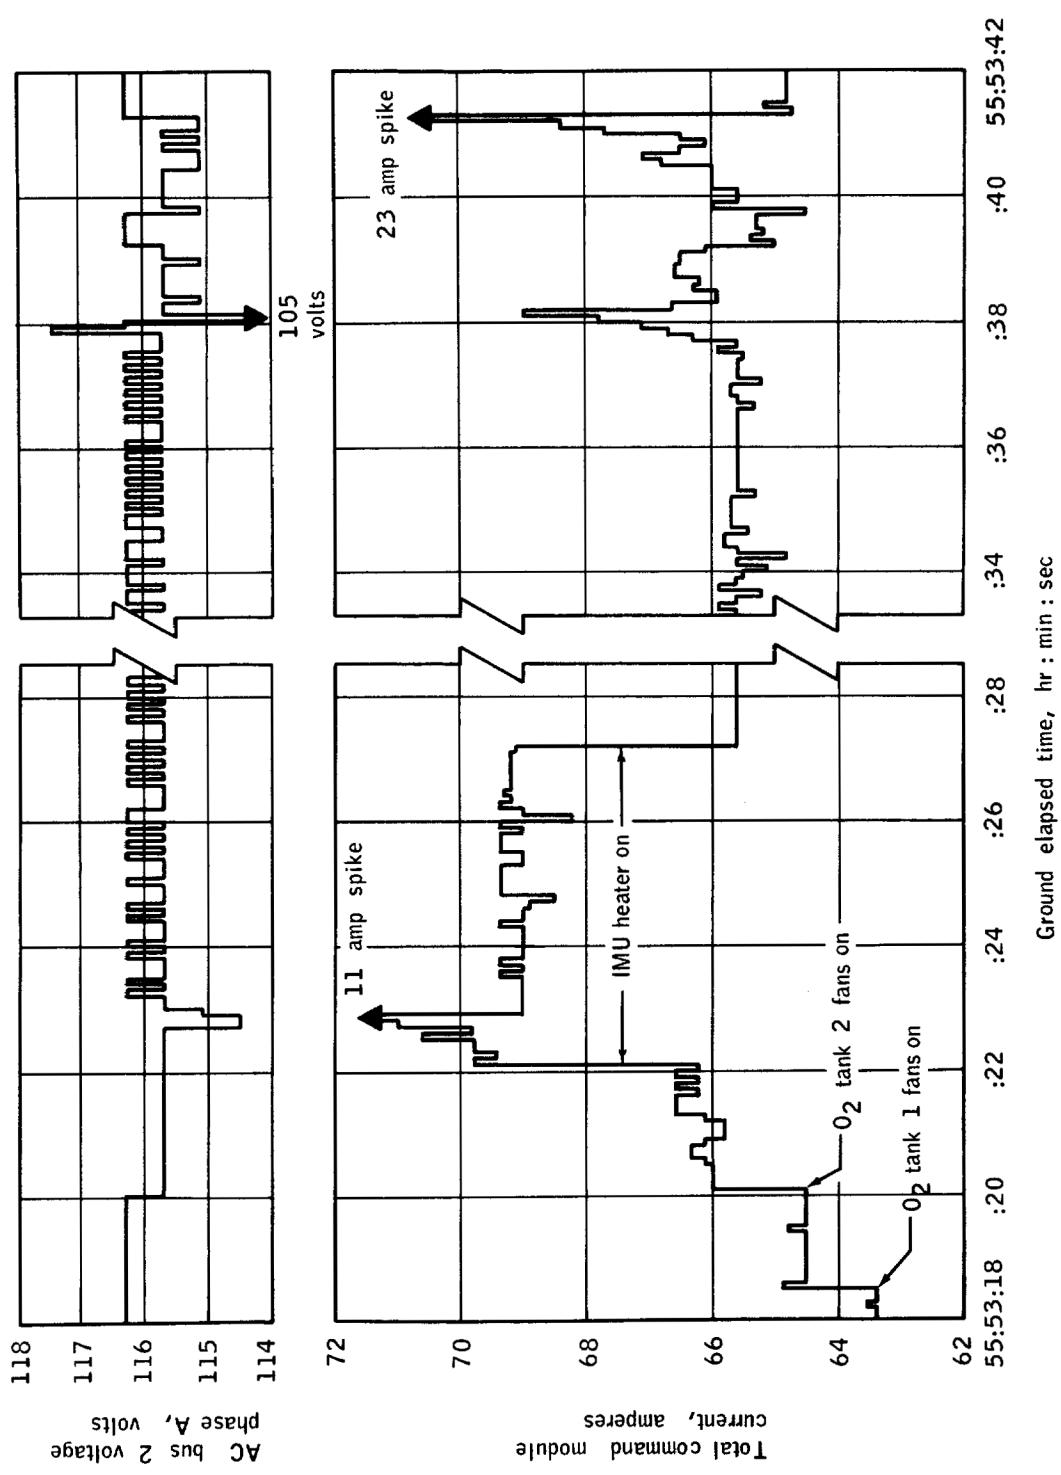
Figure F3.3-2.- Telemetry data for ac bus 2 voltage phase A and total CM current.

The 115-volt fan motor circuit is shown in figure D3-5 of Appendix D. The power for the motor comes from an inverter producing three-phase, 400-cycle, 115-volt power. The motors are operated in parallel, each phase to each motor being separately fused with a 1-ampere fuse (there are a total of six fuses in the circuit). The important portions of the telemetry traces are shown in figure F3.3-2. The sequence of events postulated is as follows:

1. Fan turnon occurs at 55:53:20 g.e.t. and the phase A voltage drops from 116.3 to 115.7 volts. This is normal. The telemetry granularity is  $\pm 0.3$  volt.
2. At 55:53:23, an ac voltage drop from 115.7 to 114.5 volts is observed, coincident with a fuel cell current increase of 11 amperes. This is the first short circuit that occurred after fan turnon. Since the ac voltage rose from 115.7 to 116.0 volts (as indicated by "toggling"

between 115.7 and 116.3 volts) after the event, it is probable that the short circuit involved phase A of the motor drive circuit, and all power may have been lost to one of the two fan motors at this time. This hypothesis is further supported by the coincident decrease in fuel cell current of 0.7 ampere, approximately half of the 1.5 amperes drawn by both motors.

4. A final short circuit occurs at 55:53:41 as indicated by the 22.9-ampere spike on the dc current telemetry. No voltage drop is observed on the ac bus, probably because the short was of such short duration that it was not picked up by the telemetry samples. All the remaining fuses are blown (or the leads open-circuited) by this short circuit since the ac bus voltage and dc current return to the levels observed prior to initial energizing of the fans in oxygen tank no. 2.

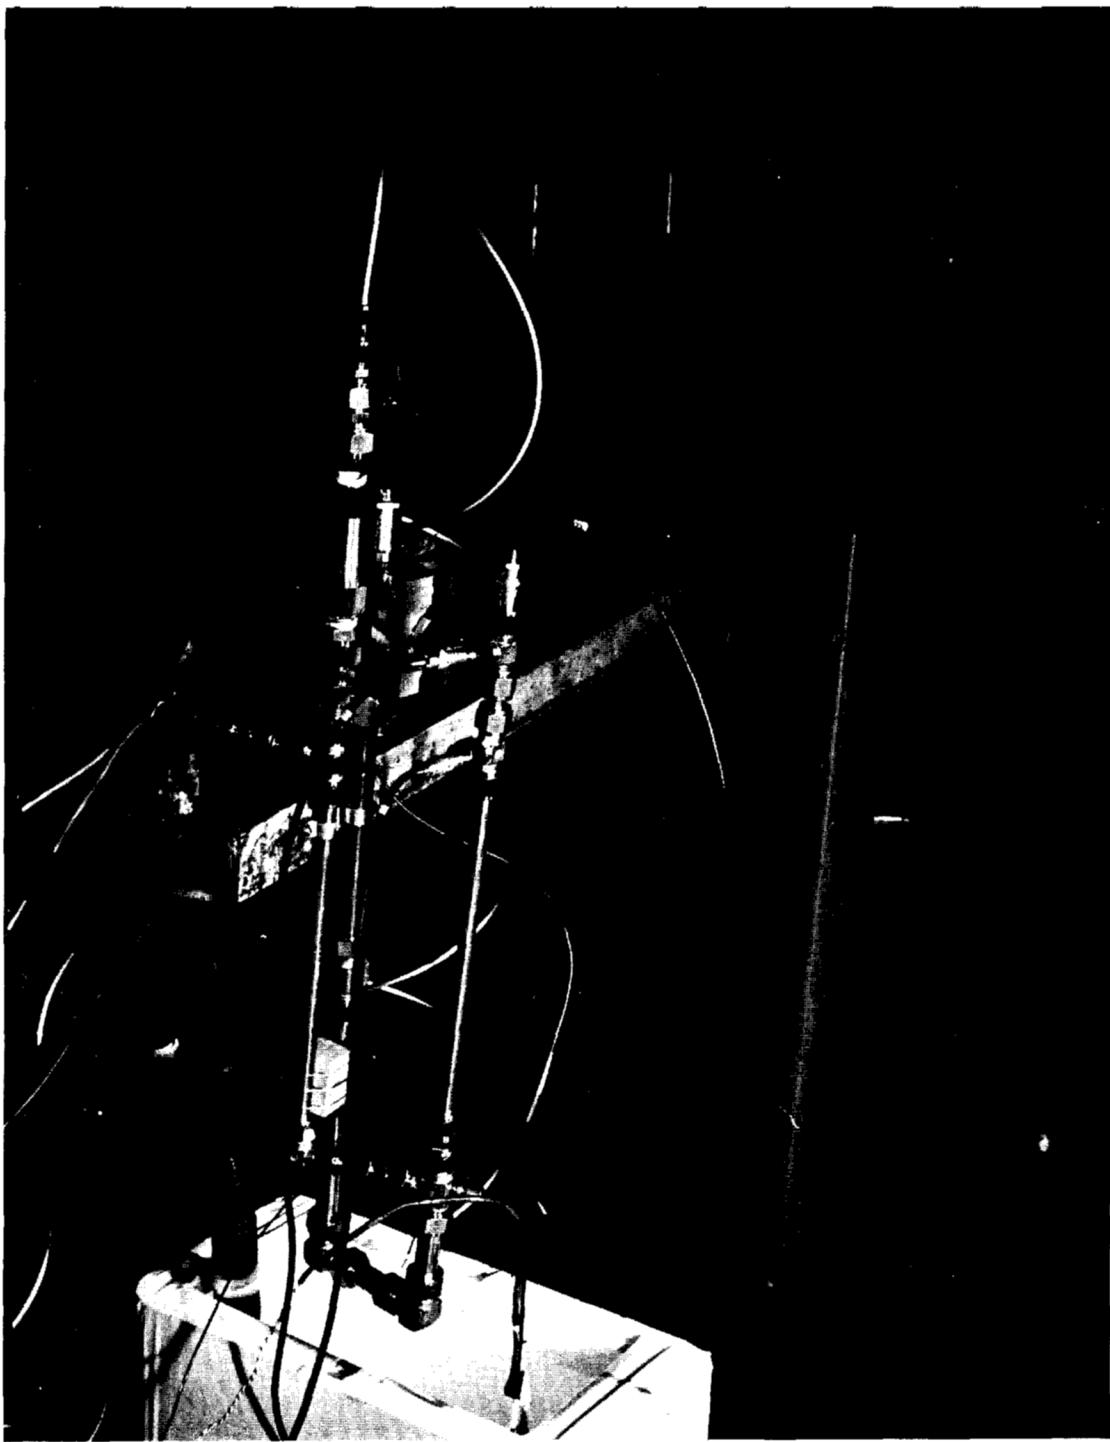
Figure F3.4-2.- Stainless steel test rig.

The specimen was immersed in liquid oxygen (as before) inside the stainless steel tubing test rig shown in figure F3.4-2. The initial pressure was 920 psi.

The test assembly withstood three firing pulses, 115 volts, 60 cycles, before igniting on the fourth. The 1-ampere fuse was blown each time. The short resistance was measured after each trial and was found to reduce progressively from about 5 ohms to 2 ohms, at which level ignition occurred on the next try. Approximately 1/2 second later the pressure gage showed the start of a 7-1/2 second pressure rise from 920 to 1300 psi. A thermocouple placed about 1 to 2 inches from the ignition point showed a small rise about 1 second after ignition and a large rise about 1/2 second later as the flame swept by. Much of the main conductor wire was consumed; all of the small thermocouple wire was gone. Virtually all of the Teflon was burned--Teflon residue was found only in the upper fitting where the electrical leads are brought into the test chamber. All but one of the alumina insulators vanished.

From the fuse energy tests and these ignition tests, it is clear that from 3.5 to 7.5 joules are adequate to initiate combustion of heat-degraded Teflon insulation. This is essentially the same as is required for unheated wire.

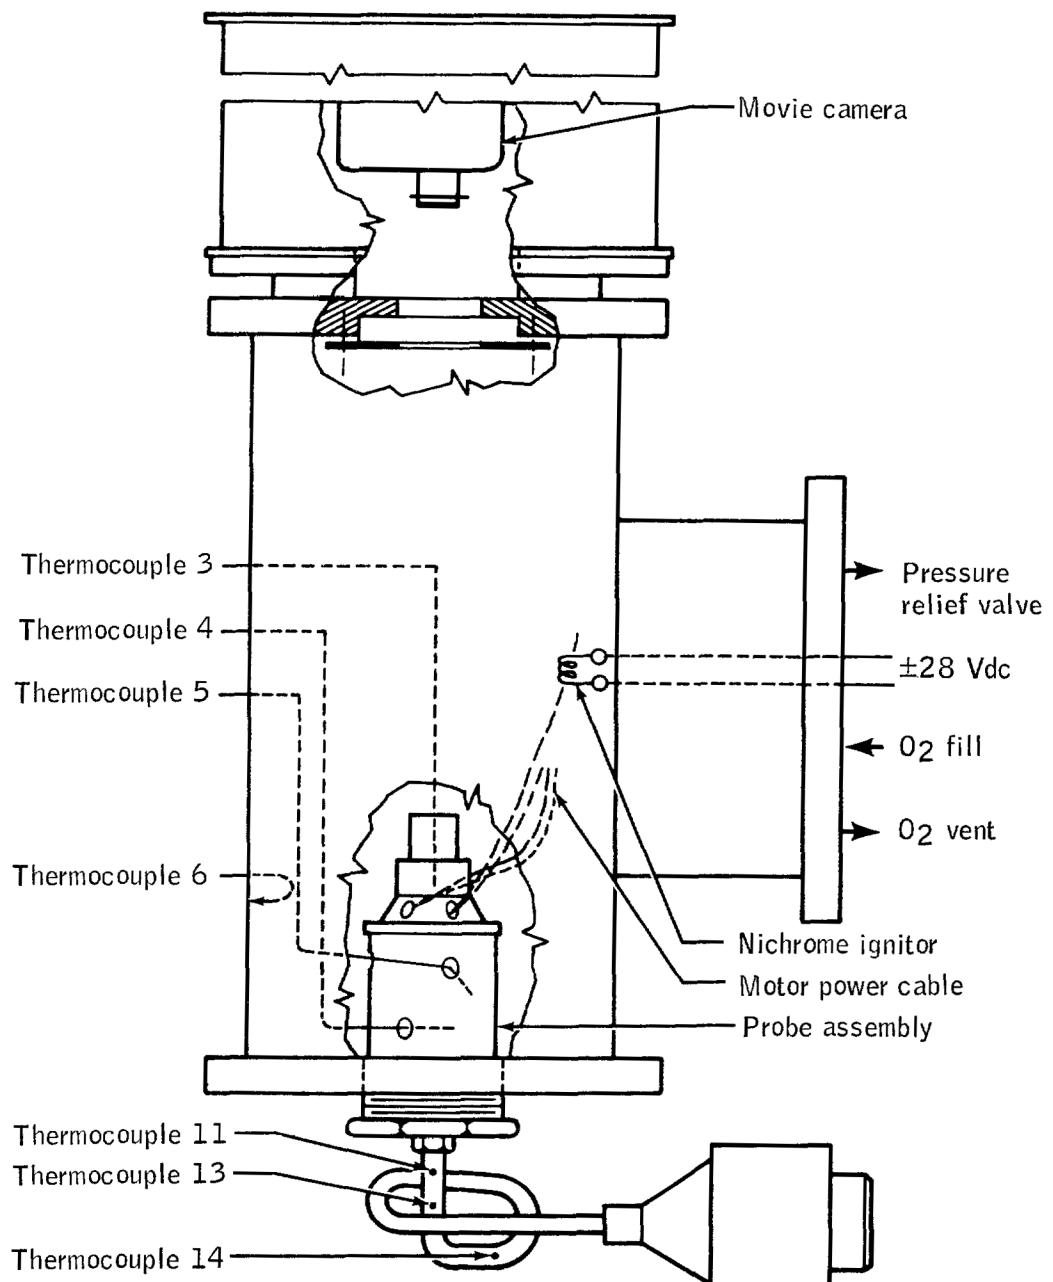
Figure F3.5-1.- Quantity probe and conduit assembly apparatus.

The chamber used for this test consisted of a schedule 80 weld-neck tee equipped with three flanges to provide a viewport, electrical and hard line feedthroughs, and conduit to quantity probe interface. The chamber, which is shown in figure F3.5-1, had a volume of approximately one-third cubic foot. A pressure relief valve was provided to maintain chamber pressure at 1050 psia during test; and, in addition, the chamber contained a rupture disc to prevent chamber failure. Supercritical conditions inside the chamber were obtained by filling with gaseous oxygen to a pressure of 940 psia and cooling externally with liquid nitrogen, using insulating foam covered with thermal blankets. Five thermocouple penetrations were provided through the chamber wall. Chamber pressure was monitored by a pressure transducer. Color motion pictures were taken through the chamber viewport at a speed of 24 frames a second. An additional camera provided external color motion pictures of the conduit-chamber interface.

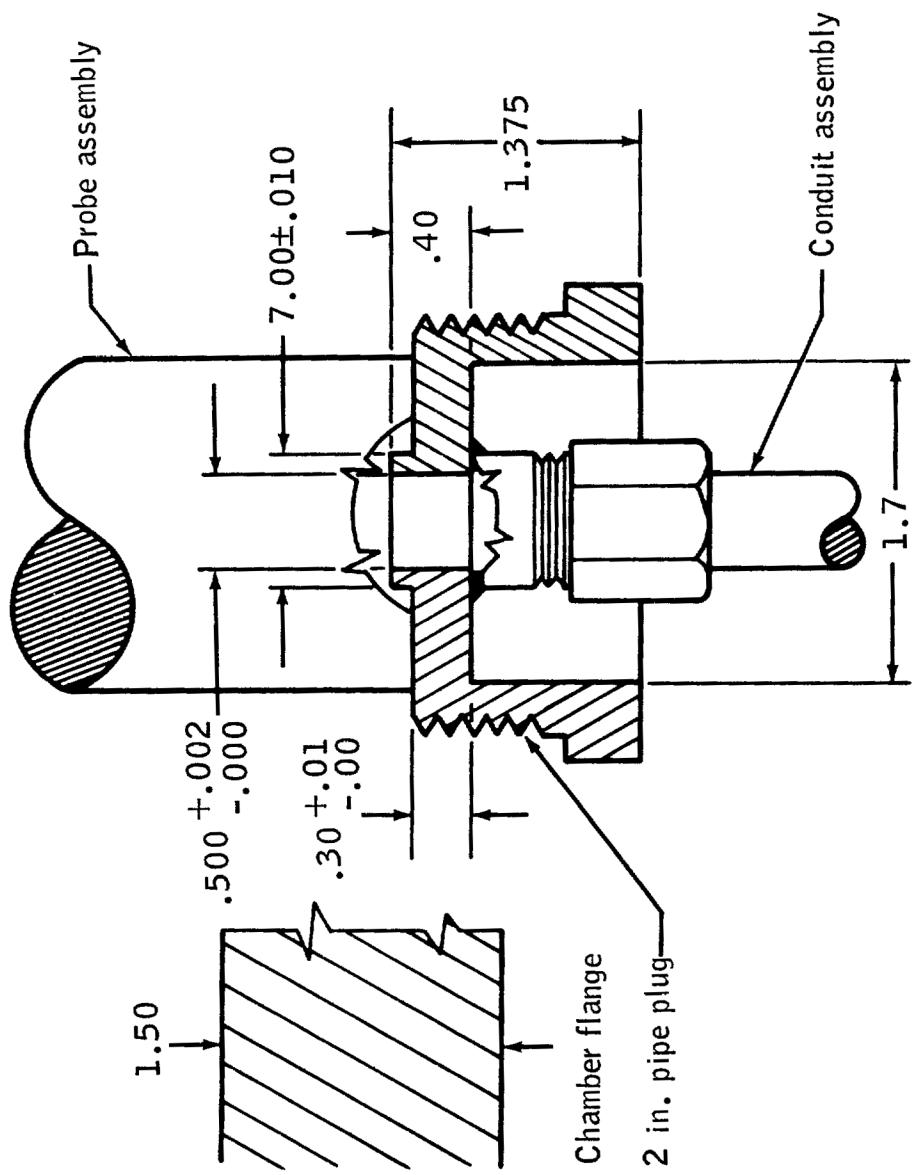
Figure F3.5-2.- Upper quantity probe - conduit interface.

The test item consisted of an upper portion of the quantity probe interfaced with a conduit assembly shown in figure F3.5-2. The quantity probe used was Block I hardware which had been sectioned for demonstration purposes. An additional hole was drilled in the probe insulator to modify it to Block II and wire was routed through it and the conduit assembly to represent the Apollo 13 configuration. Stainless steel sections were welded onto the probe to close the demonstration ports. Wiring with insulation was allowed to extend beyond the Teflon insulator approximately 4 inches. This wiring was also routed through the conduit and connected to the feedthrough pins through which power, 115 volts at 400 cycles, was supplied to both fan motor bundles by a system which had been

The probe conduit interface consisted of a stainless steel 2-inch pipe plug machined to the dimensions shown in figure F3.5-2. The interface was mounted on the bottom flange of the chamber so that flame propagation would be downward.

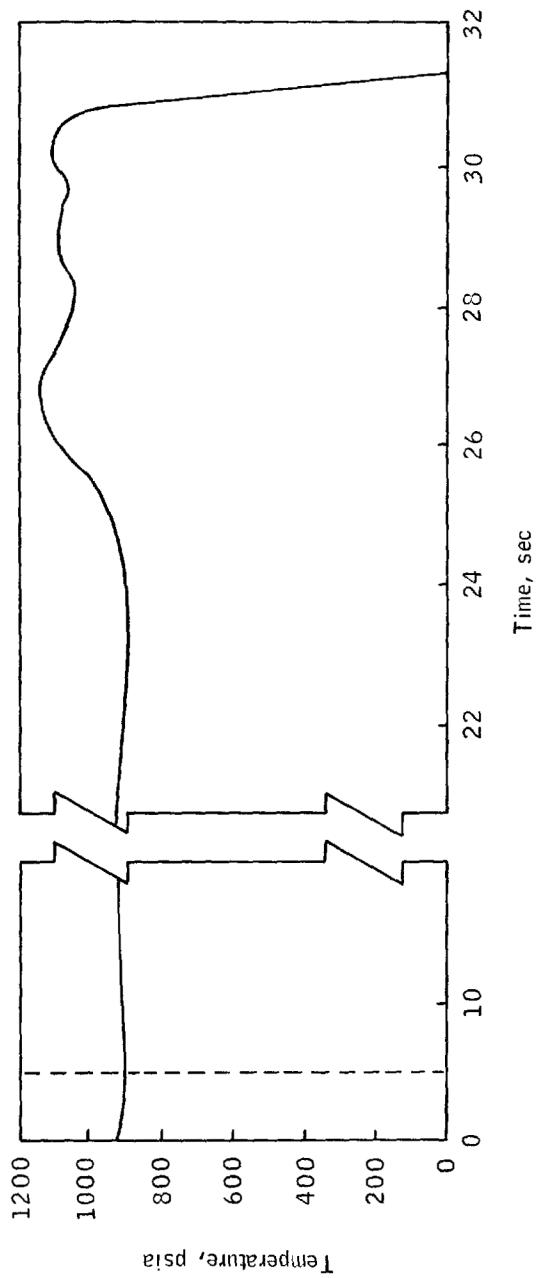
Figure F3.5-3.- Quantity probe and conduit assembly test pressure history.

Pressure history of the chamber is shown in figure F3.5-3. The first relief valve opening occurred at approximately 28 seconds. It subsequently reopened 15 times before failure occurred. Fusion of the ignitor is shown on the graph to indicate ignition of the insulation.

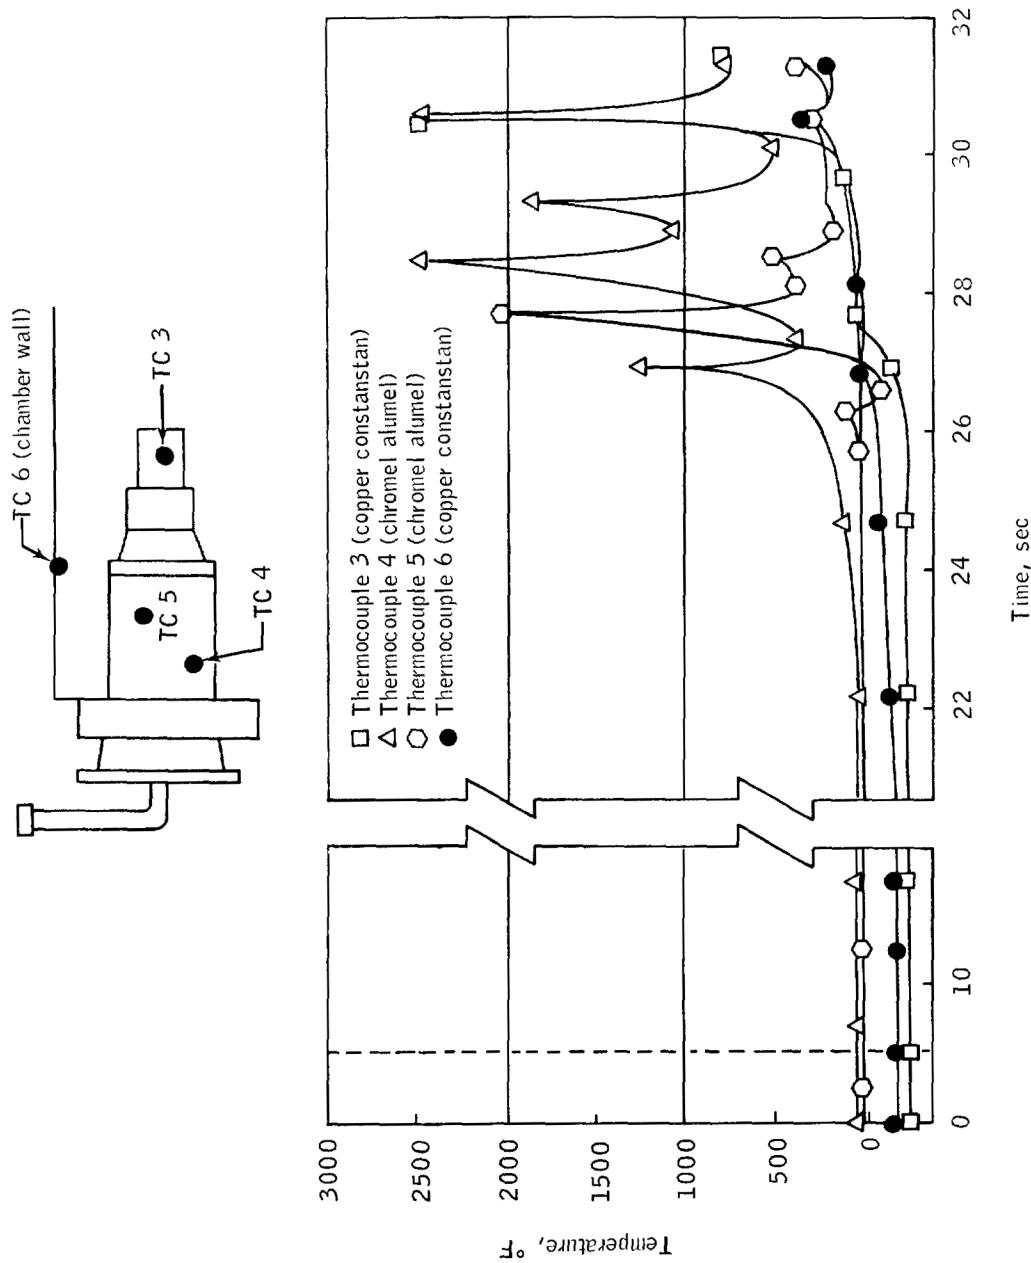
Figure F3.5-4.— Temperature history of quantity probe and chamber wall.

Temperature histories of both internal and external portions of the test apparatus are shown in figures F3.5-4 and F3.5-5. Thermocouple placements in each of these areas are included in the legend figures of each of these graphs. It should be noted that two types of thermocouples were used, one with good sensitivity at low temperatures, copper-constantan, and one with good sensitivity at high temperatures, chromel-alumel. These two types are also indicated in figures F3.5-4 and F3.5-5.

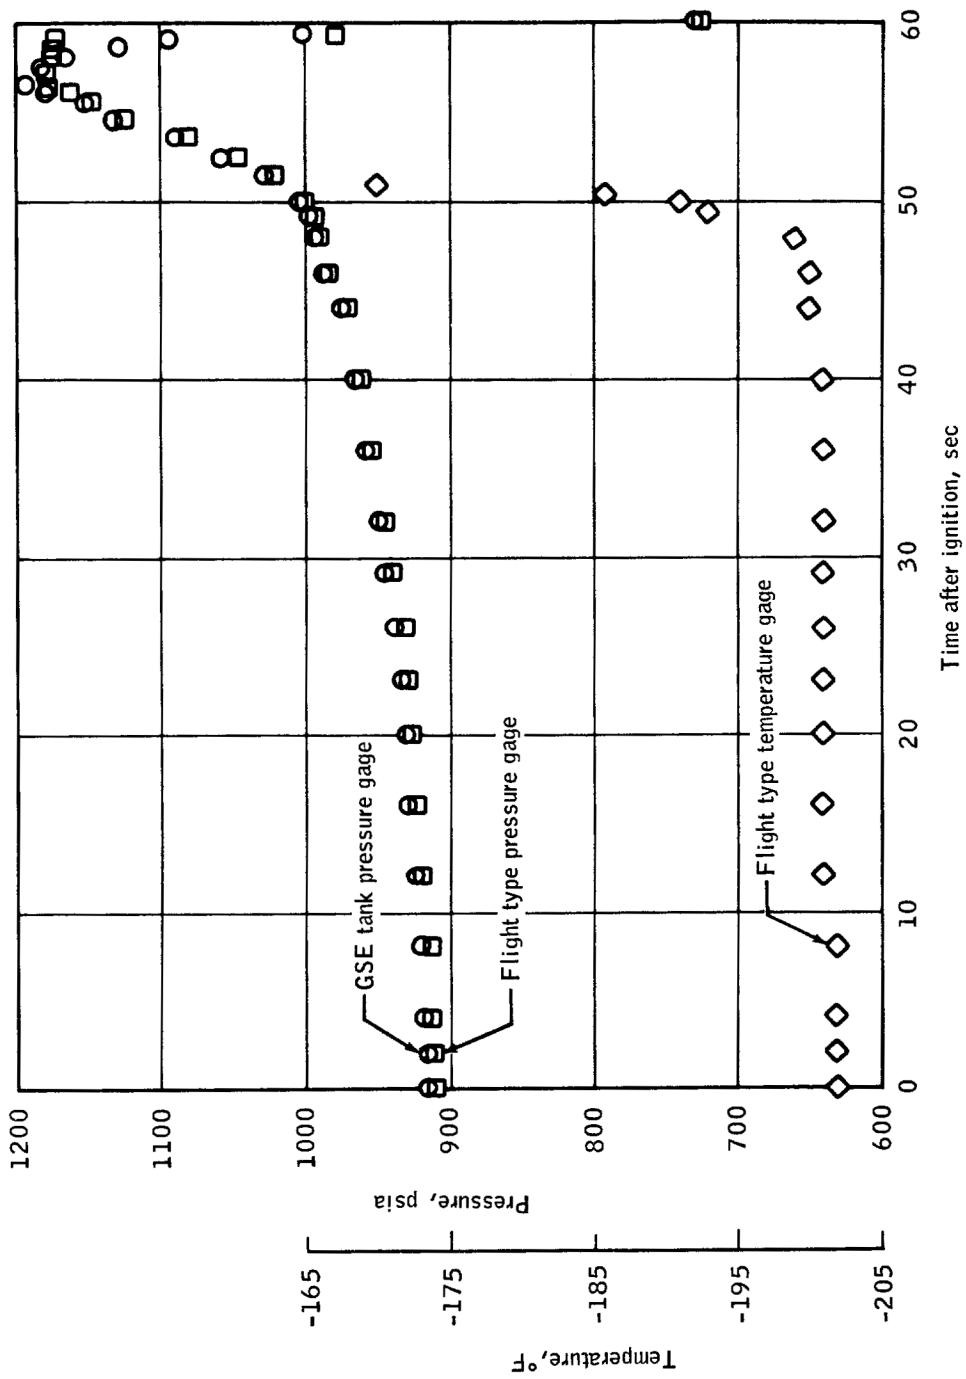
Figure F3.7-2.- Measured pressure and temperature time histories (preliminary data as of June 4, 1970).

2000° F. Failure of the temperature measuring wiring is indicated by the erratic readings that followed. These data are shown in figure F3.7-2. The pressure data shown beyond 56 seconds represent the venting of the tank contents. These pressure and temperature histories are qualitatively similar to the measured flight data but occur more rapidly than observed in flight.

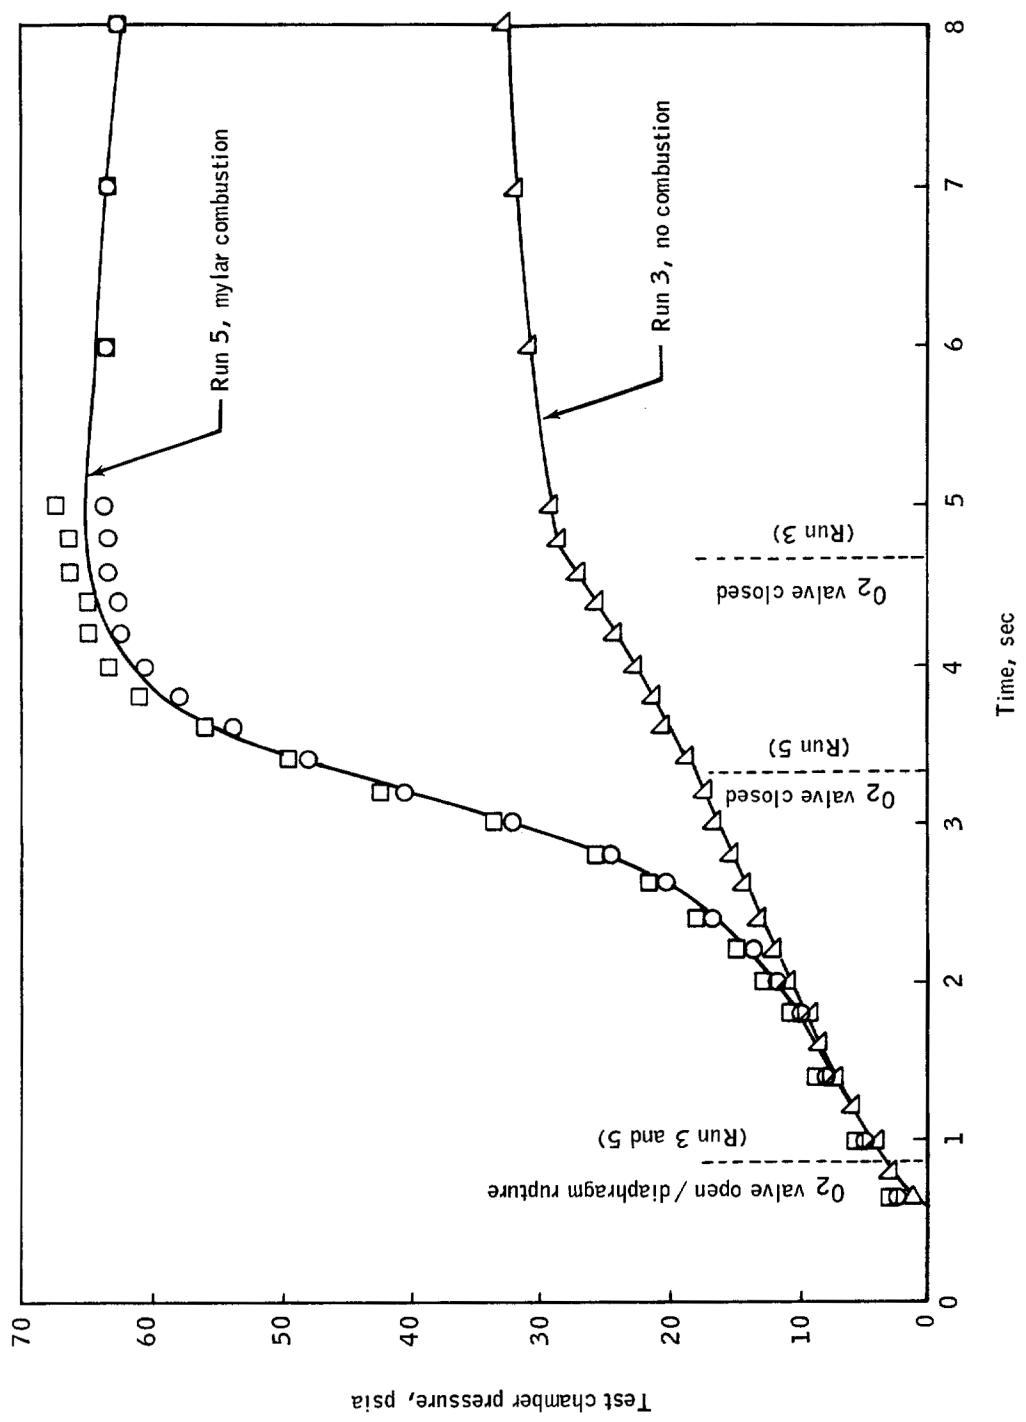
The Mylar insulation blanket burns completely when ignited locally and exposed simultaneously to oxygen from a 1000 psi/-190° F source. The pressure rise rate increases from 6 psi/sec without combustion to about 42 psi/sec with the combustion of Mylar. A substantial increase in the pressure rise rate in the oxygen tank shelf space due to Mylar combustion might therefore be expected. From tests conducted elsewhere, it is further concluded that an ignition source is required to achieve Mylar/oxygen combustion.

Figure F3.9-3. - Measured pressure histories for runs with and without Mylar combustion (initial oxygen tank temperature for Run 3 was  $-186^{\circ}$  F and for Run 5 was  $-192^{\circ}$  F).

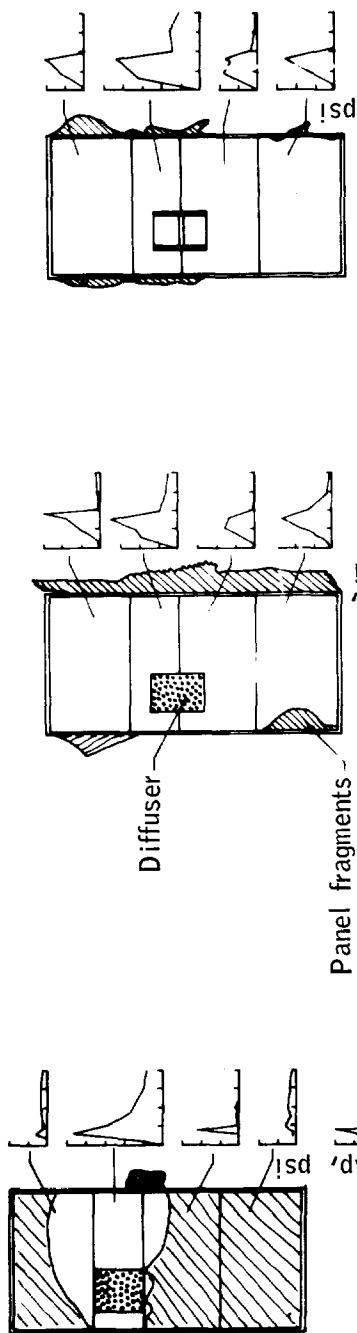
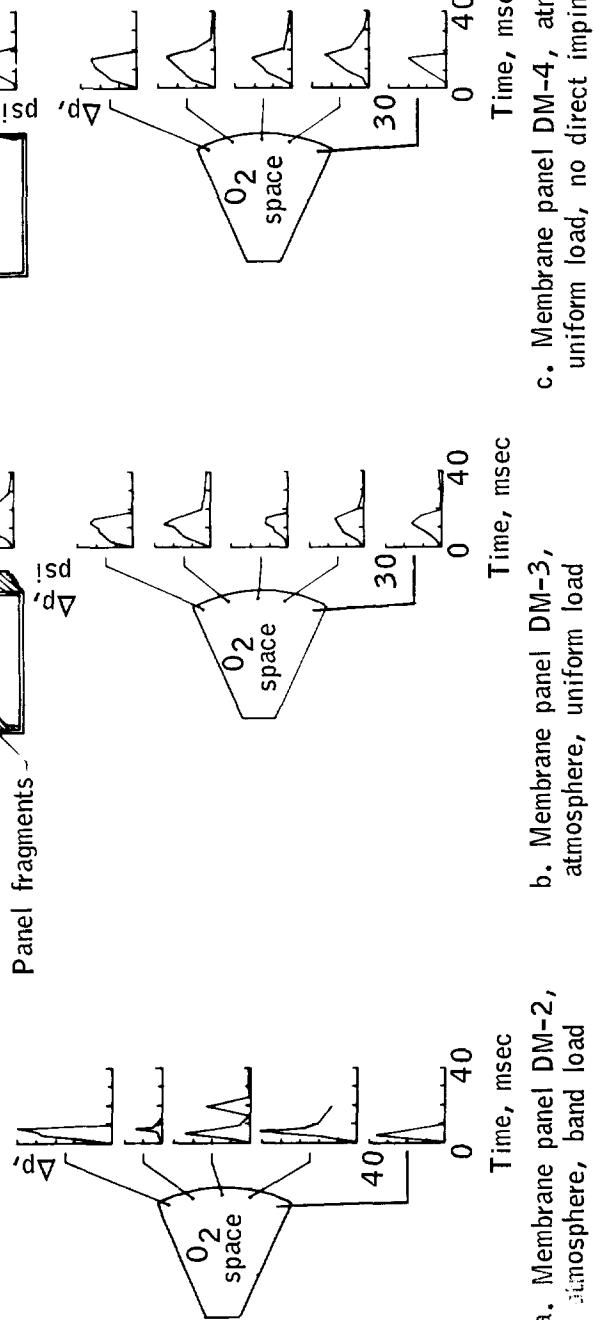
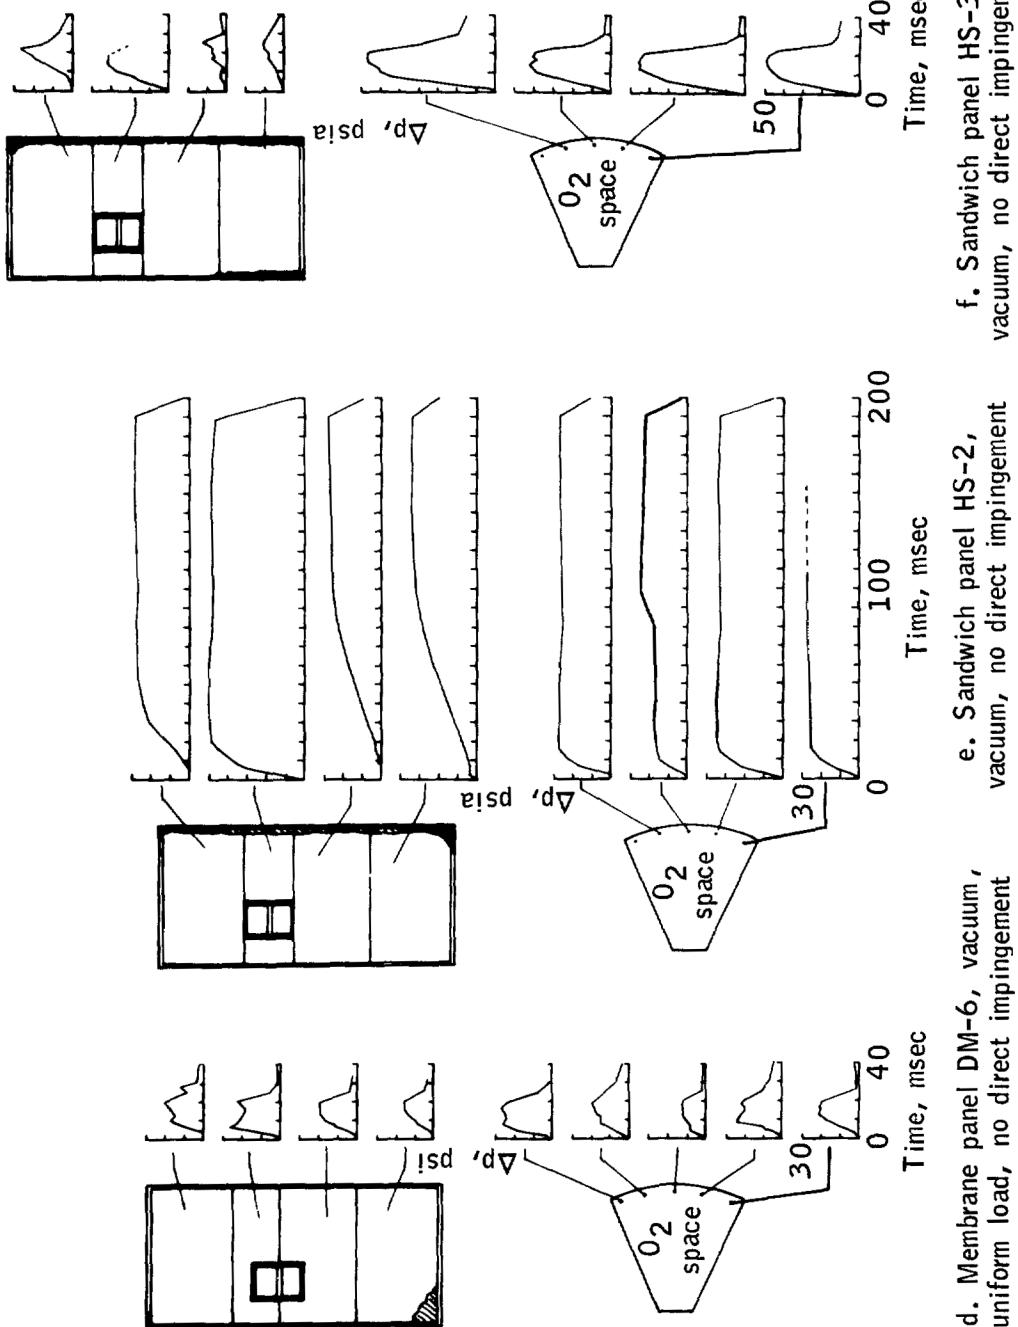
Figure F3.10-4.- Failure modes and pressure-time histories.

Demonstration of panel separation.- Panel separation has been demonstrated with both membrane and sandwich panels. Two sandwich panels separated completely from the test fixture during vacuum tests. Two membrane panels, although less representative of flight conditions, also separated completely in vacuum tests. However, similar tests with membrane panels in atmosphere left portions of panels attached to the test fixture as illustrated in figures F3.10-4(b) and (c). Complete separation in atmosphere could not be achieved due to mass and drag of the air.

Pressure distributions.- Complete membrane panel separation was achieved only with nearly uniform pressure distribution over the entire bay 4 panel cover, shown in figure F3.10-4(d). When just the oxygen shelf space experienced high pressures, membrane panel separation was localized to the area of the panel over the oxygen shelf space as shown in figure F3.10-2(a). This type of local failure occurred in both atmosphere and vacuum. When scaled internal venting was introduced, model DM-10 lost a slightly larger portion of panel due to high pressure experienced by both the oxygen shelf and fuel cell shelf spaces while the rest of bay 4 was at low pressure.

of the Apollo 13 SM shown in figure F3.10-2 and have been verified in these experiments. Peak pressure levels were varied from test to test but the curve shape was always similar. One sandwich panel separated after about 0.02 second during the initial pressure rise in the oxygen shelf space, while overall panel loading was highly nonuniform as shown in figure F3.10-4(b). The other sandwich panel did not separate until about 0.19 second after all bay 4 compartments had time to fill with gas and arrive at a much more uniform loading, as shown in figure F3.10-4(e).

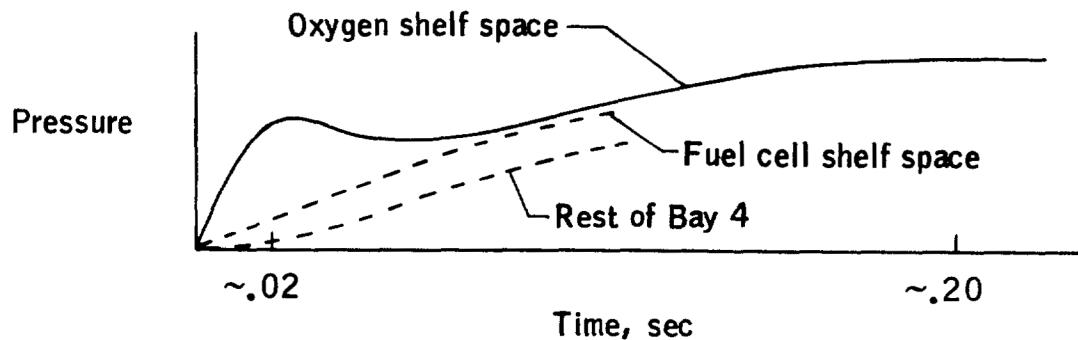
Figure F3.10-8.- Pressure build-up in bay 4.

Complete separation of sandwich panels has been obtained with both uniform and nonuniform pressure distributions. Figure F3.10-8 shows the type of pressure time histories experienced by various sections of the panels. The pressure predictions are based on the internal flow model

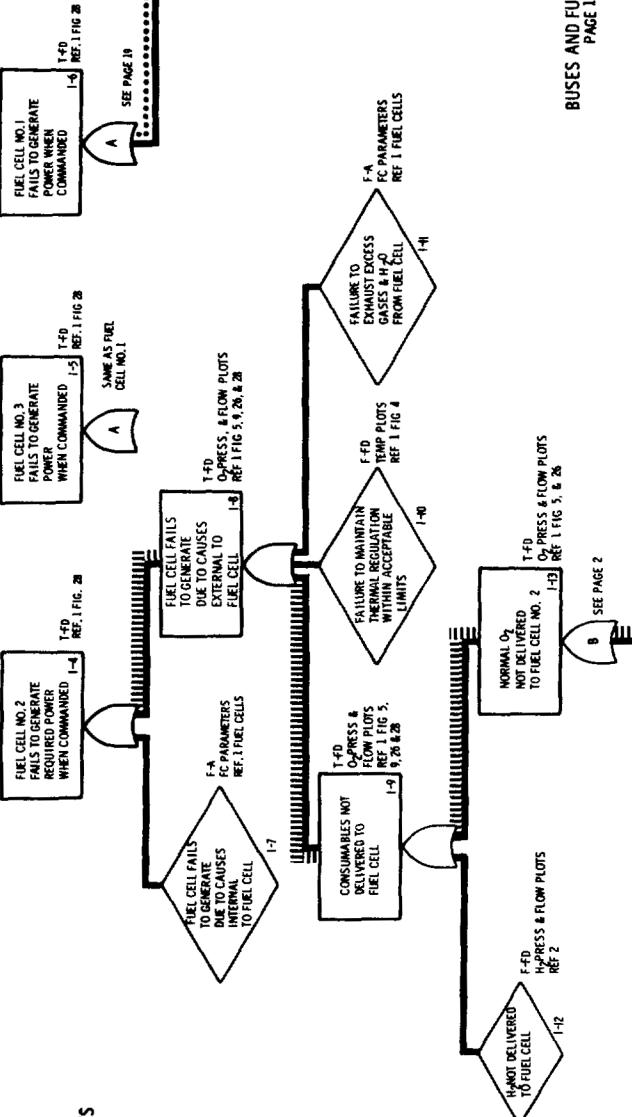
BUSES AND FUEL CELLS  
PAGE 1

F-0  
FUEL CELLS  
FAIL TO GENERATE  
POWER  
WITH COMMANDS  
PRESENT  
REF. 1 FIG. 28
